Detroit River Rehabilitation Site Survey 2015

Lake Erie Management Unit, 2016

DRAFT REPORT

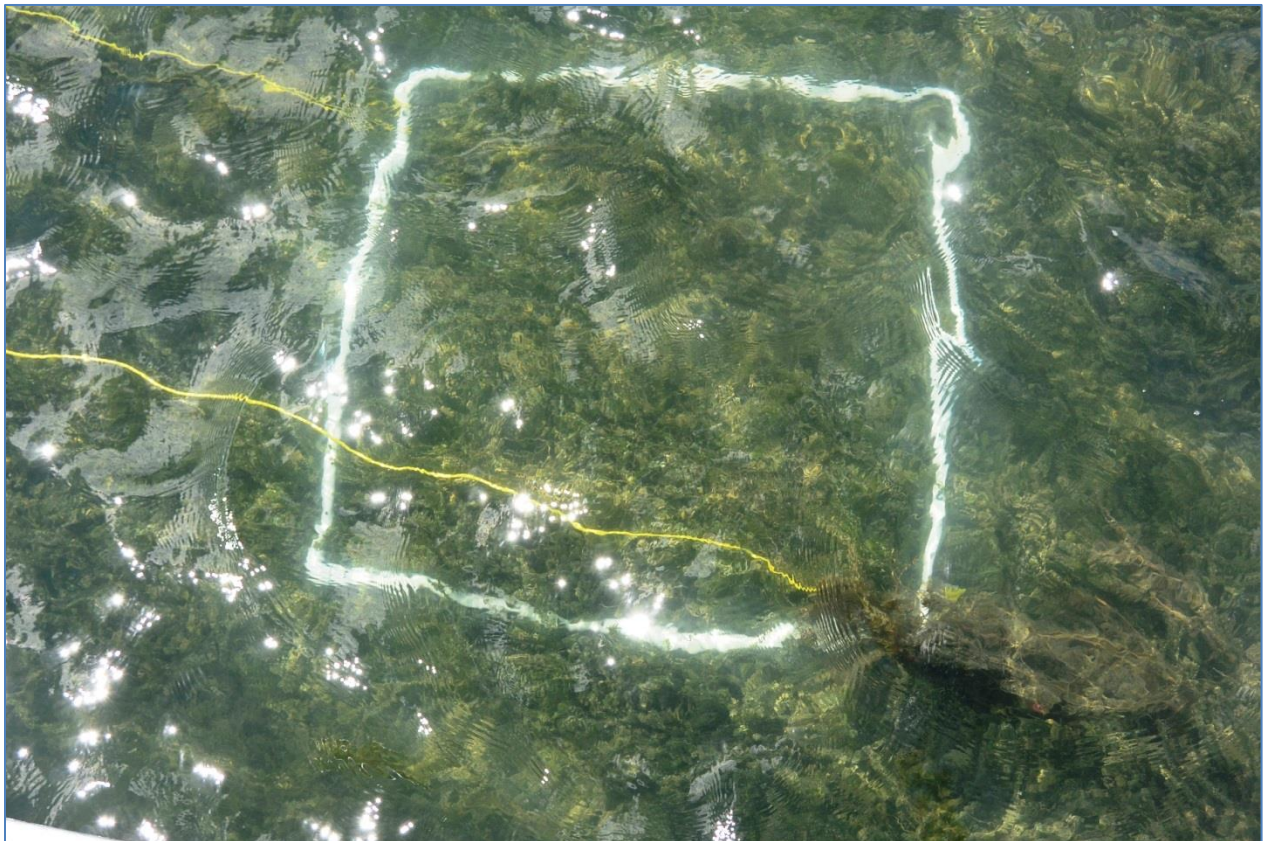
Figure 2: PVC pipe quadrat sampler, 1m x 1m, with attached floats used to sample SAV by rake method.

One of three methods were used to sample SAV at each quadrat: 1) rake method; which used a gravel rake with an extended handle to rake and retrieve all submerged vegetation within a 1m x 1m white PVC pipe quadrat sampler placed on bottom (Figure 2) 2) grapple toss; using a mesh lined grapple repeatedly

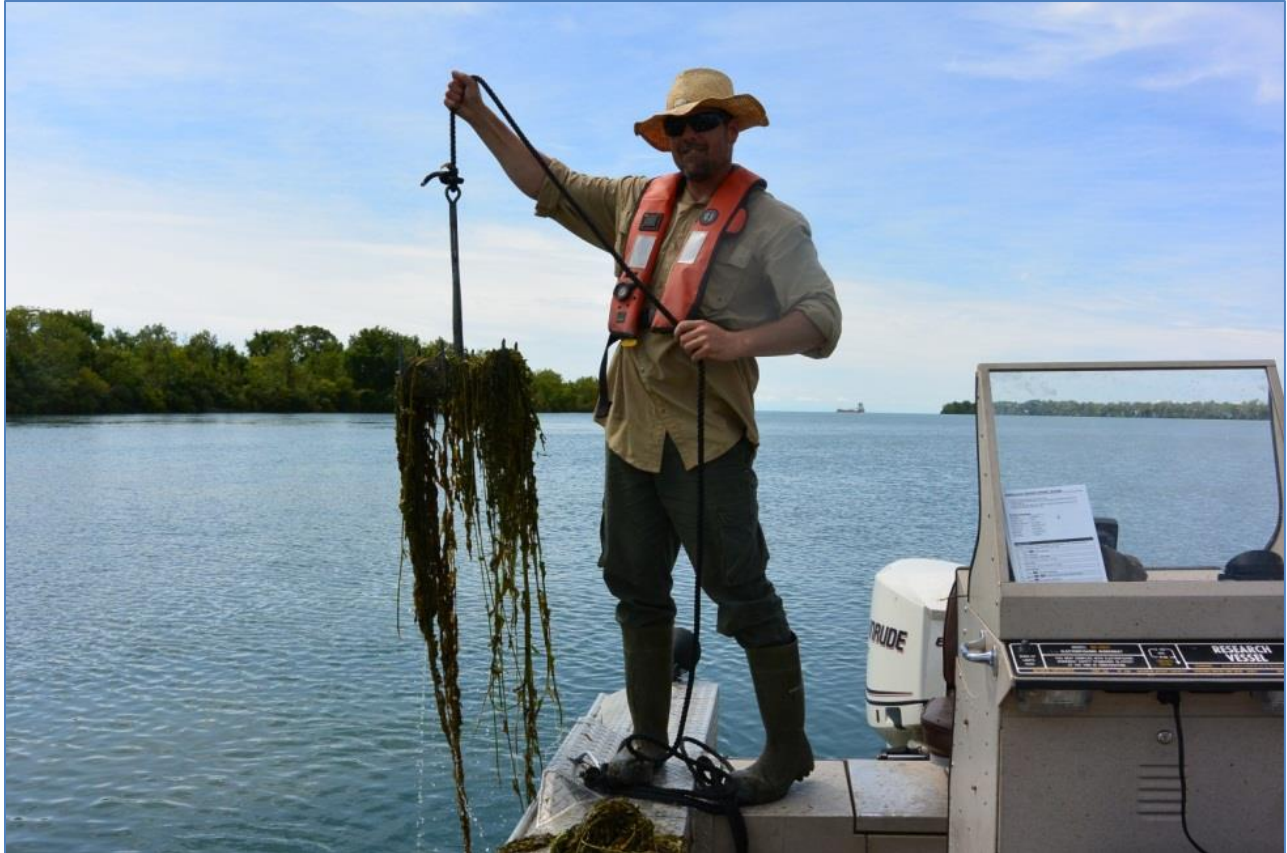
Figure 3: Grapple toss used to sample SAV at quadrats at Detroit River Rehabilitation Survey sites where water depths were too great to reach by rake.

tossed (3 times) into the water and dragged on bottom to retrieve SAV where water depths were too great for the rake method (Figure 3) 3) visual; where water depth and clarity made for easy identification of SAV coverage and species, confirmed with a quick rake sample. The percent coverage of SAV in quadrats was visually estimated; however, in cases where turbidity or depth was too great to see bottom, coverage was estimated based on feel and on quantity of SAV retrieved. SAV species were sorted and identified in the field and rated on percent dominance (Dominant $\geq 50\%$, subdominant $\geq 10\%$ to $< 50\%$, trace $< 10\%$). Species of SAV that were observed nearby but were not collected by sampling methods were recorded as being in the area. Any species of unknown SAV were bagged, labelled and kept cool to be examined and photographed for identification at a later date. Species that could not be identified were recorded to nearest identifiable family (ie. Potamogeton spp. with narrow leaf). Any presence/absence of photos of vegetation from quadrats was recorded.

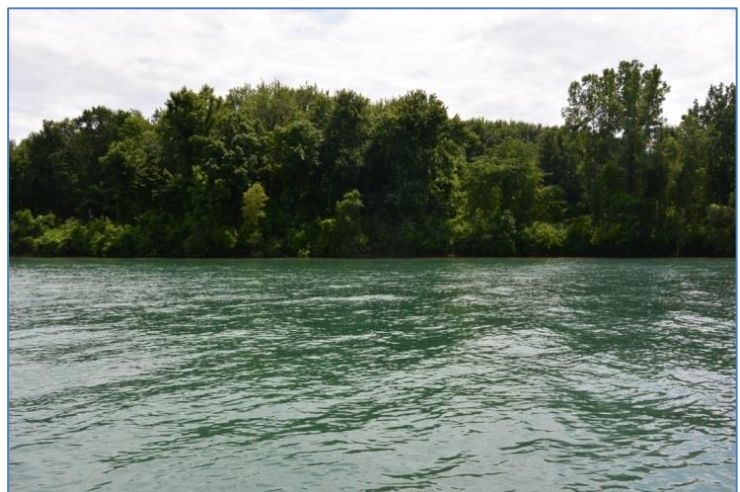
Figure 5: Pêche Island Site 1.

Pêche Island Site 1 is located on the north-east side of the island. It is fully exposed to lake conditions of Lake St. Clair and the water current that breaks at the tip of the island, flowing north around the island to the shipping channel. It has a shrubby and wooded shoreline cover and in 2015 with water levels above average, it had very little exposed shoreline (Figure 5). Conditions of the site appear to be much the same as those described in 1993 (OMNR, 1994)

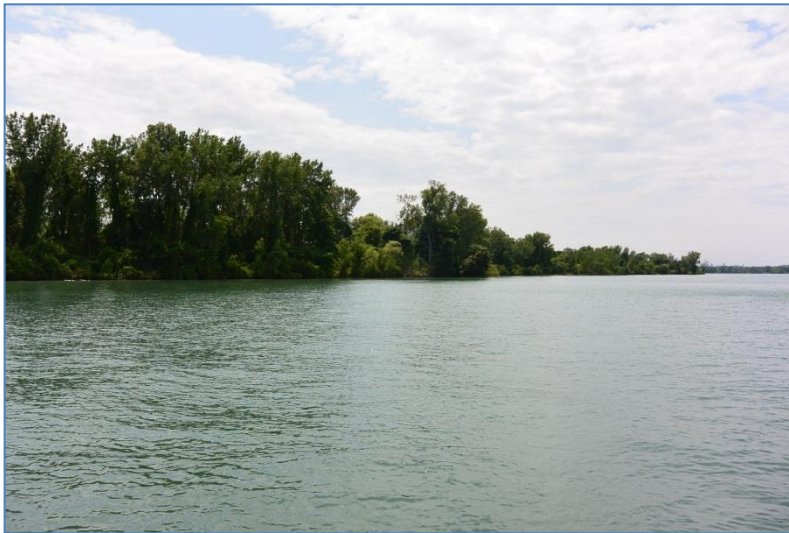
Figure 6: Pêche Island Site 2.

Sampling efforts for Pêche Island Site 2 were completed in the embayment on the northern side of the Island. Much like Site 1, this site is exposed to a large the fetch, as well as the shipping traffic that passes through the channel to the north of the island (OMNR, 1994). It has a heavily wooded and shrubby shoreline and as a result of high water levels, had very little exposed shoreline. A local kayaker encountered during the survey who frequents the island had reported that the site had experienced significant erosion over the last two years, where parts of the island trails that normally followed this shoreline had been washed away. This possibly was a result of increased ice cover and high water levels experienced in the last two years. Due to the size of the site, sampling efforts were spaced at greater distances in an attempt to accurately describe the site characteristics.

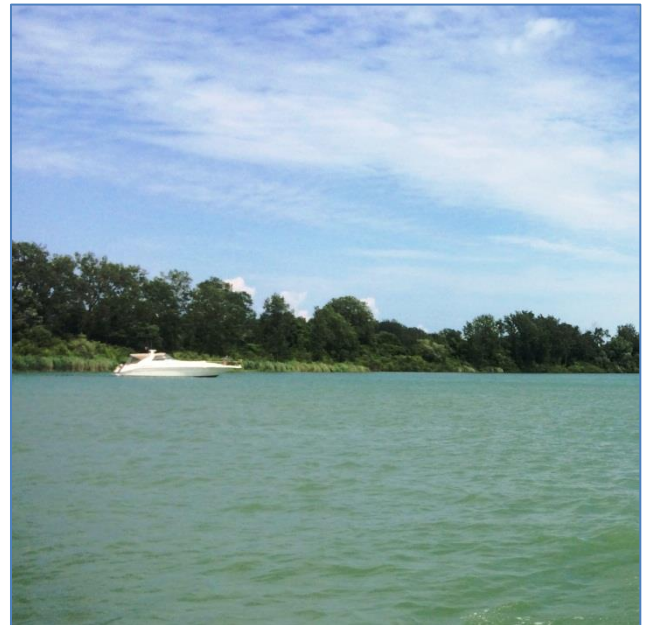
Figure 7: Pêche Island Site 3.

Located off the south and west shore of Pêche Island, Site 3 was characterized by a mix of wetland and sandy beach shoreline, as described in 1993 (OMNR, 1994). Phragmites (*Phragmites Australis*) was present along much of the shoreline. A wide, shallow shelf at the mouth of the inner canals tapers to a narrow point at the west before dropping off quickly to deeper waters (Figure 4). The channel to the south is regularly used by pleasure craft and the beach is frequented for recreational use (Figure 7).

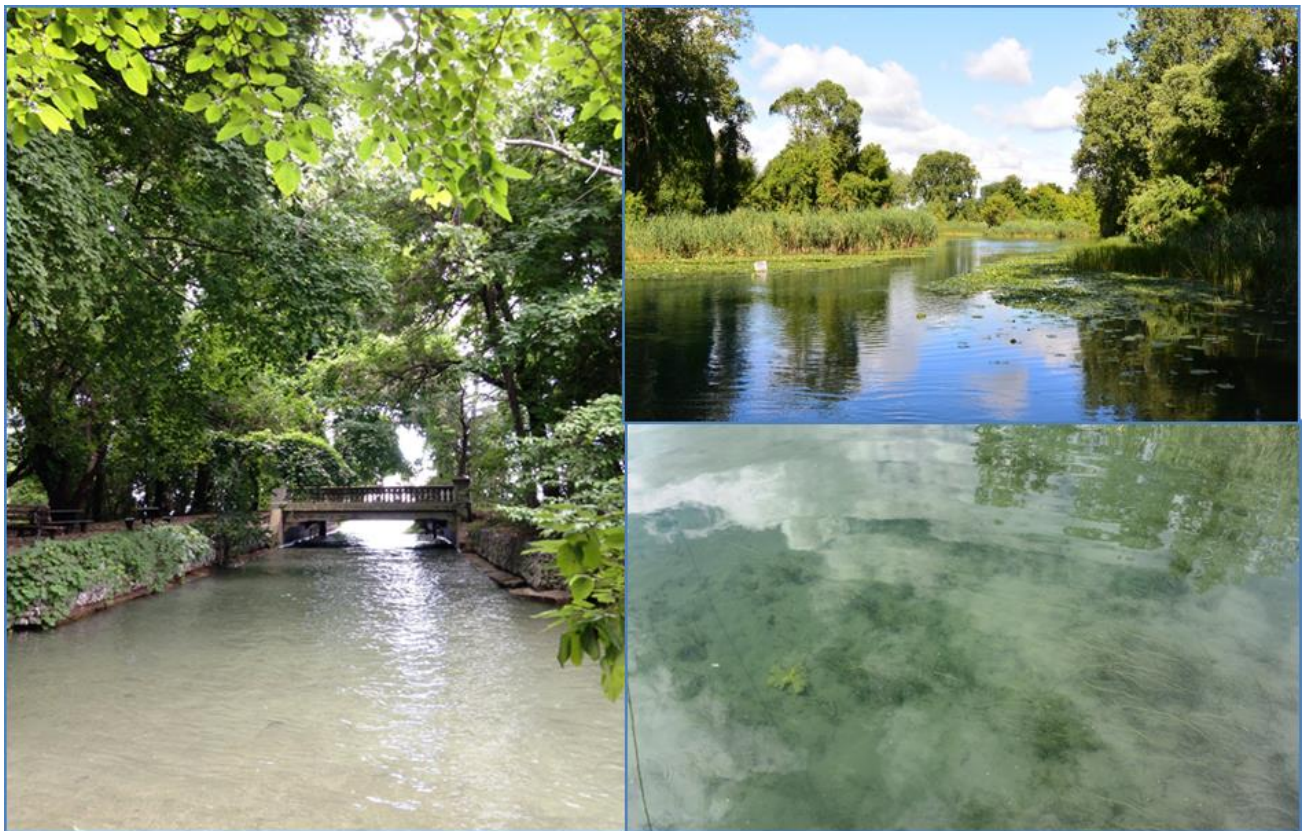
Figure 8: Pêche Island Site 4. Clockwise from left: the canal entrance, looking west at inner canals from near entrance, silt deposition in the canals.

In the 1993 OMNR report the canals were described as being “primarily closed off from flow through river water due to siltation in the upstream canal entrance” (OMNR, 1994). In 2015, the entrance channel to the inner canals did not appear to be closed off from flow-through river water, possibly as a result of high water levels. Alternatively, local information indicated that dredging had been occurring under the bridges to allow non-motorized boats passage, however, this information was not confirmed with the City of Windsor. There did appear to be evidence of heavy siltation in the canals in general. Local knowledge indicated that the canals used to be deep enough to allow for passage of sail boats with

Water quality, specifically turbidity, was not found to be degraded in the summer of 2015. Parameters met PWQOs and were within normal ranges for a freshwater river (Table 4). Sediment composition was mostly made up of silt (56%), sand (21%) and clay (14%) (Figure 37). Mean SAV coverage was relatively low 56% (SE = ± 16%) with only three other river survey sites with lower mean coverage. However, SAV species richness was highest (SR=17) at this location. Canada Waterweed, Curly White Water Crowfoot, and Wild Celery were the most dominant species. This site had some unique species not seen at other survey sites including; Duckweed sp. (*Lemnaceae sp.*), sedge sp (*Carex sp.*), and Yellow Waterlily (*Nuphar sp.*). Phragmites was observed in the canals as well, however did not fall within any quadrat samples.

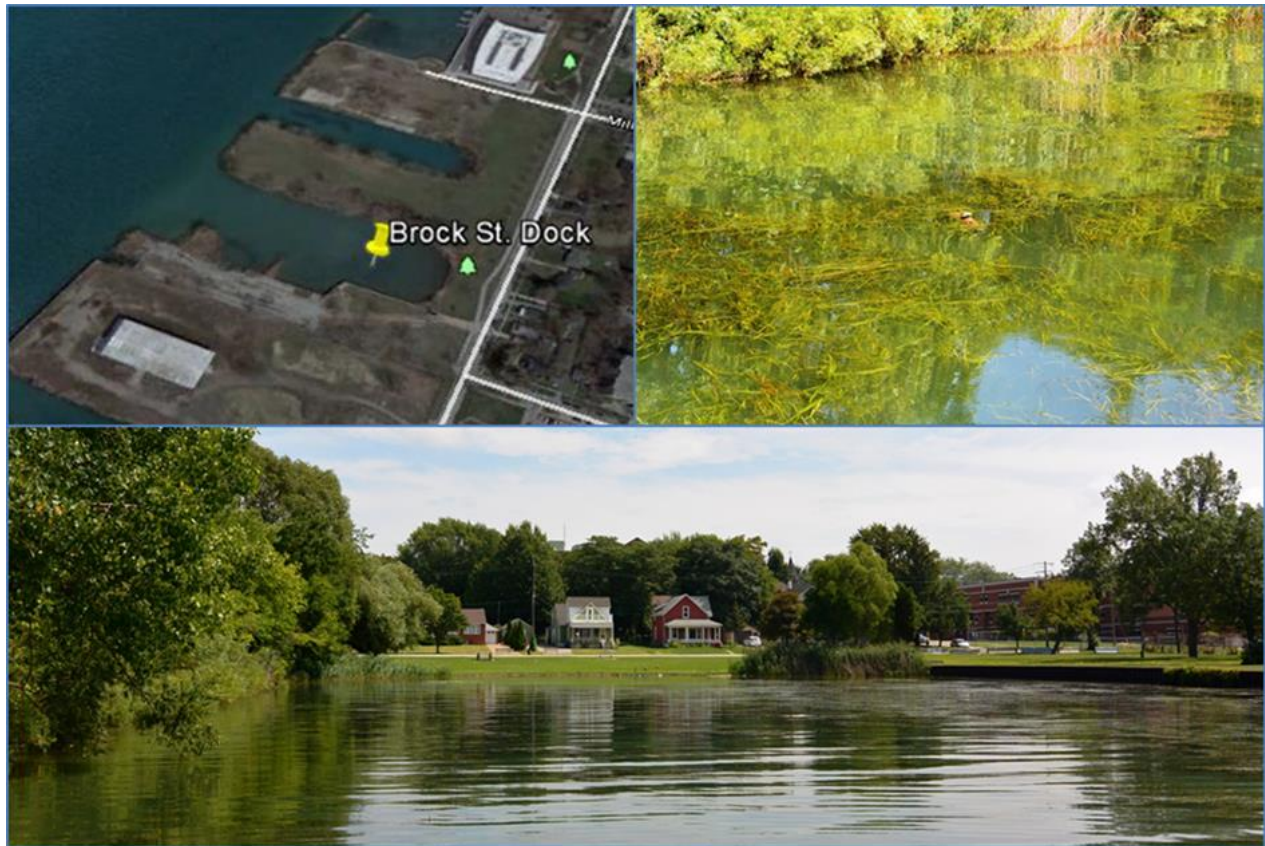
Figure 9: Brock St. Dock. (Satellite image: Google, 2016).

Brock Street Dock is located just south-west of the Ambassador Bridge and is owned by Windsor Port Authority, City of Windsor and Ambassador Bridge. The shoreline is mostly rocky rubble on the north side of the dock and a mix of failing steel wall and rubble on the south side. The dredging company that previously owned the property used material from another dredging site to fill in behind the steel wall. This was done illegally in the 1970's and the federal government subsequently took possession of the property (DRCC, personal correspondence). The city has created a small park on the shoreline and locals angle from the steel wall for fish. This site was not previously assessed in the 1993 OMNR report.

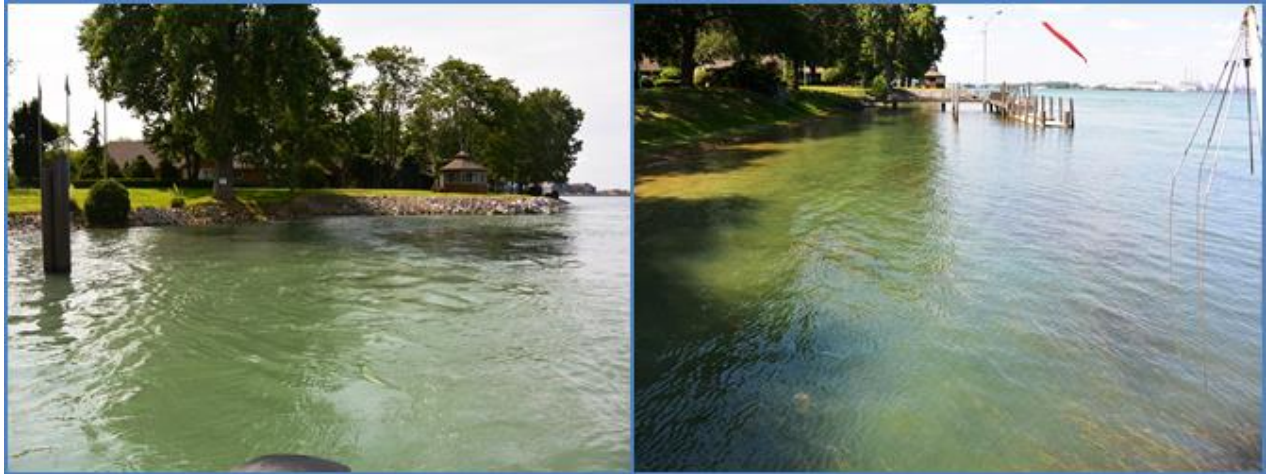
Figure 11: Fighting Island Site 1.

In 2015, the coordinates provided for the site 1 survey were located in the small bay adjacent to the main lodge for the hunting club and gazebo. The survey was completed from the gazebo to approximately 100m downstream past the main guest dock to the small caretaker and fishing boat docks. The underwater shelf at this location extends approximately 20m into the river before water depths drop off quickly from approximately 1m to 8m depth. The site description in the 1993 report suggests that the site identified for potential rehabilitation could have been 300 – 400 m further downstream, from the tip of the point to the work dock across from Senator Street. At this location the underwater shelf extends approximately 100m into the river as described in the 1993 report. Likely this was due to a misinterpretation of the text which described the site as being “a small cove adjacent to the northeast shore of the island where the corporation has its hunting club and docking facilities” (OMNR, 1994).

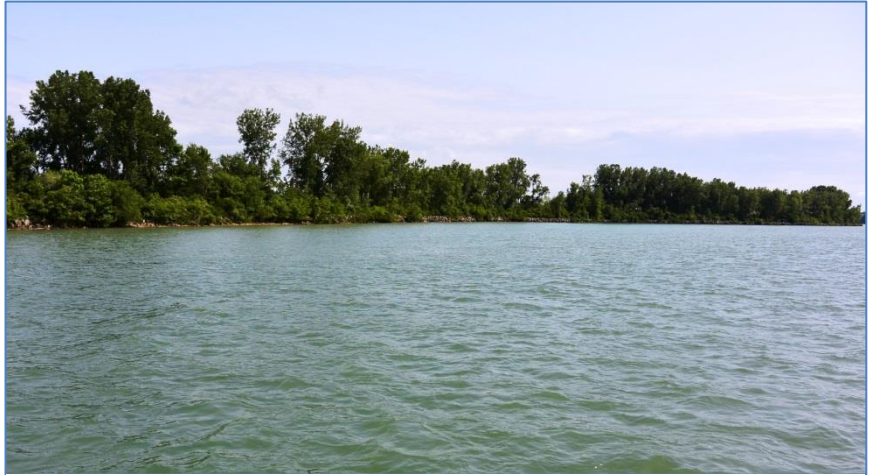
Figure 12: Fighting Island Site 2.

Site 2 is located in a cove off the northwest tip of Fighting Island. The shoreline is vegetated with trees and shrubs, reinforced with rock and boulders (Figure 12). It has a shallow underwater shelf that extends approximately 200m into the river. It is open to shipping traffic in the Fighting Island Channel and the day the surveys were completed it was observed that the wake from a single freighter could produce a wave over 5ft tall that would travel the length of the shoreline.

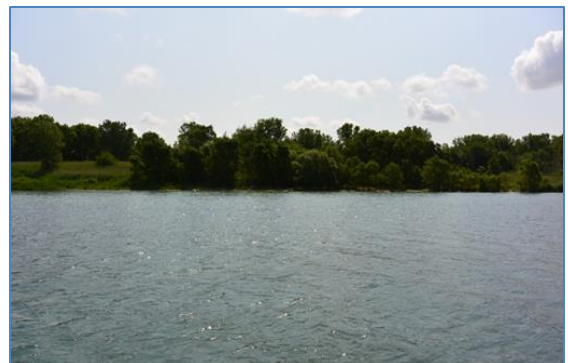
Figure 13: Fighting Island Site 3.

The site survey was completed off the most northerly end of the northern disposal cell, starting at the islands north channel working south. As site characteristics were similar along the disposal cell the survey location was considered to be representative of the entire area. The shoreline is a mix of sandy beach, Phragmites, trees and shrubs (Figure 13). The shoreline of the north channel is reinforced with rock where it drains into the Detroit River.

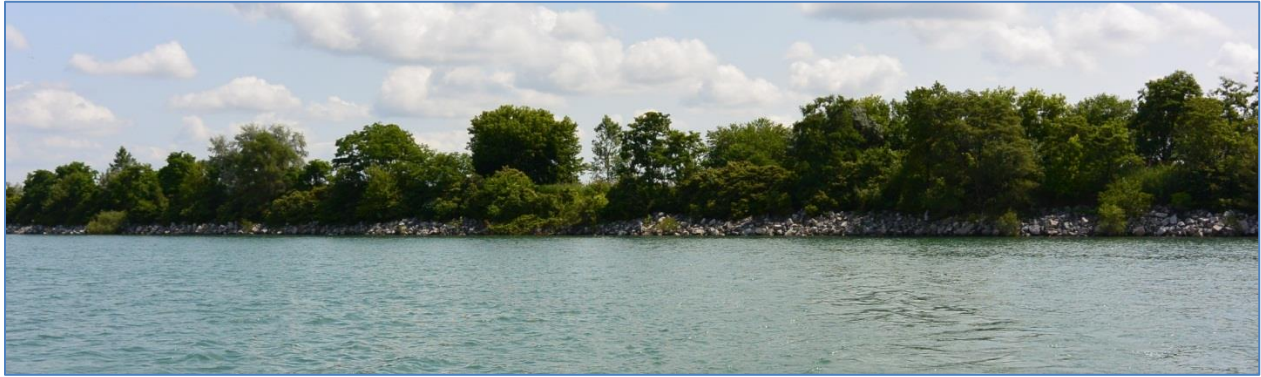
Figure 15: Fighting Island Site 5.

Fighting Island Site 5 is located off the western shoreline of the southern disposal site. In 1993, it was reported that “some gravel and boulders exist along the shoreline” however, in 2015 it appeared that the shoreline was heavily reinforced with rocks and boulders (OMNR, 1994). The expanse of the underwater shelf remained to be approximately 600m from shore to its drop off at the main channel. Also, a narrow channel exists immediately parallel to shore, running the length of the disposal cell.

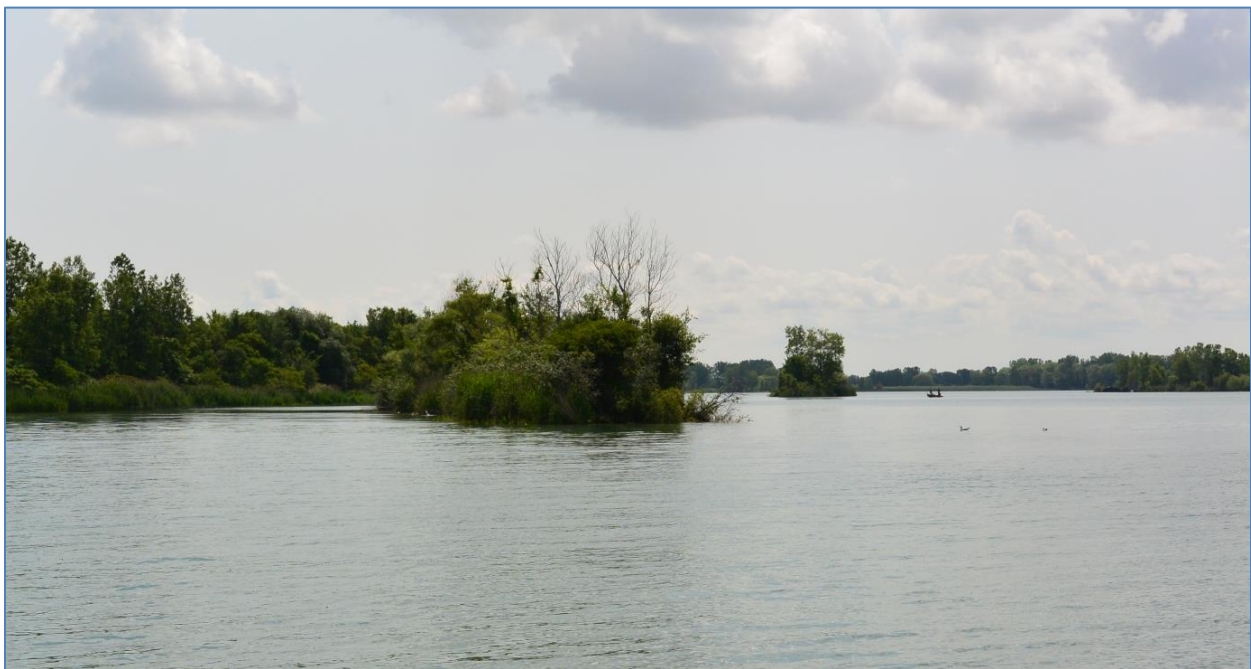
Figure 16: Fighting Island Site 6.

Located on the southern shore of Fighting Island, Site 6 has a narrow channel that runs immediately parallel to the shoreline. On the south side of the channel are two islands approximately 300 meters apart; the western island is approximately 125m long by 15m wide and the eastern island is approximately 40m long and 15m wide. As described in 1993, the main shipping channel lies to the west and the smaller Grassy Island boating channel lies to the east. These channels meet roughly 3500 meters to the south. It was reported that the historic wetlands and islands have eroded away as a result of wave action and higher water levels (OMNR, 1994). Evidence of such erosion was observed in 2015 (Figure 16) where vegetation could be seen falling into the river on the south side of the small western island. The shoreline of the island was characterized with shrub and tree cover with Phragmites. This site was surveyed across the expanse of the island due to the variability in site characteristics.

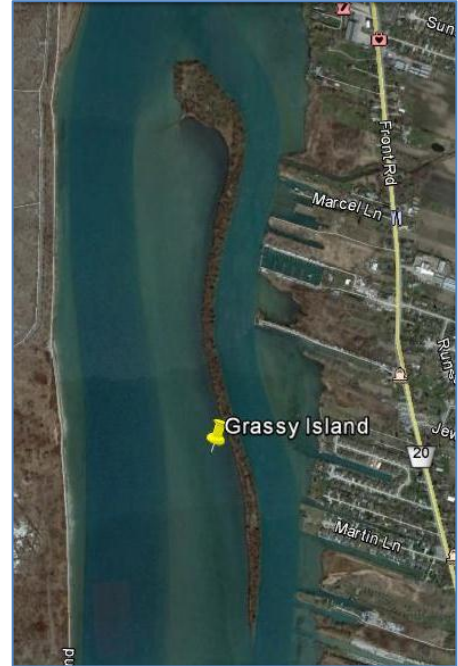
Figure 17: Grassy Island.

Surveys were completed off the western shoreline of Grassy Island, where an underwater shelf extends approximately 300m to the Grassy Island boating channel (Figure 17). Local knowledge indicated that the island is mostly reclaimed land filled with refuse from Detroit, Michigan. It was observed that pieces of broken glass, china and other bits of refuse comprised most of the shoreline material at minimum at the survey site and the southern tip of the island. It is vegetated mostly with trees, shrubs and Phragmites. The island extends over 1600 meters (north-south) and although there is a small protected cove at the head of the island, the majority of the shoreline had similar characteristics to the survey location. It was therefore considered to be representative of the majority of the western shoreline of the island.

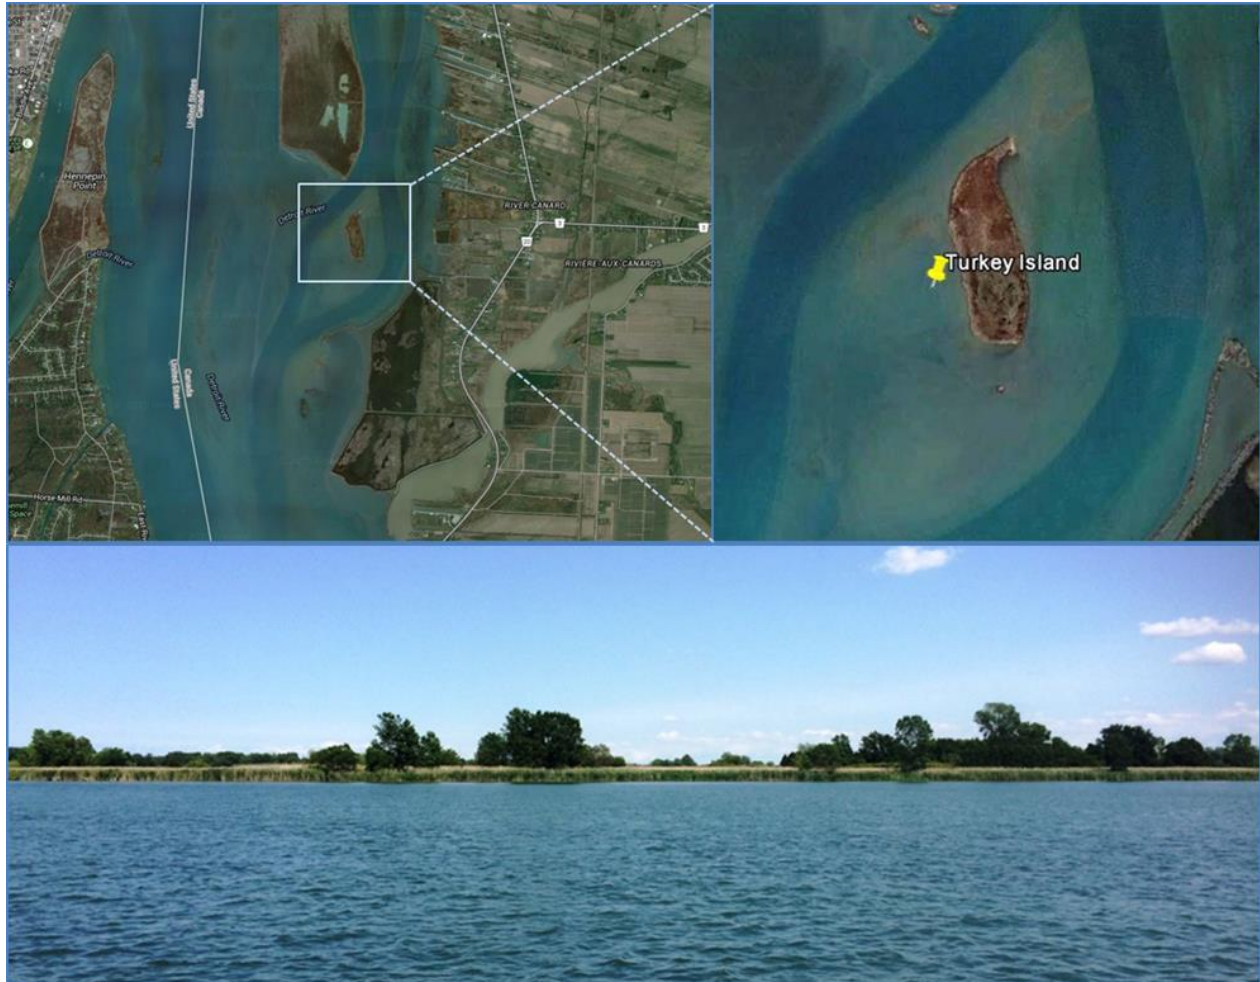
Figure 19: Turkey Island. Top: satellite images (Google, 2016), bottom: looking east at islands western shoreline.

Turkey Island is a privately owned island located off the south east tip of Fighting Island. The boating channel, which runs along the east side of Fighting Island, splits at the northeast end of Turkey Island and then re-converges downstream at the southwest end of the island (Figure 19). The site is open to a large fetch to the south and west as well as wave action from boat wake from the surrounding channels. The island is vegetated with some trees and shrubs, with a fairly dense population of *Phragmites* (Figure 19). No description of the site was available from the 1993 OMNR report as a result of a page missing from the original scanned document.

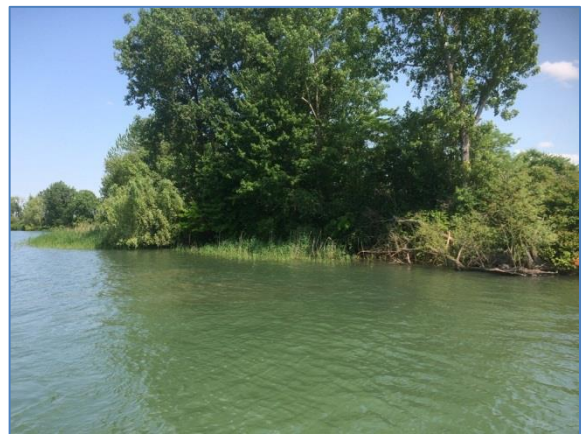
Figure 21: Canard River Marsh site (finger dyke).

The Canard River marsh survey site was located on the north shore of the finger dyke (Figure 20). It was reported in 1993 that the finger dyke had significantly eroded as a result of wave action and currents (OMNR, 1994). This dyke protects the Detroit River AOC wetland (Canard River Marsh wetland) by creating a calm water area to the south of the dyke. The dyke vegetation includes shrubs and trees with patches of Phragmites on a rocky shoreline. In 2015, high water levels allowed overtopping in low areas of the dyke.

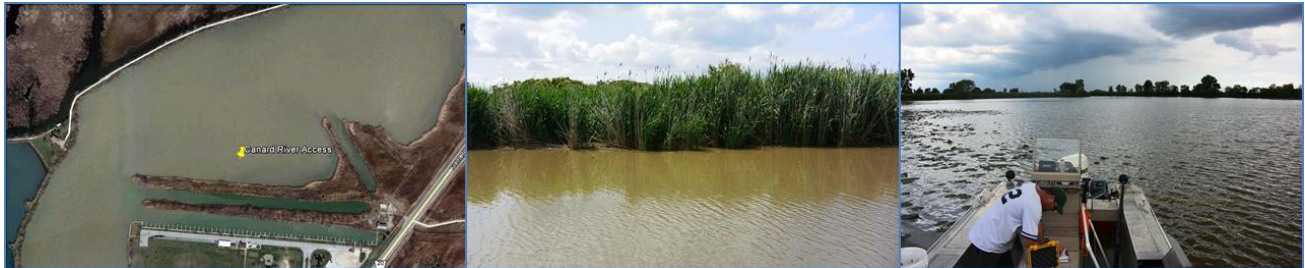
Figure 22: Canard River Access. Left: Satellite image (Google, 2016); Centre: Phragmites and high turbidity at site; Right: looking north from site location.

In 1993 the site was described as the area of wetland located southwest of the bridge for Highway 20 (formerly Hwy 18) (Figure 22, left). It was characterised as a shallow with a silty clay bottom, with four hardened land spits which protrude into the river. The land spits were described as vegetated in coarse herbaceous plants such as ragweed and some willow clumps, and SAV was identified as being limited by high turbidity (OMNR, 1994). The land spit shoreline vegetation characteristics observed in 2015 appear to differ from those in 1993. Dense populations of Phragmites currently line the shoreline for much of the area around the land spits (Figure 22, centre). Shallow water conditions of the river made sampling the >2m water depth habitat difficult, therefore the deepest location found (average depth = 1.3m, north of the centre of the river) was sampled instead.

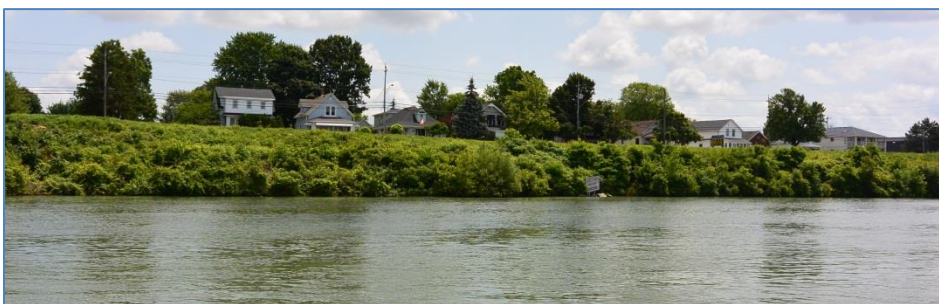
Figure 24: Heritage River Lookout.

This site was not originally identified for potential rehabilitation or enhancement projects in the 1993 OMNR report. It was identified by the DRCC working group as a potential location due to proprietary access. The strip of land south of the marina and north of the Amherstburg visitor centre, between the river and the road, is owned by the Essex Region Conservation Authority (Figure 23). The shoreline is covered in herbaceous vegetation and with sparse shrubs. There is a 'Do Not Anchor' sign, indicating a submerged cable crosses this section of the river, approximately 150m downstream of the marina (Figure 24).

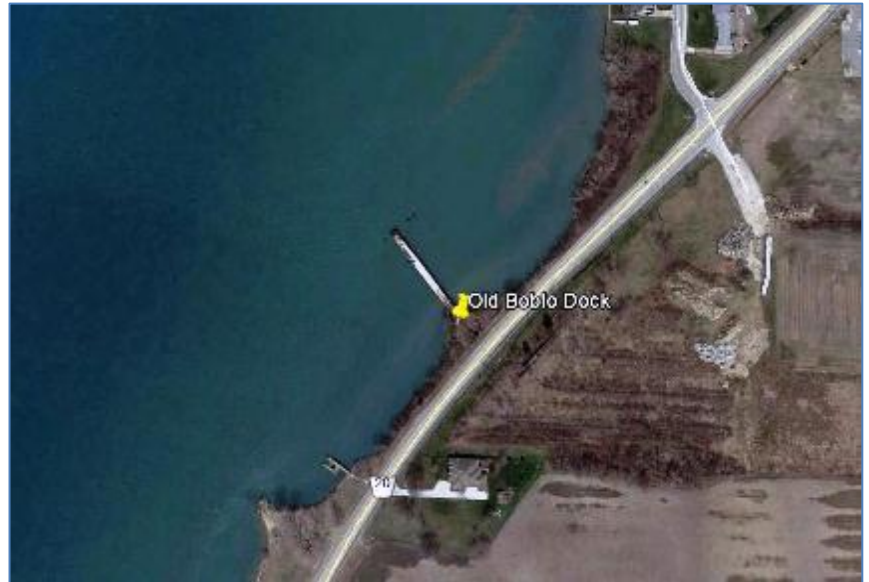
Figure 25: Old Boblo Dock (Amherstburg) (Google, 2016).

This site was also not originally identified for potential rehabilitation or enhancement projects in the 1993 OMNR report. It was identified by the DRCC working group as a potential location due to proprietary access (owned by DFO). The old amusement park loading dock currently resides in a dilapidated state in a shallow cove adjacent to Hwy 20 (Figure 25). The dock has been a topic of interest for the town of Amherstburg who reportedly want the old dock removed or improved as it is potentially a safety hazard and unsightly for local residents (Windsor

Star, 2016). The shoreline is vegetated with a mix of grass, trees, and shrubs, reinforced in areas with riprap material. There is also a frame of a sunken vessel or barge at the north east end of the cove. The site was surveyed approximately 100m upstream and downstream of the Old Boblo Dock.

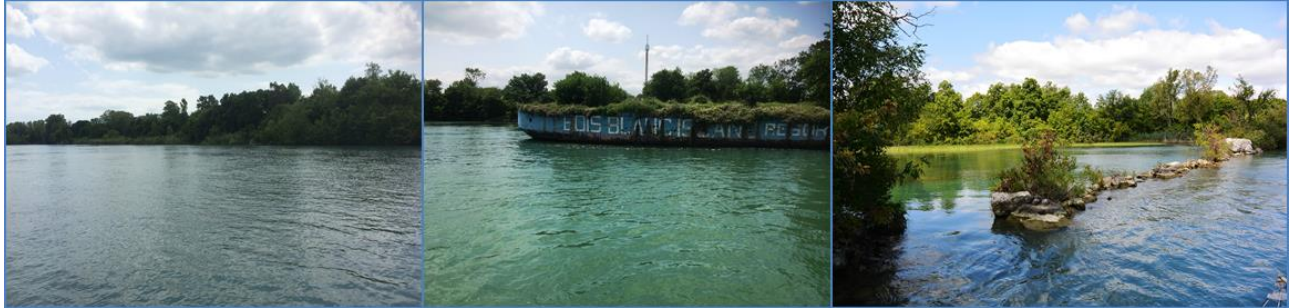
Figure 28: Boblo (Bois Blanc) Island Site 3. Left : South end of cove; Centre : abandoned dock in centre of cove; Right : north end of cove).

This site was described as a shallow cove (depths averaging 1.5m) on the eastern shore of the island, divided by a permanent docking facility (OMNR, 1994). It was characterized by an existing breakwall on the north side of the dock and the absence of any such breakwall to the south (OMNR, 1994) (Figure 28). In 2015, a partial submersed breakwall composed of armourstone was observed to extend approximately 100m north from the southern tip of the cove. Survey sampling was minimal (one bin with three quadrats) on the north side of the dock as the shallow embayment behind the breakwall was inaccessible by electroboat. It was observed that both emergent and submergent aquatic plants were present in the bay and that highwater levels allowed for overtopping of the breakwall. The majority of survey sampling was conducted south of the dock.

The area south of the dock is characterized by a sandy beach embayment created by the dock structure itself. The dock has fallen into a state of disrepair and steel walkways extending from the dock were observed to be falling into the water. The eastern shoreline of the cove was vegetated with trees, shrubs and patches of Phragmites. The shoreline was also reinforced with riprap in different locations. The south end has a natural shoreline leading up to the point from which the submersed rock wall extends. During the habitat survey a freighter passed the site heading north in the Amherstburg channel (east of the island) which caused a significant displacement of water from the cove, drawing SAV out of the cove and drastically raising turbidity levels when water returned to the cove. It can be concluded that freighter traffic has a significant effect on the habitat of the cove.

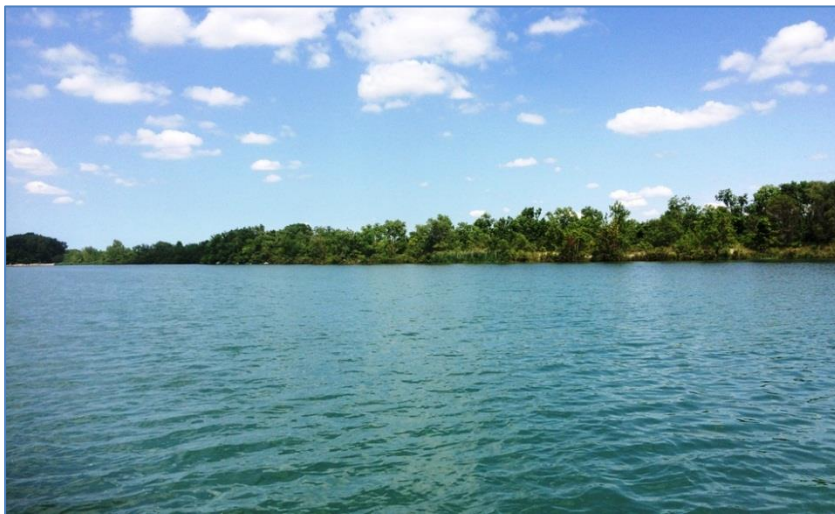
Figure 29: Boblo (Bois Blanc) Island Site 4.

As described in 1993, this site is adjacent to a large sand spit approximately 1900 m long, extending from the southeast tip of the main island in a south west direction (OMNR, 1994). The resulting cove on the west side of the spit was described as having minimal aquatic vegetation, as well as minimal vegetation on the spit in 1993, which no longer appeared to be the case in 2015 (Figure 29). ERCA's

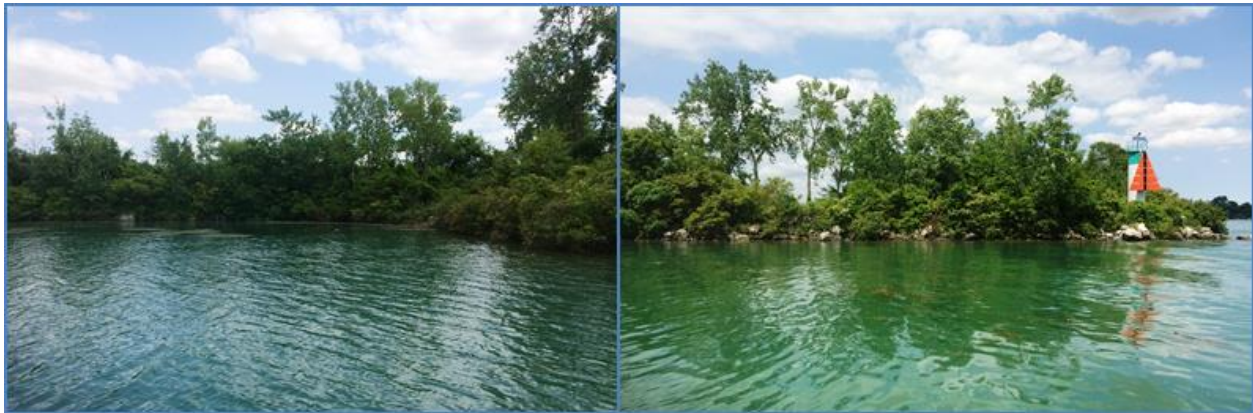
Figure 30: Boblo (Bois Blanc) Site 4b. Left : north shoreline of the boot shaped tip; Right : South shoreline of the boot.

The southern tip of the Boblo Island sand spit forms a boot shape, creating a small cove on the northern shoreline (Figure 27). This section of the sand spit is heavily reinforced with rocks and armourstone with trees and shrubs providing overhanging cover for the shoreline (Figure 30 and 31). Water depths quickly drop off to depths greater than 5m. It was not identified originally in the 1993 report to be able to infer any changes that may have occurred over the following 22 years.

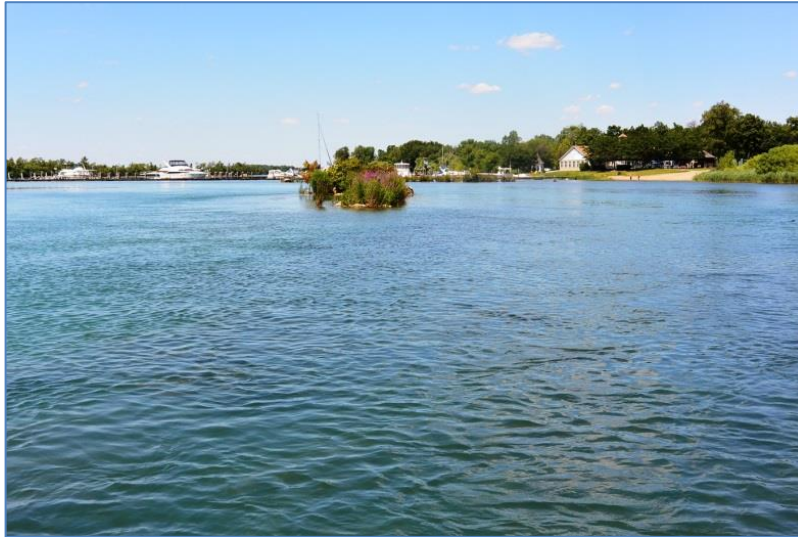
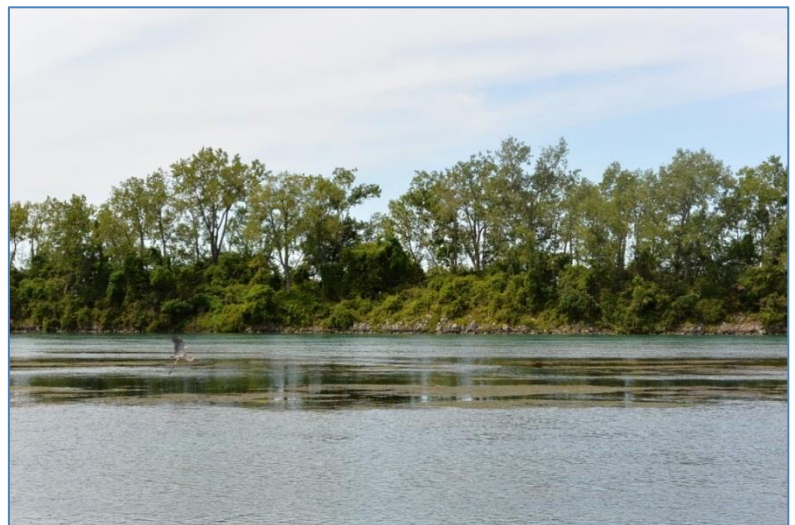
Figure 32: Boblo Island Site 5, south of marina, looking north.

remained the same in 2015, although only two shoals (partially exposed) could be found south of the marina and none on the north side (Figure 32 and 33). The survey was restricted to the area south of the marina as it appeared to be representative of the entire shoreline.

Figure 33: Looking west at the Livingston Channel berm from Boblo Island Site 5.

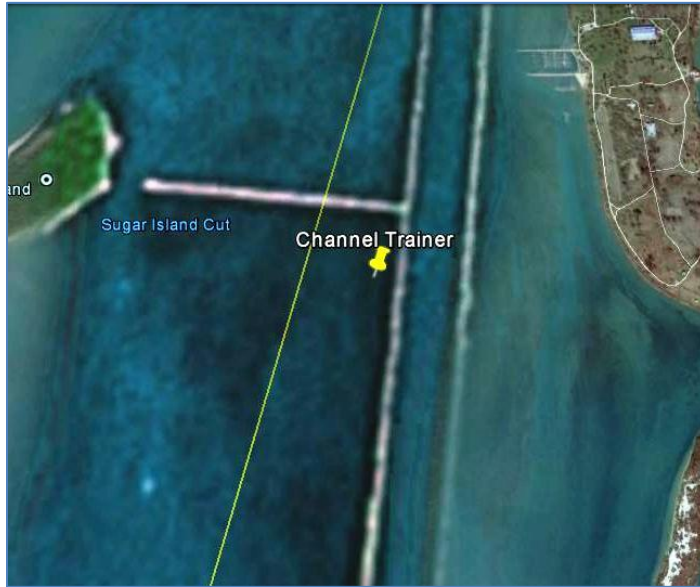
Figure 34: Channel Trainer.

The channel trainer runs perpendicular to the the west berm of the Livingston Channel and ends straight out from Sugar Island in U.S. waters (Figure 34). The international boundary lies approximately 200-300m west of the Livingston Channel at the channel trainer and continues in a southwest direction from that location. The berms to the north and east are constructed of armourstone and are partially vegetated with shrubs and trees (Figure 35). To the south, the site is open to the west basin of Lake Erie. The area south of the berm was described as a calm water area averaging one to three meters depth with a “good amount “ of SAV in

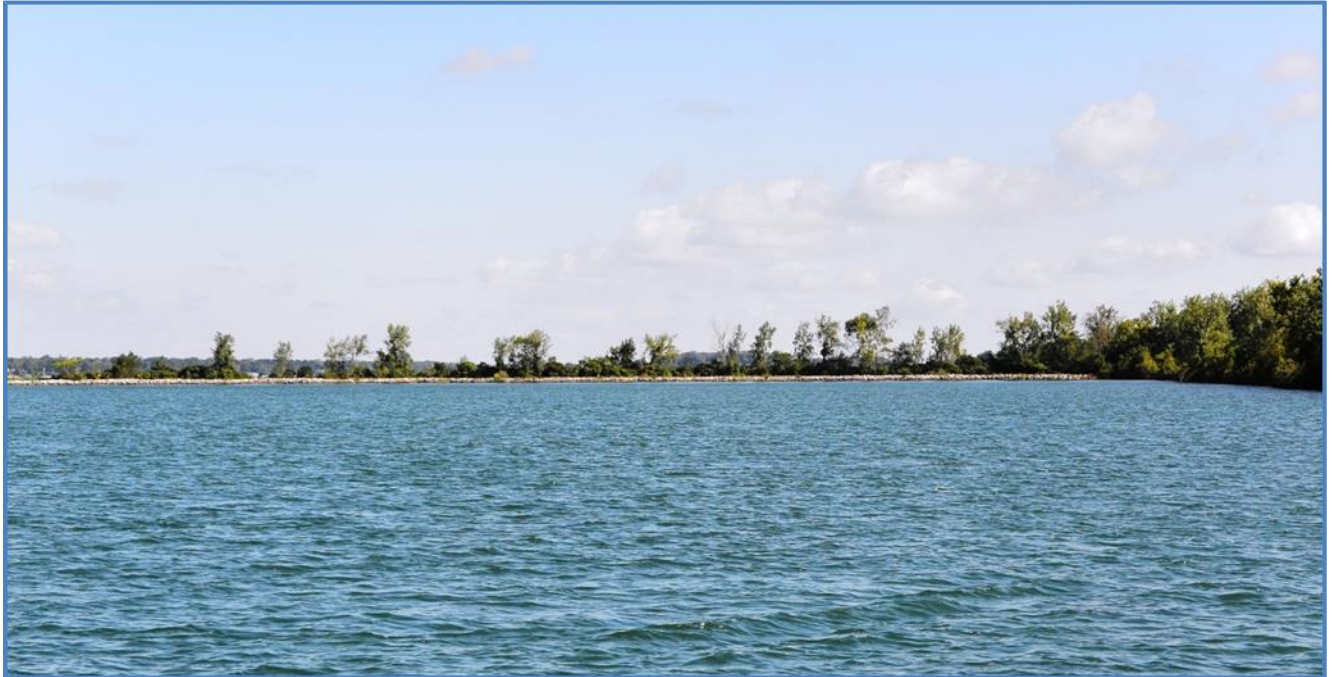
except along shore, therefore estimating SAV coverage was very difficult to determine with any accuracy. It is this author's opinion that SAV coverage at least exceeded 50% for the site based on the frequency and quantity of SAV retrieved during the survey. Species richness was the second highest for this site of all sites surveyed (Table 4), its composition dominated by Wild Celery, Richardson's Pondweed, Canada Waterweed, Slender Naiad, and Coontail.

Figure 35: Picture taken south of the channel trainer, facing north.
