HILLMAN MARSH CONSERVATION AREA

RESTORATION PLAN

ESSEX REGION CONSERVATION AUTHORITY

ENVIRONMENT AND CLIMATE CHANGE CANADA

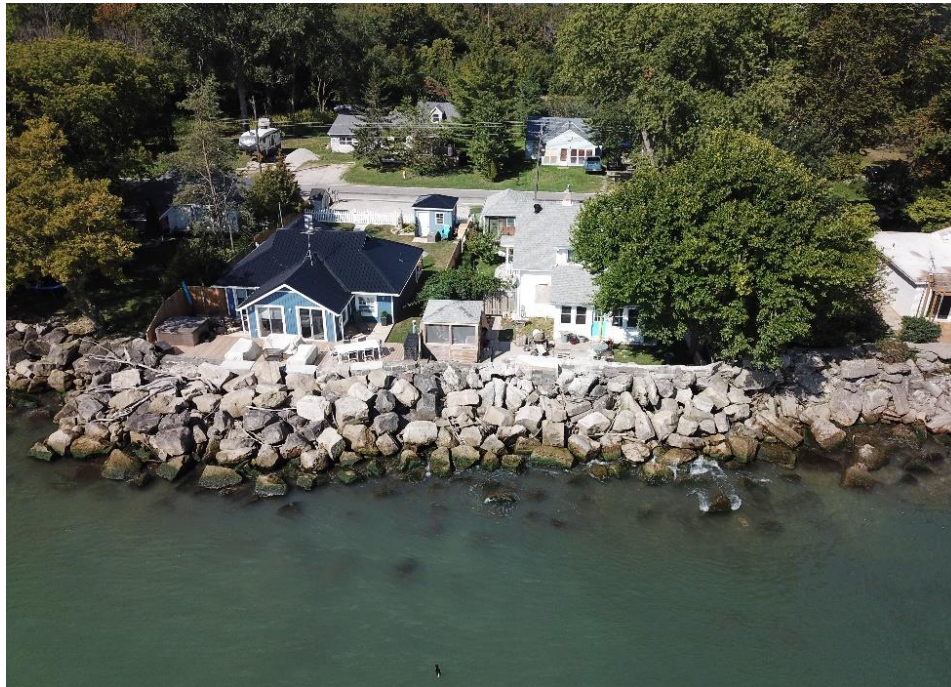
Figure 2: Shore parallel armour stone structures along Pulley Road.

supply of sediment that nourished and maintained the barrier beach, and this likely accelerated nearshore downcutting of the lakebed (Fig. 2; Zuzek Inc., 2021).

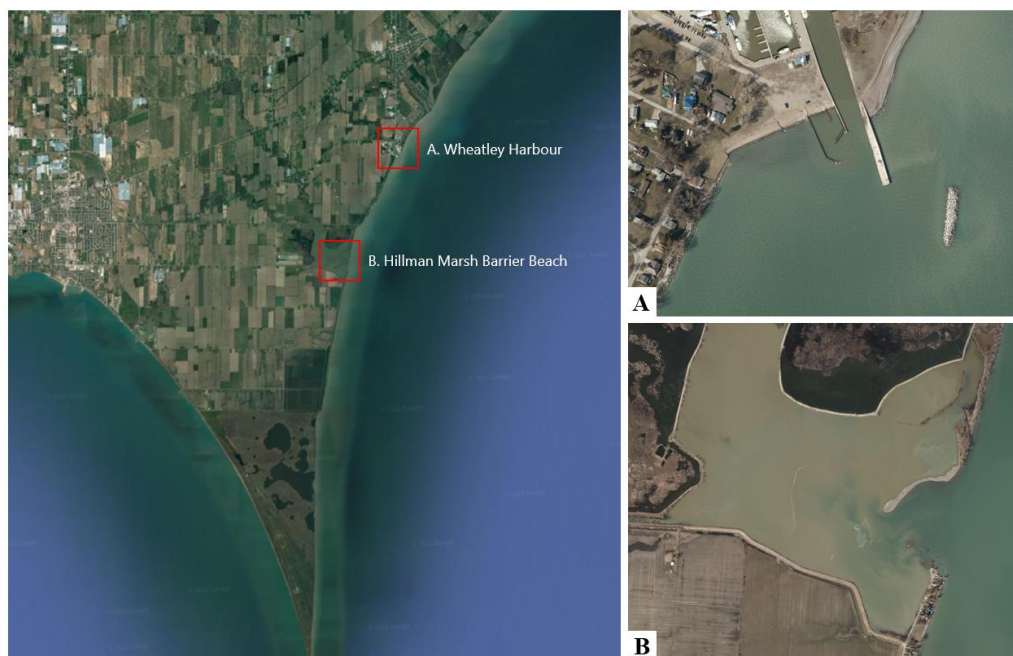
Figure 3: Hillman Marsh is located on the Point Pelee Peninsula, extending south of the shore of Essex-County. (A) The Wheatley Harbour and attached jetty have trapped or removed 525,000 m³ of sediment from the downdrift shoreline, directly affecting (B) the Hillman Marsh Barrier Beach, a 1.5 km long, eastern-facing shoreline.

The sudden rise in water levels and increase in wave exposure in 2017 resulted in significant barrier beach erosion. Record high lake levels and storms in the following years resulted in the rapid expansion of a breach to a record of 500 metres (Fig. 3B), leaving Hillman Marsh exposed to the forces of Lake Erie and exposing the Road 1 dyke to direct wave attack (Zuzek Inc., 2021). Due to a combination of factors in the updrift portion of the littoral cell including the breakwater and jetties at Wheatley Harbour, extensive shoreline armouring, and a deep nearshore due to ongoing lakebed downcutting, the Hillman barrier beach is being starved of the sediment that it needs to naturally recover from breaching events. Over time, what is left of the barrier is rapidly eroding, resulting in the loss of more marsh habitat, submerged aquatic vegetation, and endangered and rare species. Ice-free winters and higher lake levels due to climate change are expected to exacerbate these challenges to the overall resilience of the marsh and barrier beach.

The natural delivery of longshore sediment transport to the Hillman Marsh barrier beach has been negatively impacted by the Wheatley Harbour jetty since its construction in 1951 (Baird, 2007). The Wheatley Harbour (built in early 1900's), attached jetty (1951), and offshore breakwater (1978) have collectively trapped or removed 525,000 m³ of sediment (Fig. 3A), but since ~2010, Small Craft Harbours and the Wheatley Harbour Authority have been mechanically bypassing dredged sediment from the navigation channel at Wheatley and placing it at the north end of the barrier beach (Zuzek Inc., 2018). Waterfront development between Wheatley Harbour and Hillman Marsh, as well as communities in East Beach and Marentette Beach, began in the 1920's when there was a lack of understanding of hazards, but has continued despite an eroding shoreline, flooding, and sediment supply concerns (Baird, 2007). While hardening at the southern spit slowed the erosion of East Beach Road, the lake bottom continues to experience significant downcutting along the stretch of shoreline from Wheatley to Point Pelee National Park. A 2019 survey found that the north end of the Hillman Marsh barrier beach nearshore area roughly 200 m offshore was 2 m deeper compared to the conditions from the 1964 survey (Fig. 5, Line 19). Similarly, approximately 2.5 km south of the site along East Beach, the entire nearshore area was more than 1 m deeper in 2019 compared to 1964 out to depths of 5 m below Chart Datum (Fig. 5, Line 21).

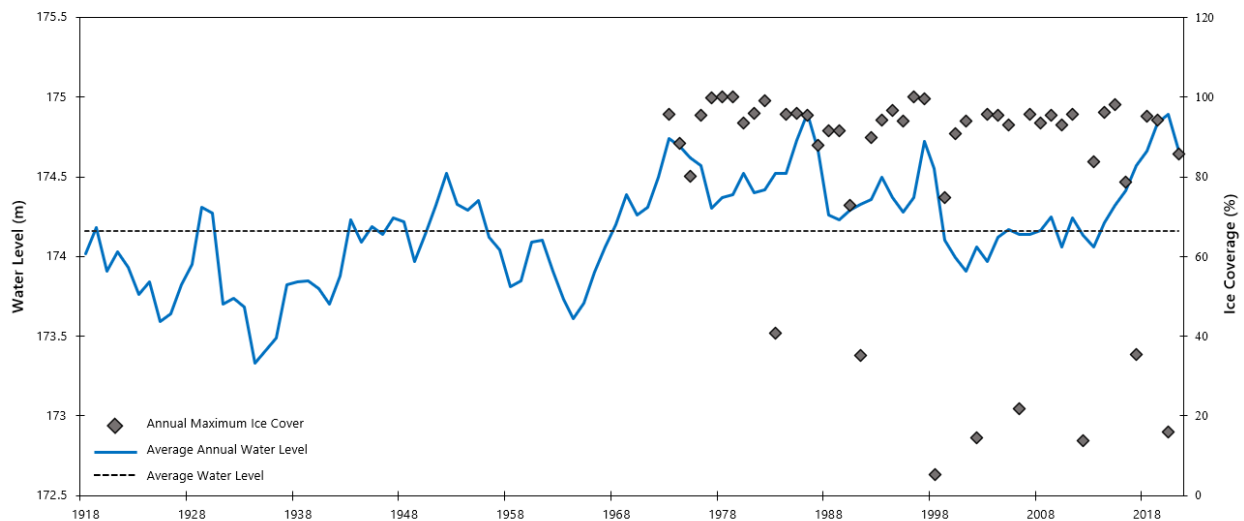
Figure 6: Average annual water levels (1918 – 2021) and long-term average water level (174.16 m) for Lake Erie were obtained from US Army Corps of Engineers. Annual Maximum Ice Cover (AMIC) from 1973 to 2021 was obtained from NOAA’s Great Lakes Environmental Research Laboratory (GLERL).

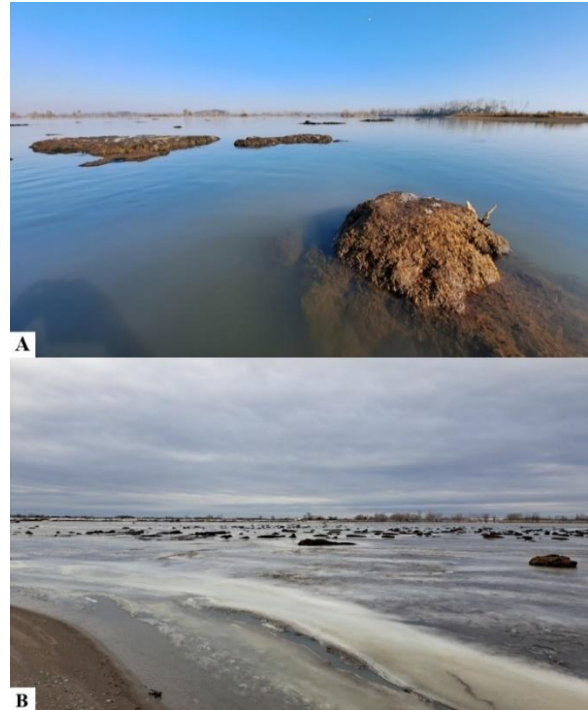
Figure 7: Decrease in width and elevation of the barrier beach has resulted in 3000-year-old chunks of peat to be exposed and dislodged. Photos taken (A) November 2nd, 2022 and (B) December 30th, 2022. Photos courtesy of Wayne King.

Due to the shallow bathymetry of Lake Erie's west basin (average depth of 8 m; Assel, 2004), ice develops quickly around Hillman Marsh, protecting the beach and marsh from winter storm-driven waves and sediment loss (BaMasoud and Byrne, 2012). However, rising temperatures and milder winters will reduce the amount of protective ice cover. Most notably, the winter of 2019/2020 had a near record low Annual Maximum Ice Cover (AMIC) of 15.9%, which had not been observed in almost a decade (Fig. 6; GLERL, 2022). Due to the collective factors of inadequate sediment supply, an eroding lake bottom, rising water levels, warming temperatures, and climate driven extreme storm events, Hillman Beach has decreased in both elevation and width, to such a degree that 3,000-year-old chunks of underlying peat are being exposed in the breach channel and dislodged (Zuzek Inc., 2021; Fig. 7).

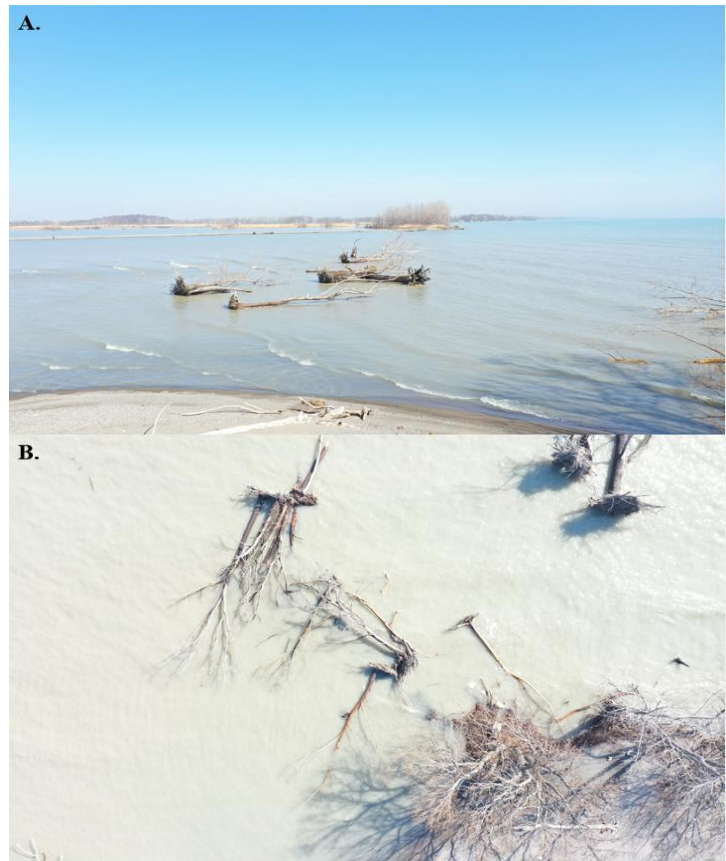
Figure 10: Dislodged and submerged vegetation along eroding shoreline in original barrier location. A) View from the southern spit looking north, B) aerial view between both spits. Photos taken March, 2021.

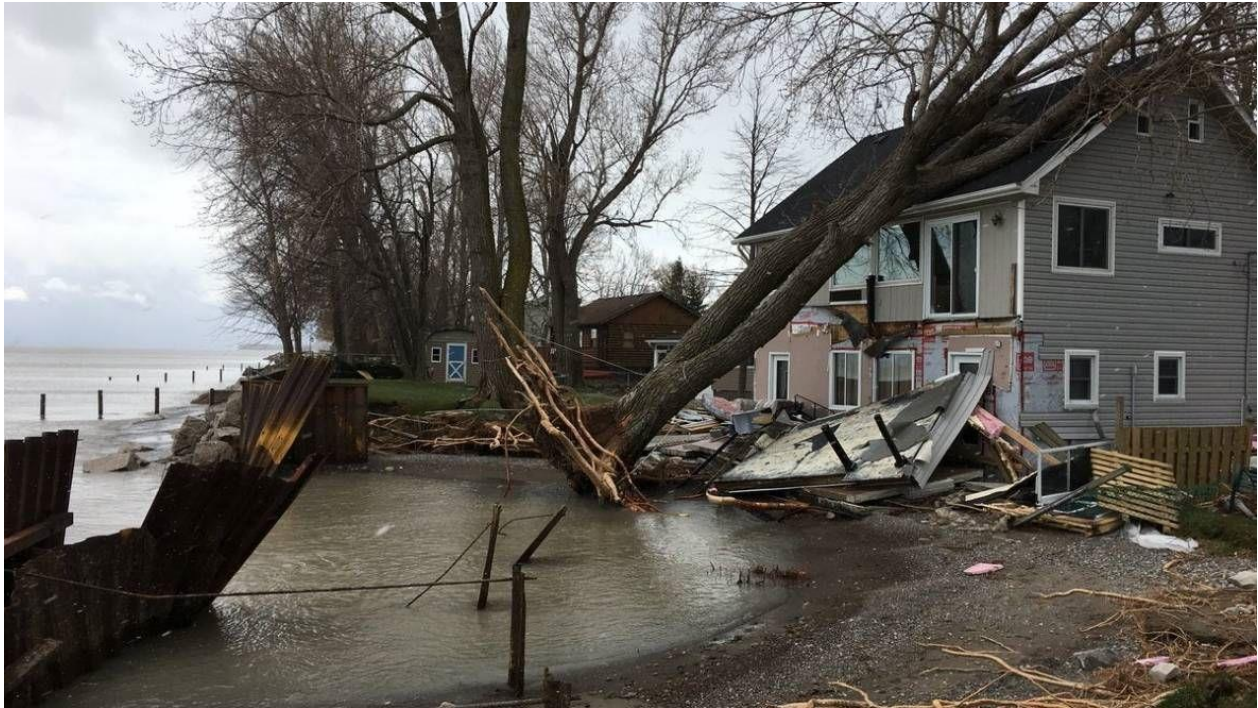
Figure 19: Failed seawall and home damage along Marentette Beach (south of HMCA) following the April 2018 ice storm.

can become breached and damaged, reducing their protective function for coastal infrastructure (Fig. 19). The increased exposure to coastal storms is a pressing issue at HMCA, as the Road 1 dyke is vulnerable to failure, which could lead to extensive inland flooding due to the low-lying nature of the agricultural lands in the drainage schemes (Zuzek Inc., 2021).

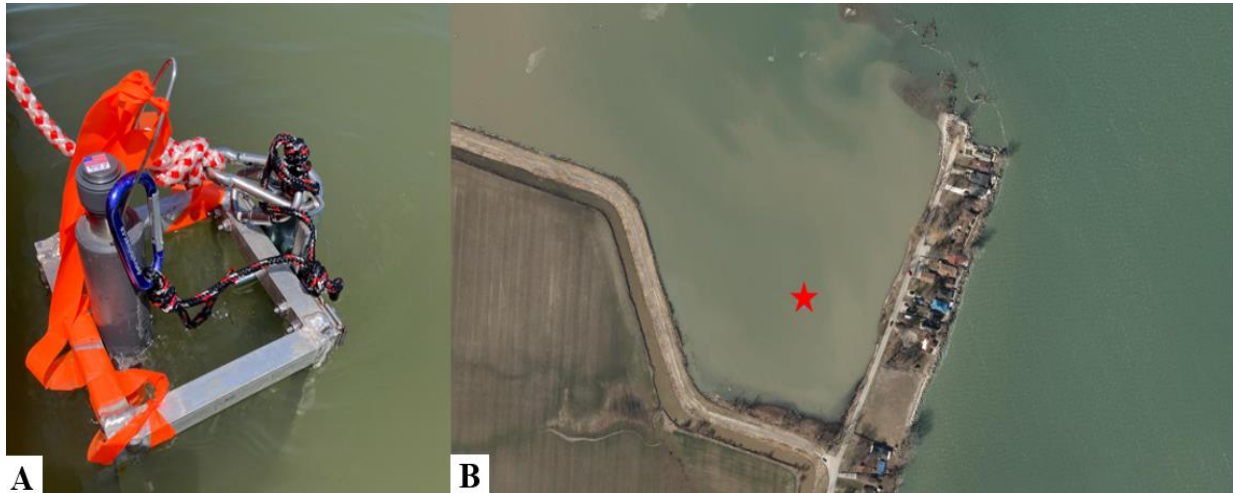
Figure 21: (A) Set up of deployed turbidity sensor. (B) Location of turbidity sensor in the Marsh.

A water quality monitoring instrument (YSI 600OMS V2 Optical Monitoring Sonde; Fig. 21A) was deployed at Hillman Marsh in July 2023 to collect continuous measurements of temperature and turbidity at an interval of 15 minutes. The sensor was placed in a sheltered area of the marsh, roughly 80 m offshore (Fig. 21B), to get an accurate understanding of turbidity levels in the area that would be the main focus in revegetation efforts further along in the project. Discrete measurements were taken of pH, dissolved oxygen, specific conductivity, and ambient conductivity roughly every 3 weeks using a YSI ProDSS Multiparameter Digital Meter (Table 1). Water samples were collected and sent to a laboratory for measurements of total suspended solids (TSS). The sensor was retrieved in late October 2023, with a total of 111 full days and 2 partial days of data.

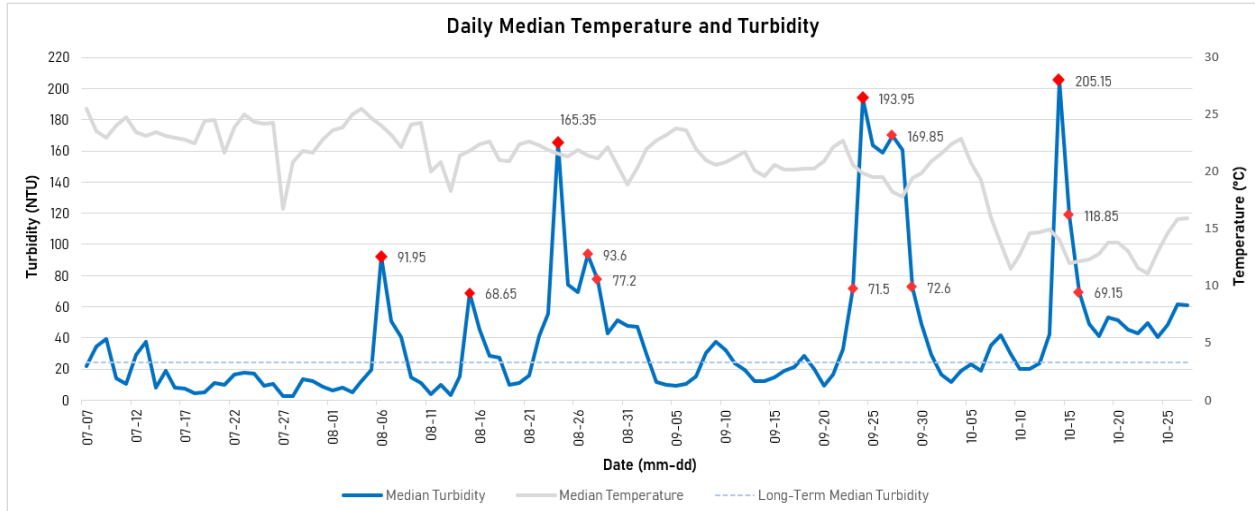
Figure 22: Daily median temperature and turbidity from July 7, 2023, to October 27, 2023. Peaks in turbidity marked in red, often lining up with precipitation events.

Preliminary results show the median turbidity for the Summer 2023 season as 24.2 NTU with frequent spikes ranging between 68.65 NTU and 205.15 NTU (Fig. 22). These peaks in turbidity often lined up with periods of precipitation that result in increased sediment and nutrient loads from non-point source agricultural runoff (Table 2; Carter et al., 2022). Most notably, 18.1 mm of precipitation on October 14, 2023, that yielded a median turbidity of 205.15 NTU. Although the exact cause for spiked turbidity in the absence of precipitation cannot be confirmed, studies suggest increased turbidity can be a result of algae growth (USGS, 2018), wave action (Paul et al., 1982), or resuspension from carp and other bottom-feeding fish (Weber and Brown, 2009). Turbidity standards set out by the Provincial Water Quality Objectives (PWQO) state that turbidity should not change by more than 10% above the natural levels for the protection of aquatic life (MECP, 2021). Although this dataset is only one season and is not enough to make final conclusions, turbidity often spiked above this 10% threshold this season. Monitoring of Hillman Marsh water quality should continue to grow a large enough data set to do proper statistical analysis.

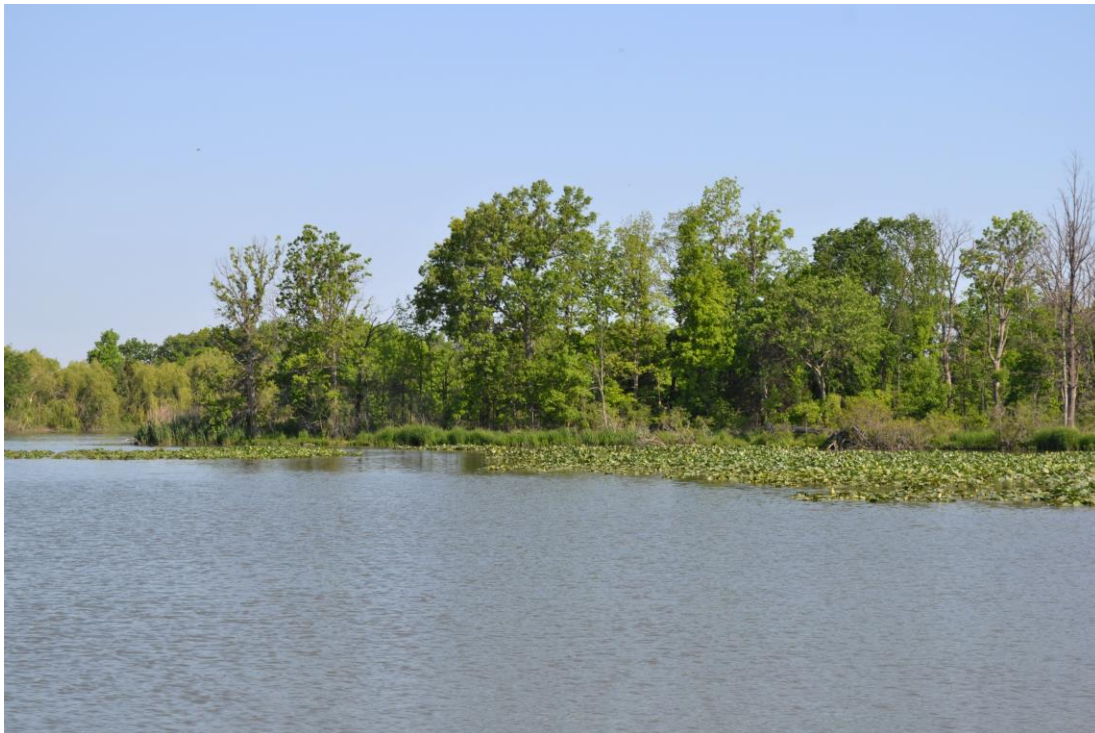
Figure 23: Floating aquatic vegetation in Hillman Marsh re-establishing this summer (June 2023).

Since breaching of the protective barrier beach, wave agitation may have resulted in sediment stirrup in Hillman Marsh, and the subsequent increased turbidity levels resulted in the loss of submerged aquatic vegetation. Although emergent and floating vegetation can grow in turbid waters (floating vegetation has resurfaced this summer; Fig. 23), clear water is needed early in the growing season for new seedlings to establish (Austin et al., 2017). Once the barrier beach is restored, there will be a buffer between the marsh and the harsh conditions of Lake Erie, which should result in less sediment stirrup - allowing for the successful reestablishment of aquatic vegetation. Additionally, an increase in aquatic vegetation will help reduce future turbidity levels caused by bottom-feeding fish by trapping sediment (McNair and Chow-Fraser, 2003). Re-establishing aquatic vegetation will also help attenuate waves, regulate nutrients, and absorb CO₂ (Austin et al., 2017).
