# GREAT LAKES WATER LEVELS

## Current Conditions and Outlook

July 15, 2019

Essex Region  
Conservation Authority  
*sustaining the place for life*

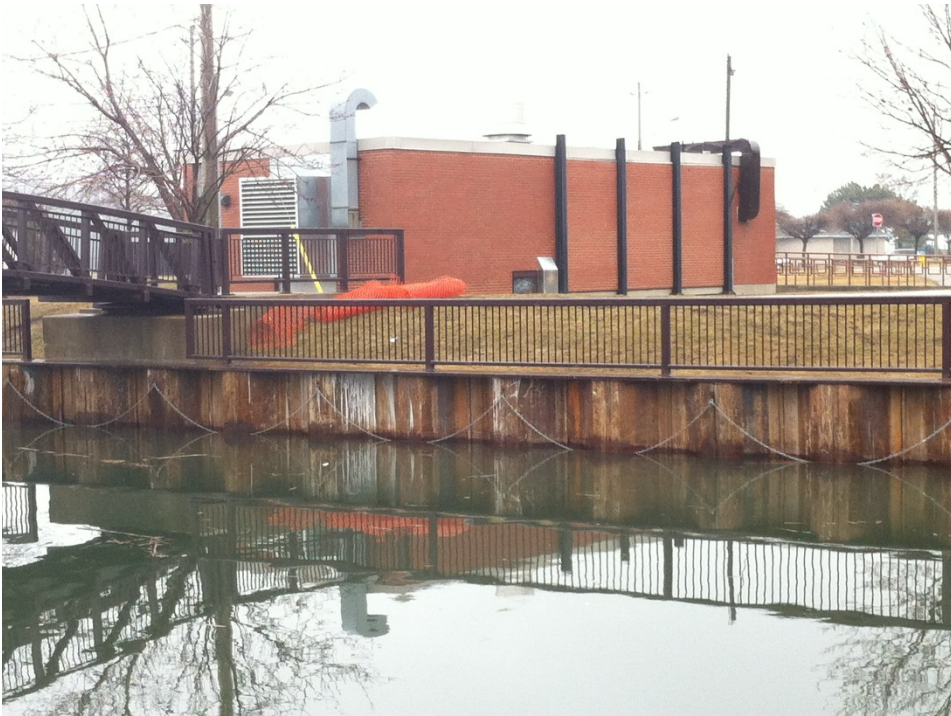
March 2015

# Little River – Little River Pump Station at Riverside Drive

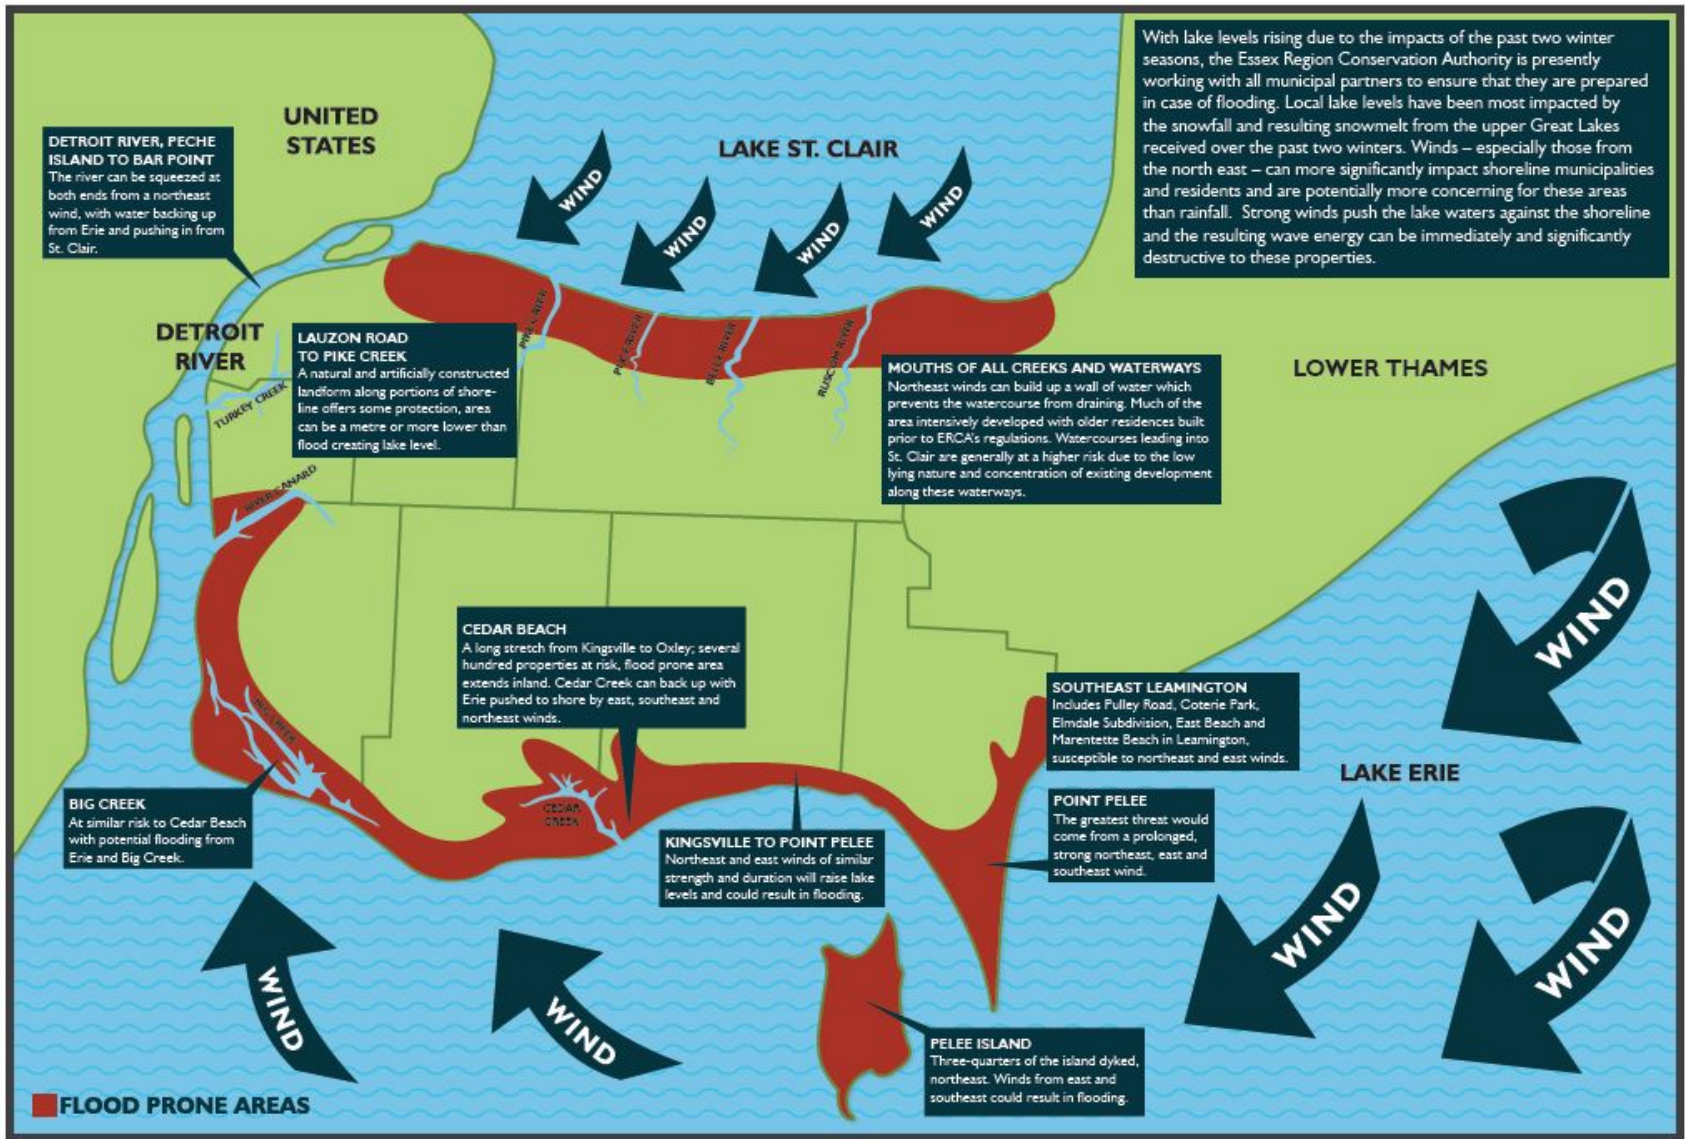
# Wind and Lake Flooding

With lake levels rising due to the impacts of the past two winter seasons, the Essex Region Conservation Authority is presently working with all municipal partners to ensure that they are prepared in case of flooding. Local lake levels have been most impacted by the snowfall and resulting snowmelt from the upper Great Lakes received over the past two winters. Winds – especially those from the north east – can more significantly impact shoreline municipalities and residents and are potentially more concerning for these areas than rainfall. Strong winds push the lake waters against the shoreline and the resulting wave energy can be immediately and significantly destructive to these properties.

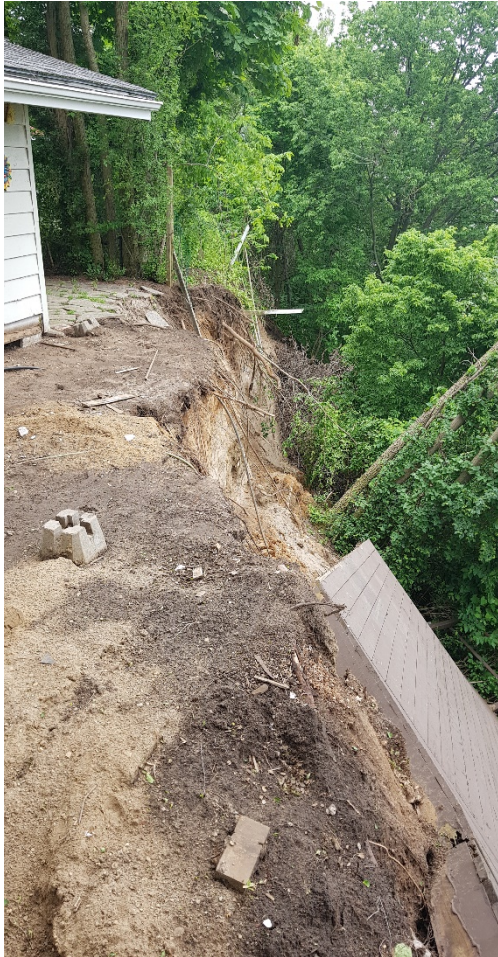
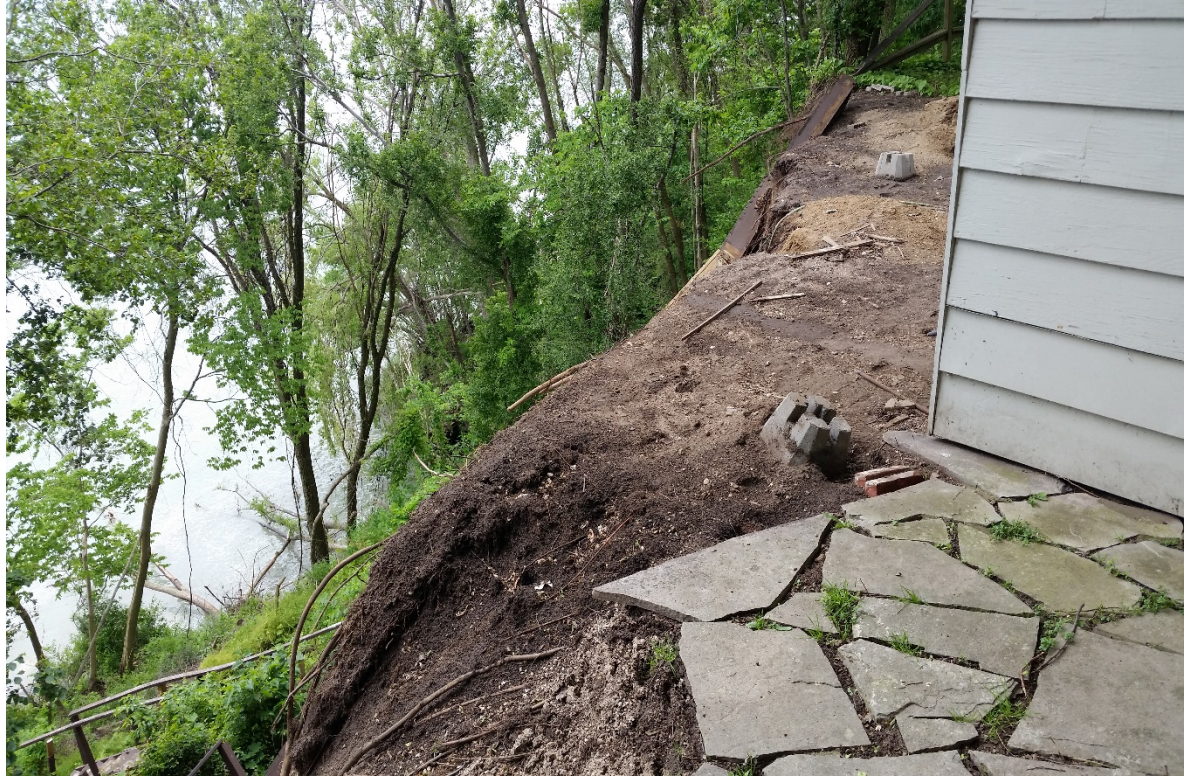
Colchester Bluff Failure

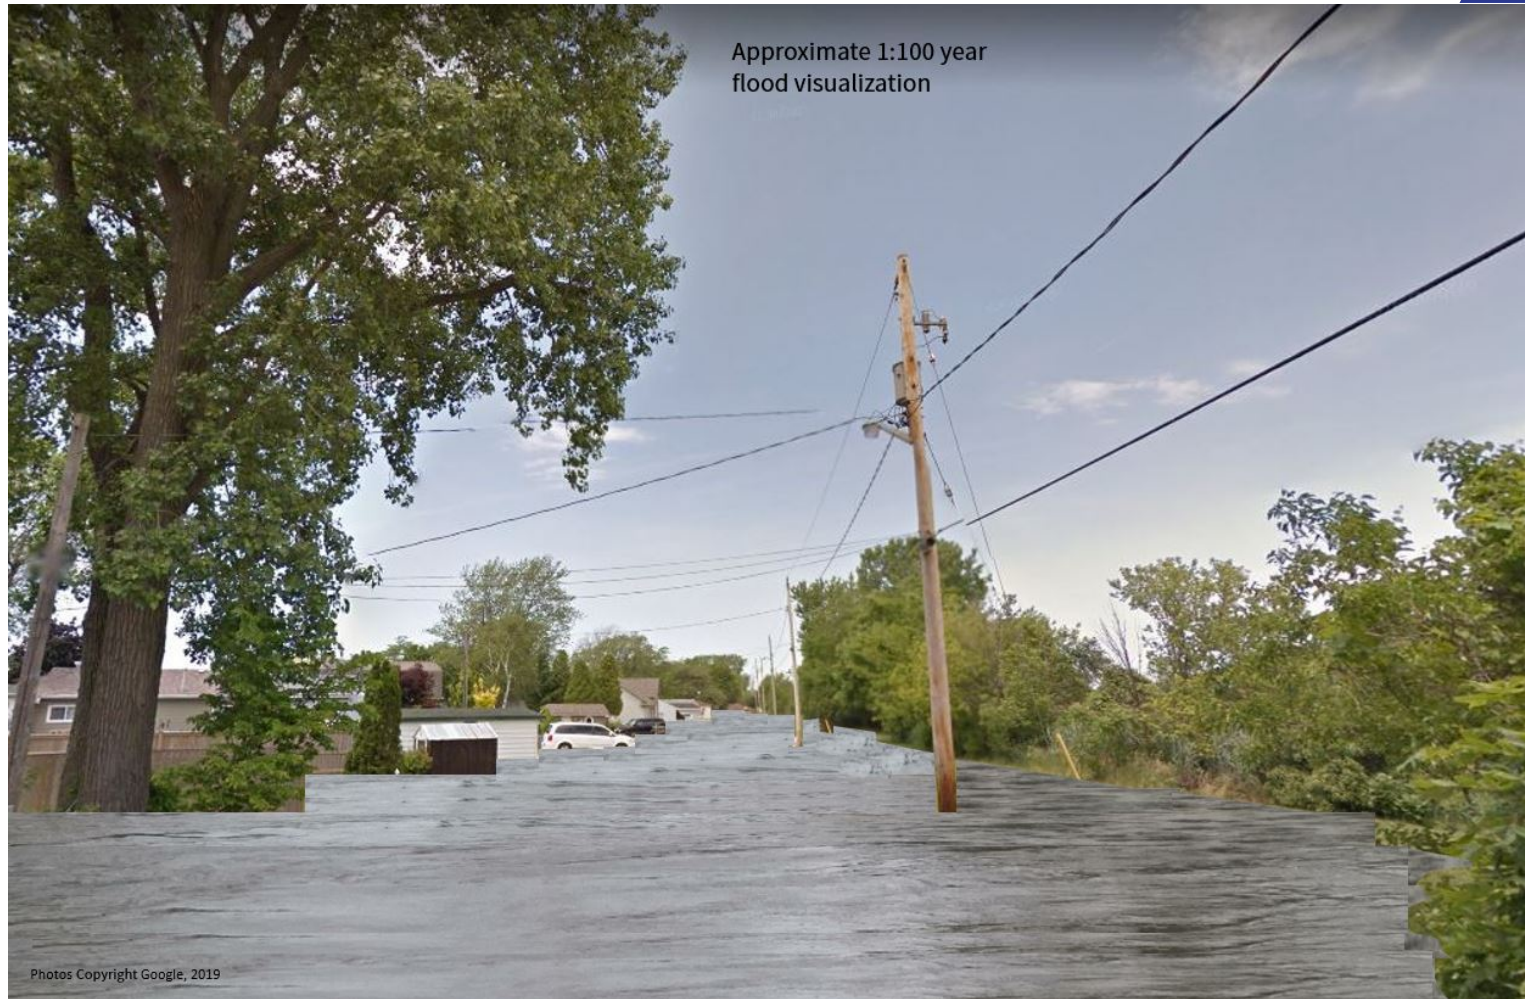
Lypps Beach Road (visualization)

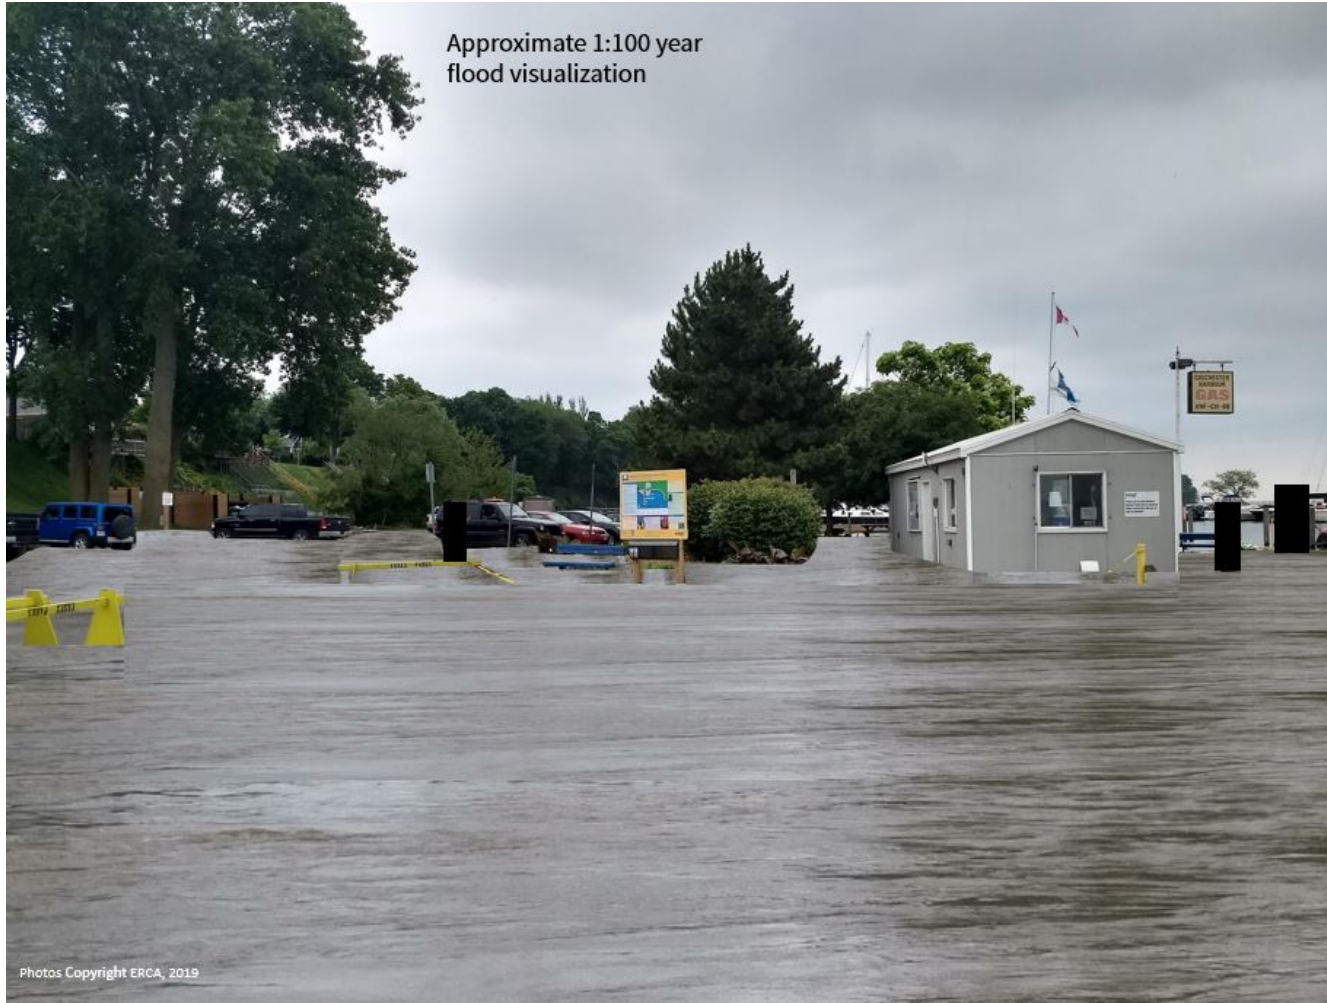
Colchester Harbour (visualization)

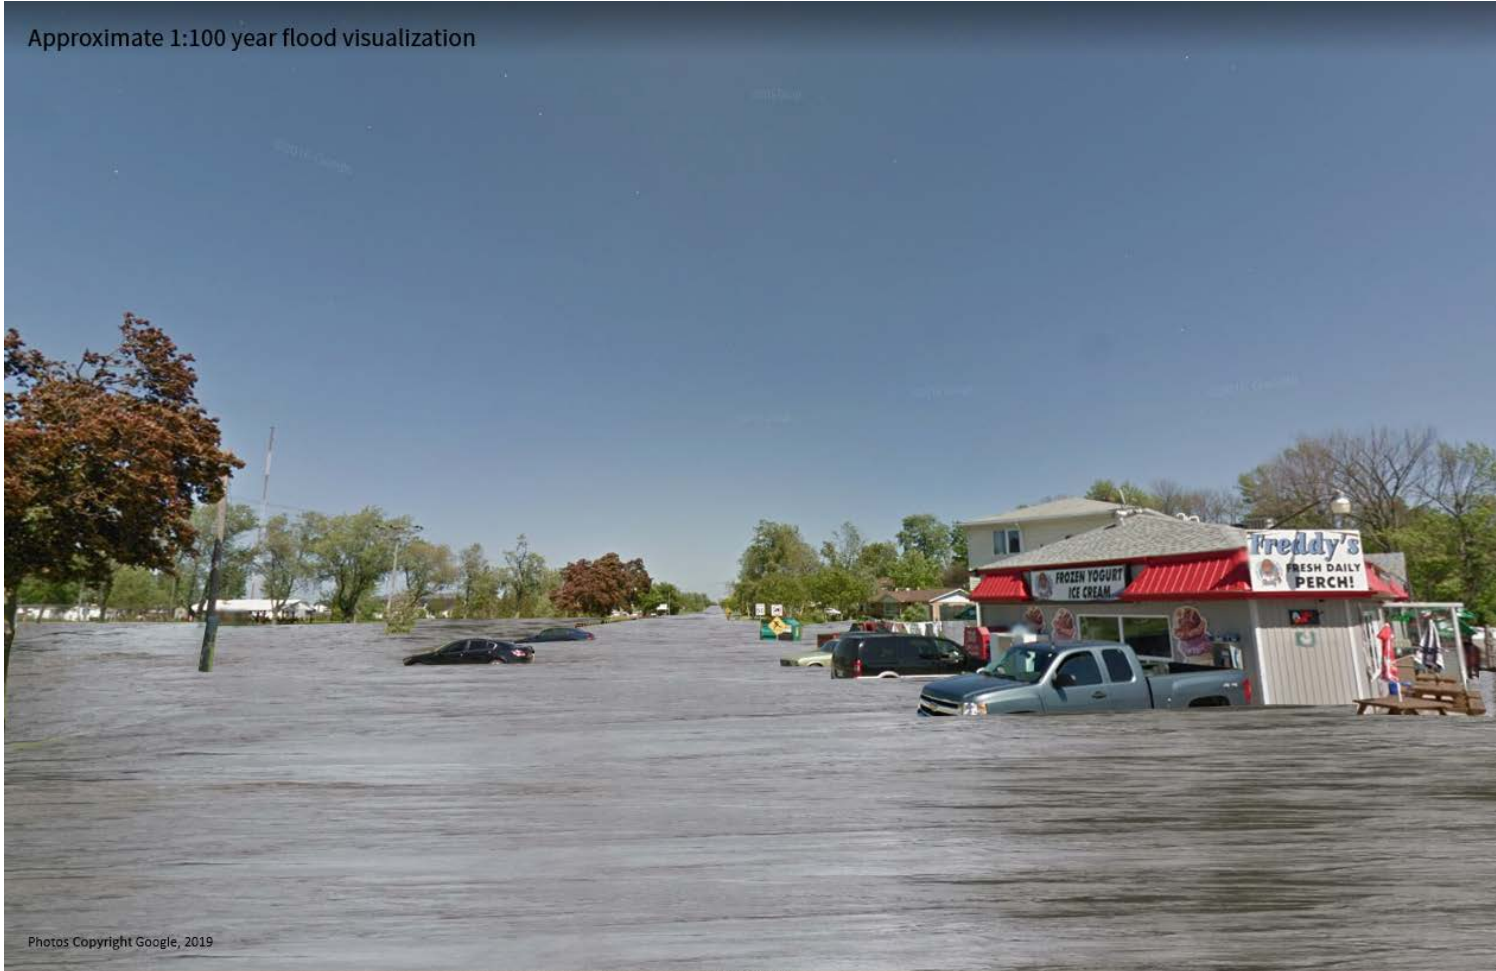
Point Pelee Drive and Mersea Road C

Approximate 1:100 year flood visualization

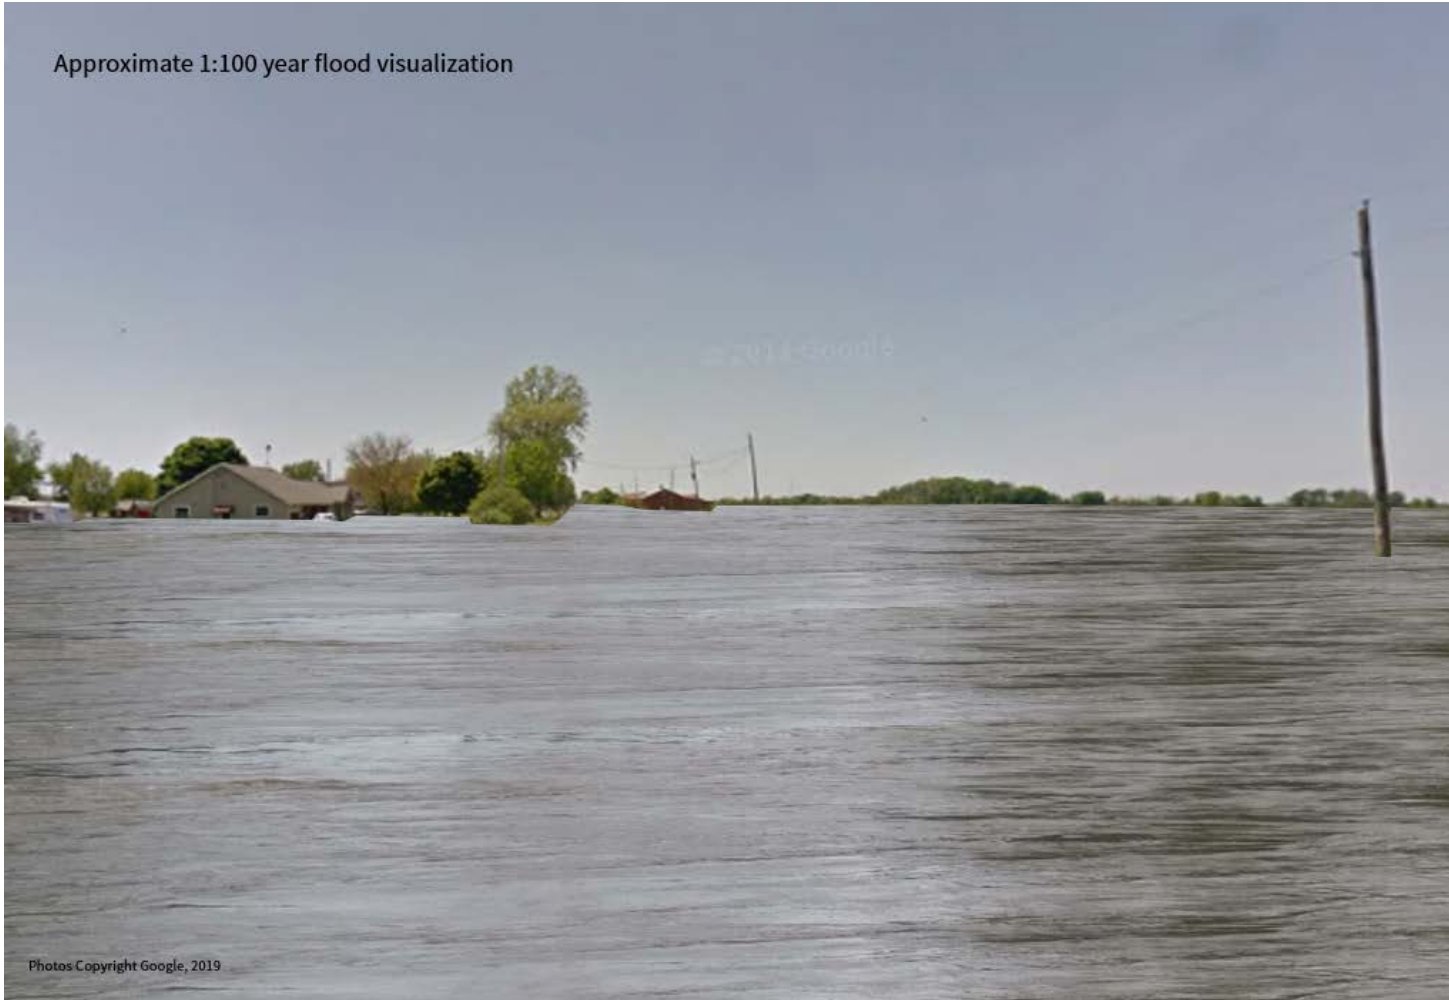
Mersea Road C

Approximate 1:100 year flood visualization

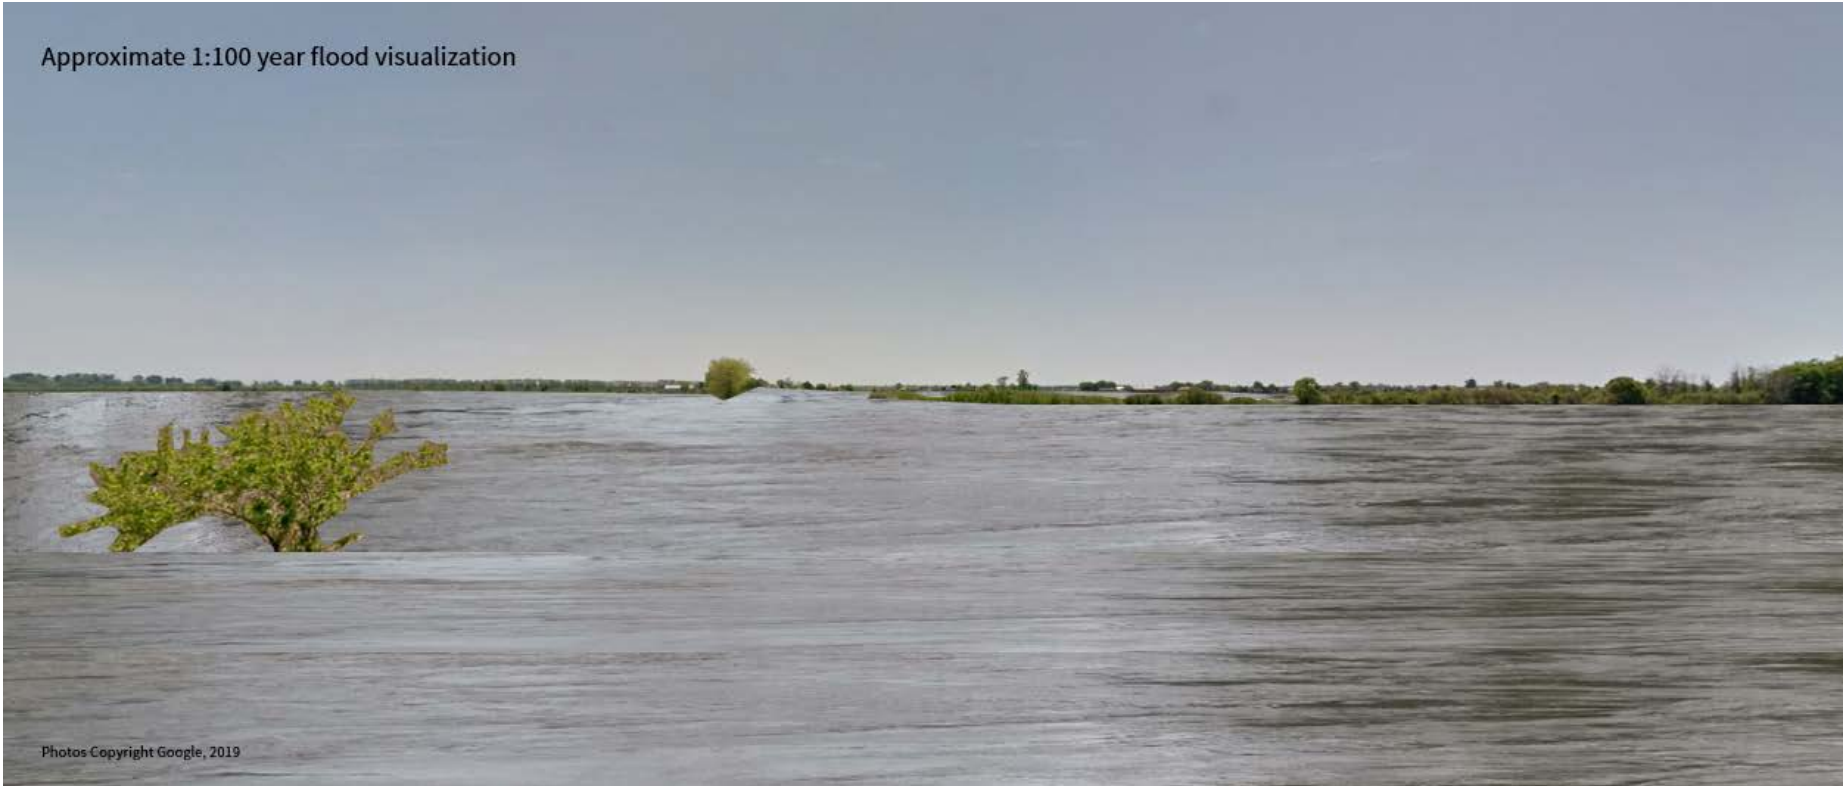
Mersea Road 19

Approximate 1:100 year flood visualization
