GREAT LAKES WATER LEVELS

Current Conditions and Outlook

July 15, 2019

Essex Region
Conservation Authority
sustaining the place for life

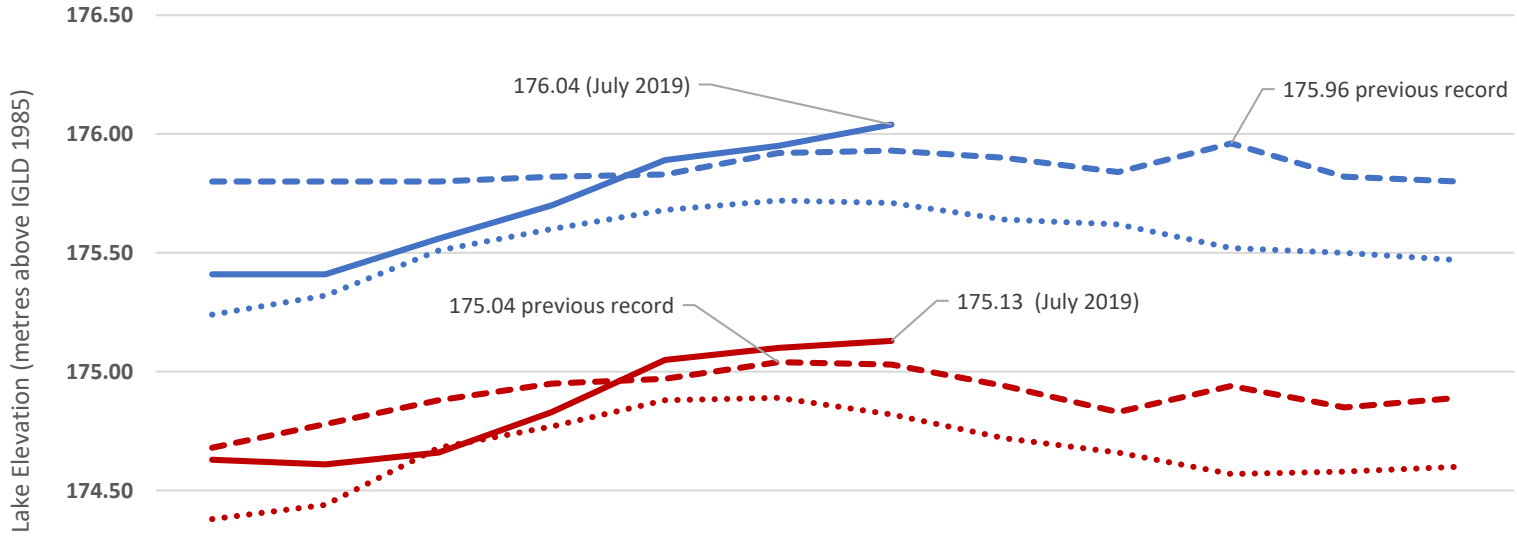
Lake Levels

Jan	Feb	Mar	Apr	May	Jun	Jul	Aug	Sep	Oct	Nov	Dec
--- St. Clair 1986	175.80	175.80	175.80	175.82	175.83	175.92	175.93	175.90	175.84	175.96	175.82	175.80
..... St. Clair 2018	175.24	175.32	175.51	175.60	175.68	175.72	175.71	175.64	175.62	175.52	175.50	175.47
— St. Clair 2019	175.41	175.41	175.56	175.70	175.89	175.95	176.04					
--- Erie 1986	174.68	174.78	174.88	174.95	174.97	175.04	175.03	174.94	174.83	174.94	174.85	174.89
..... Erie 2018	174.38	174.44	174.68	174.77	174.88	174.89	174.82	174.72	174.66	174.57	174.58	174.60
— Erie 2019	174.63	174.61	174.66	174.83	175.05	175.10	175.13

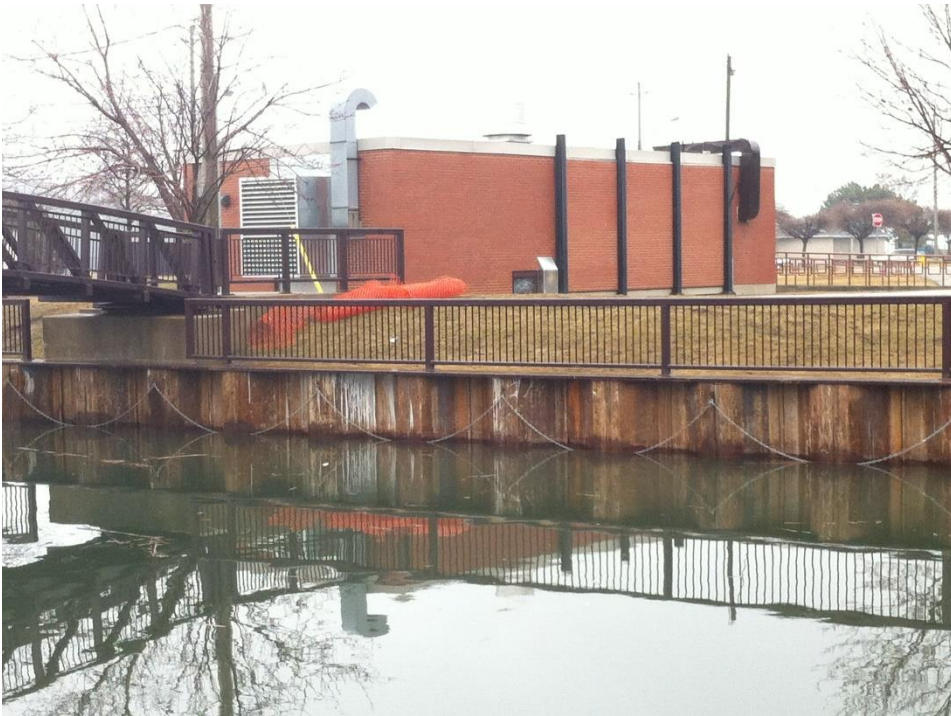
March 2015

Little River – Little River Pump Station at Riverside Drive

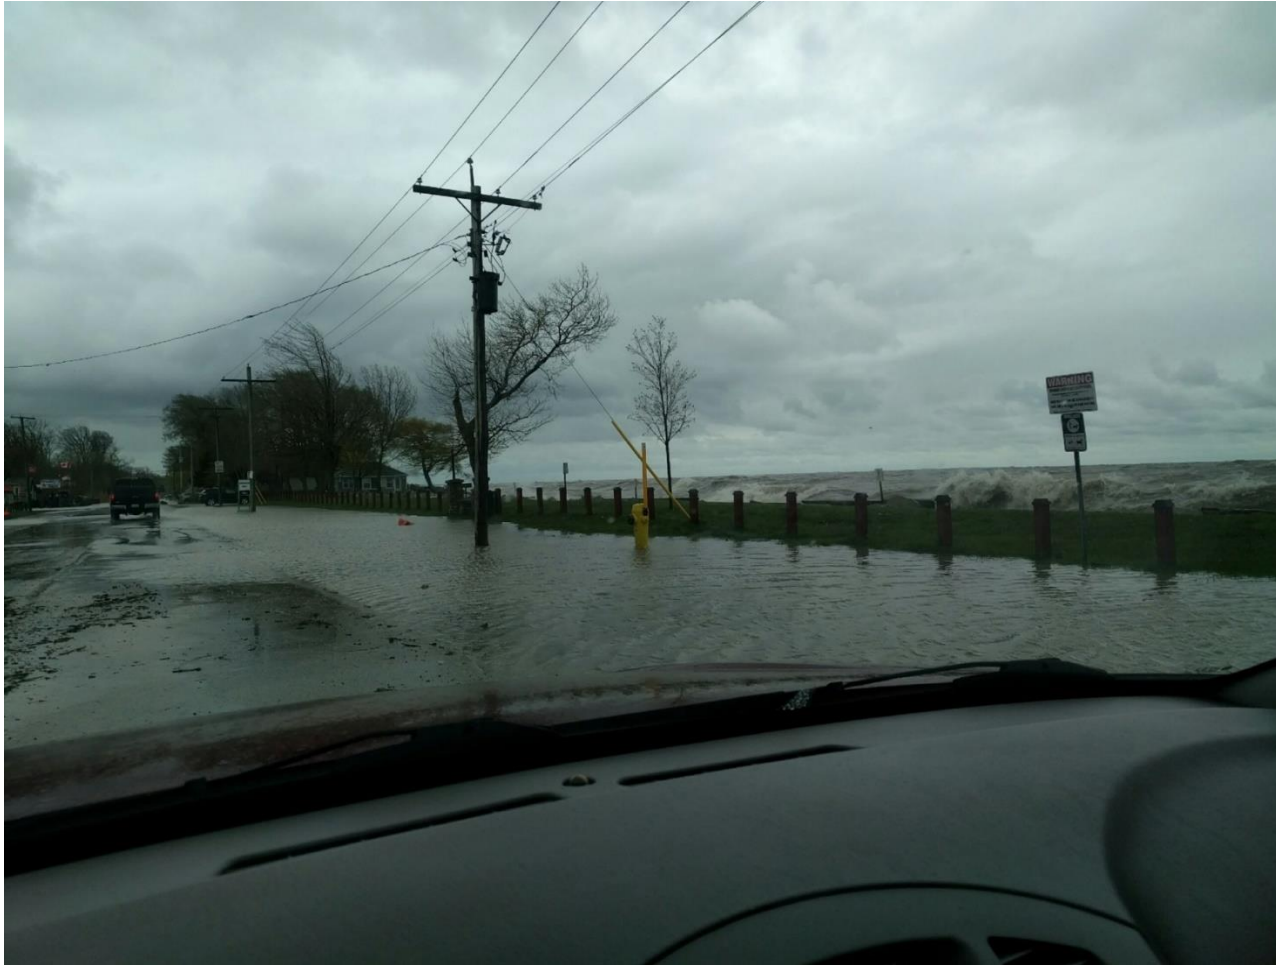
Lake Erie – Point Pelee Drive

Recent Storm Events

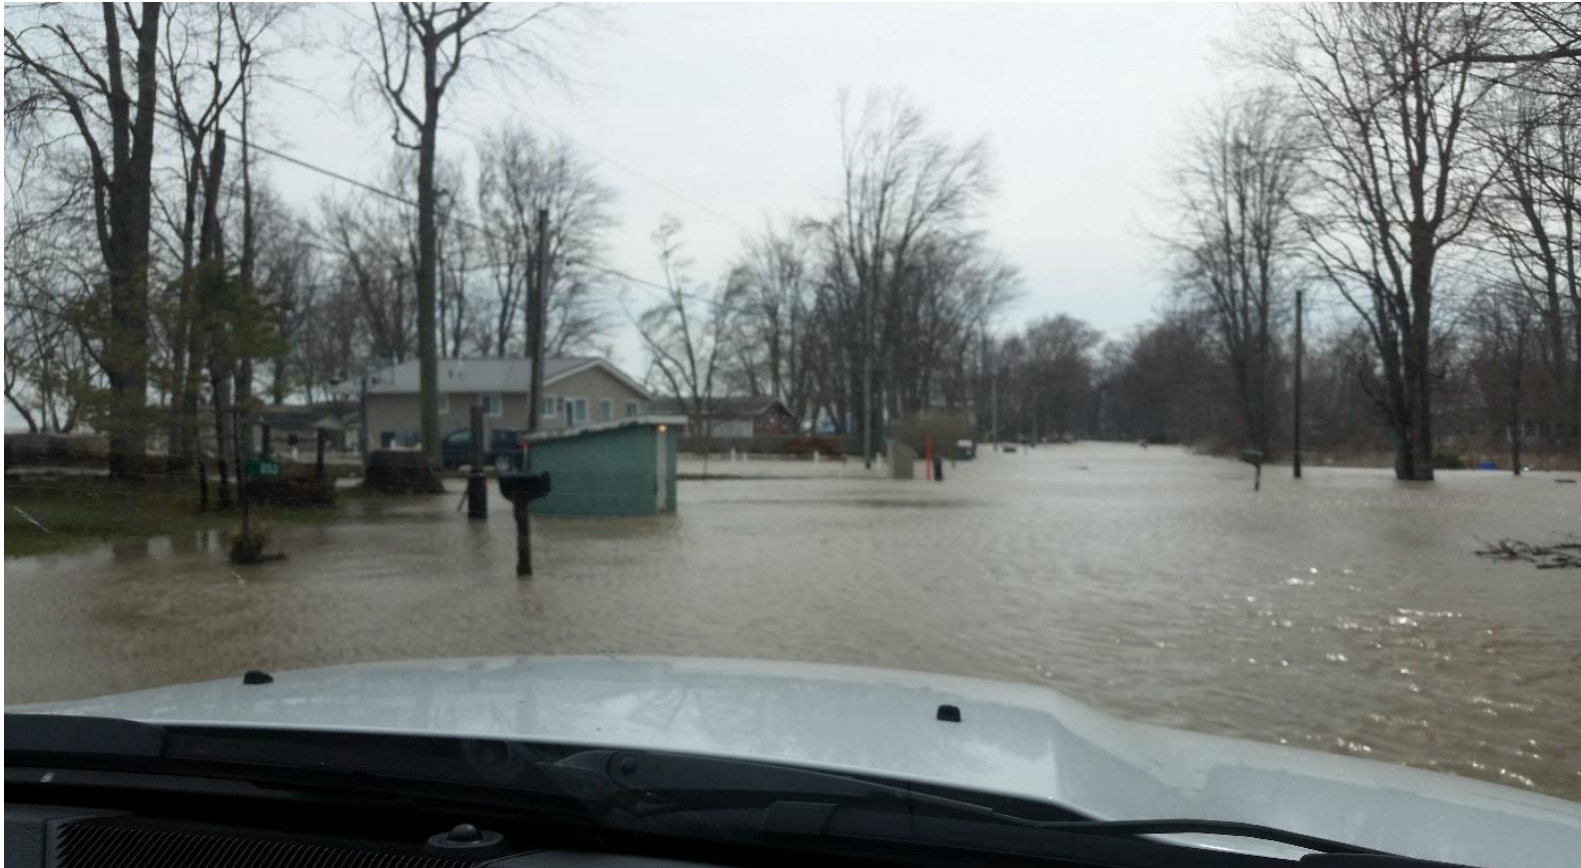
Lake Erie – Cotterie Park Road 2019 (April 11, 14 and May 1, 8, 12)

Recent Storm Events

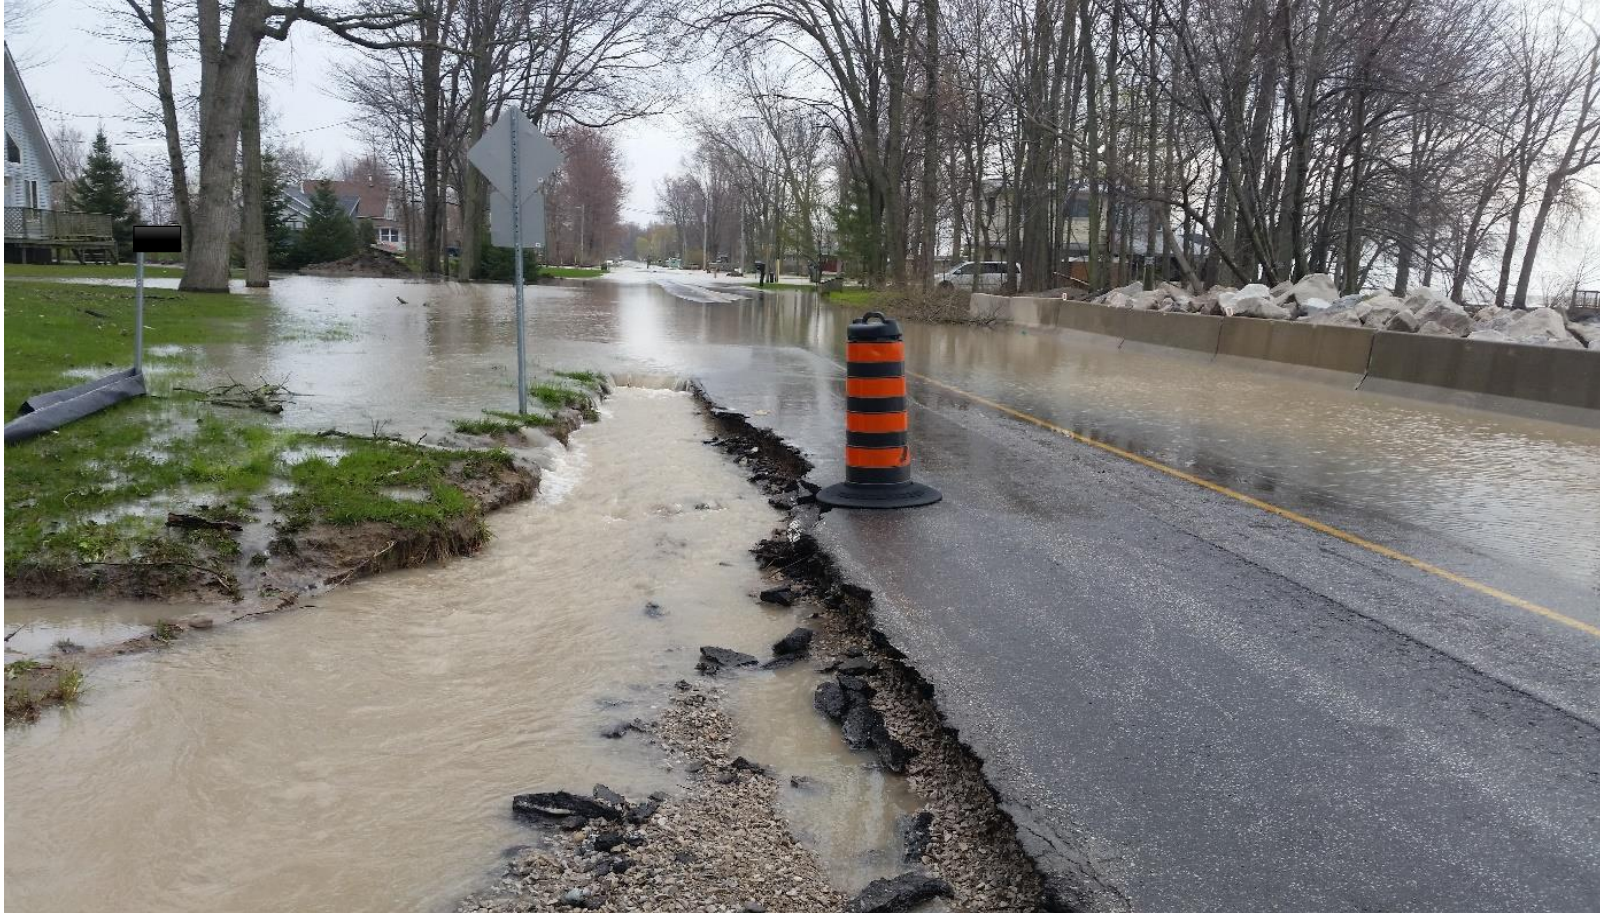
Lake Erie – Cotterie Park Road (2019)

Recent Storm Events

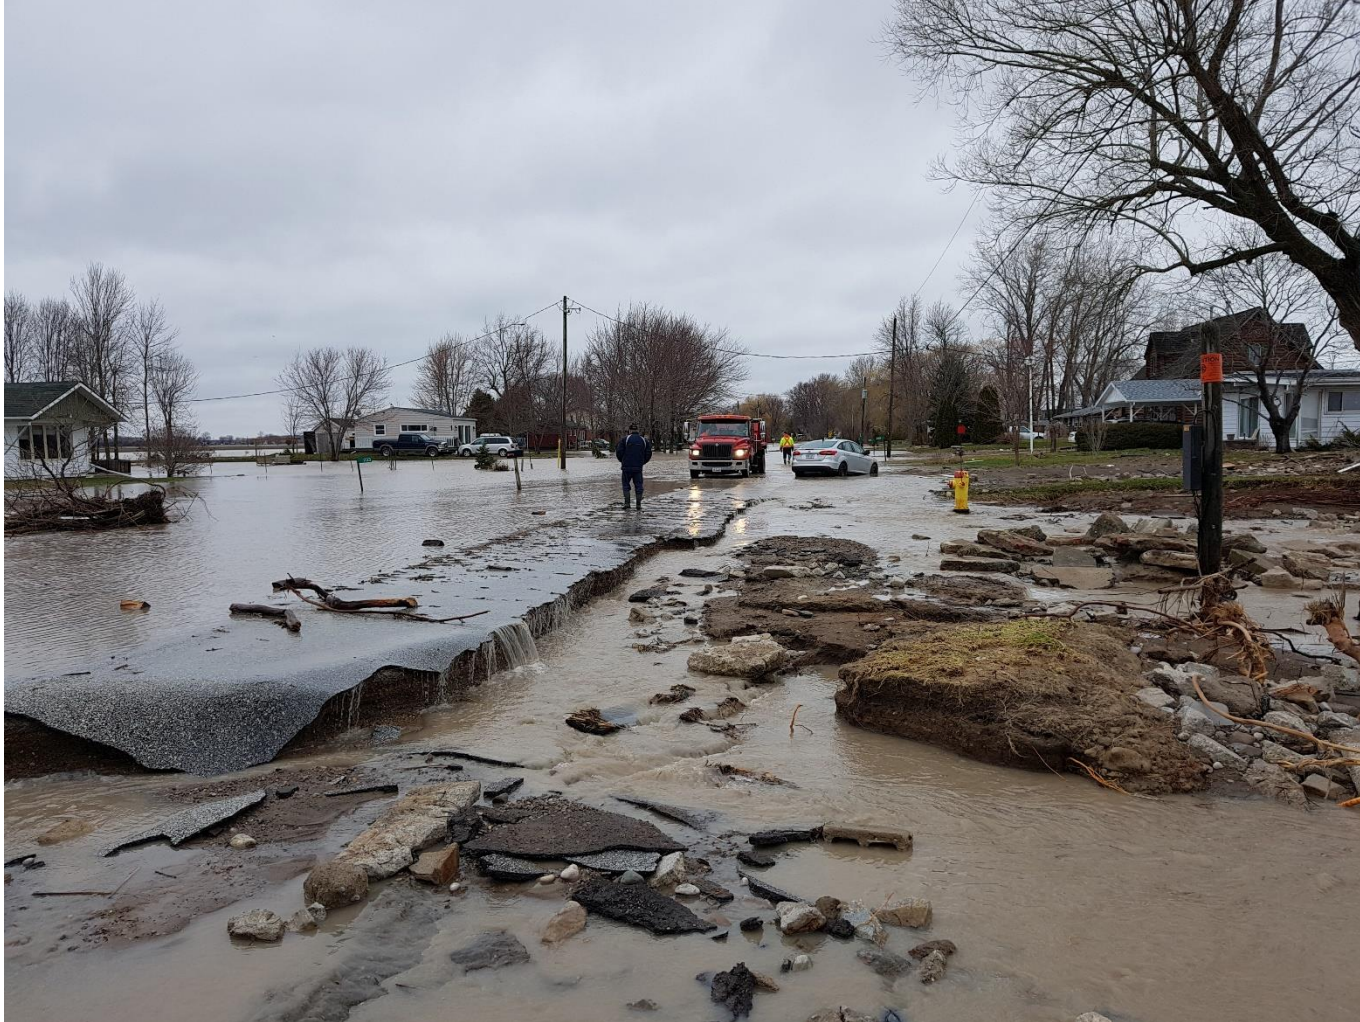
Lake Erie – Cotterie Park Road (2018)

Recent Storm Events

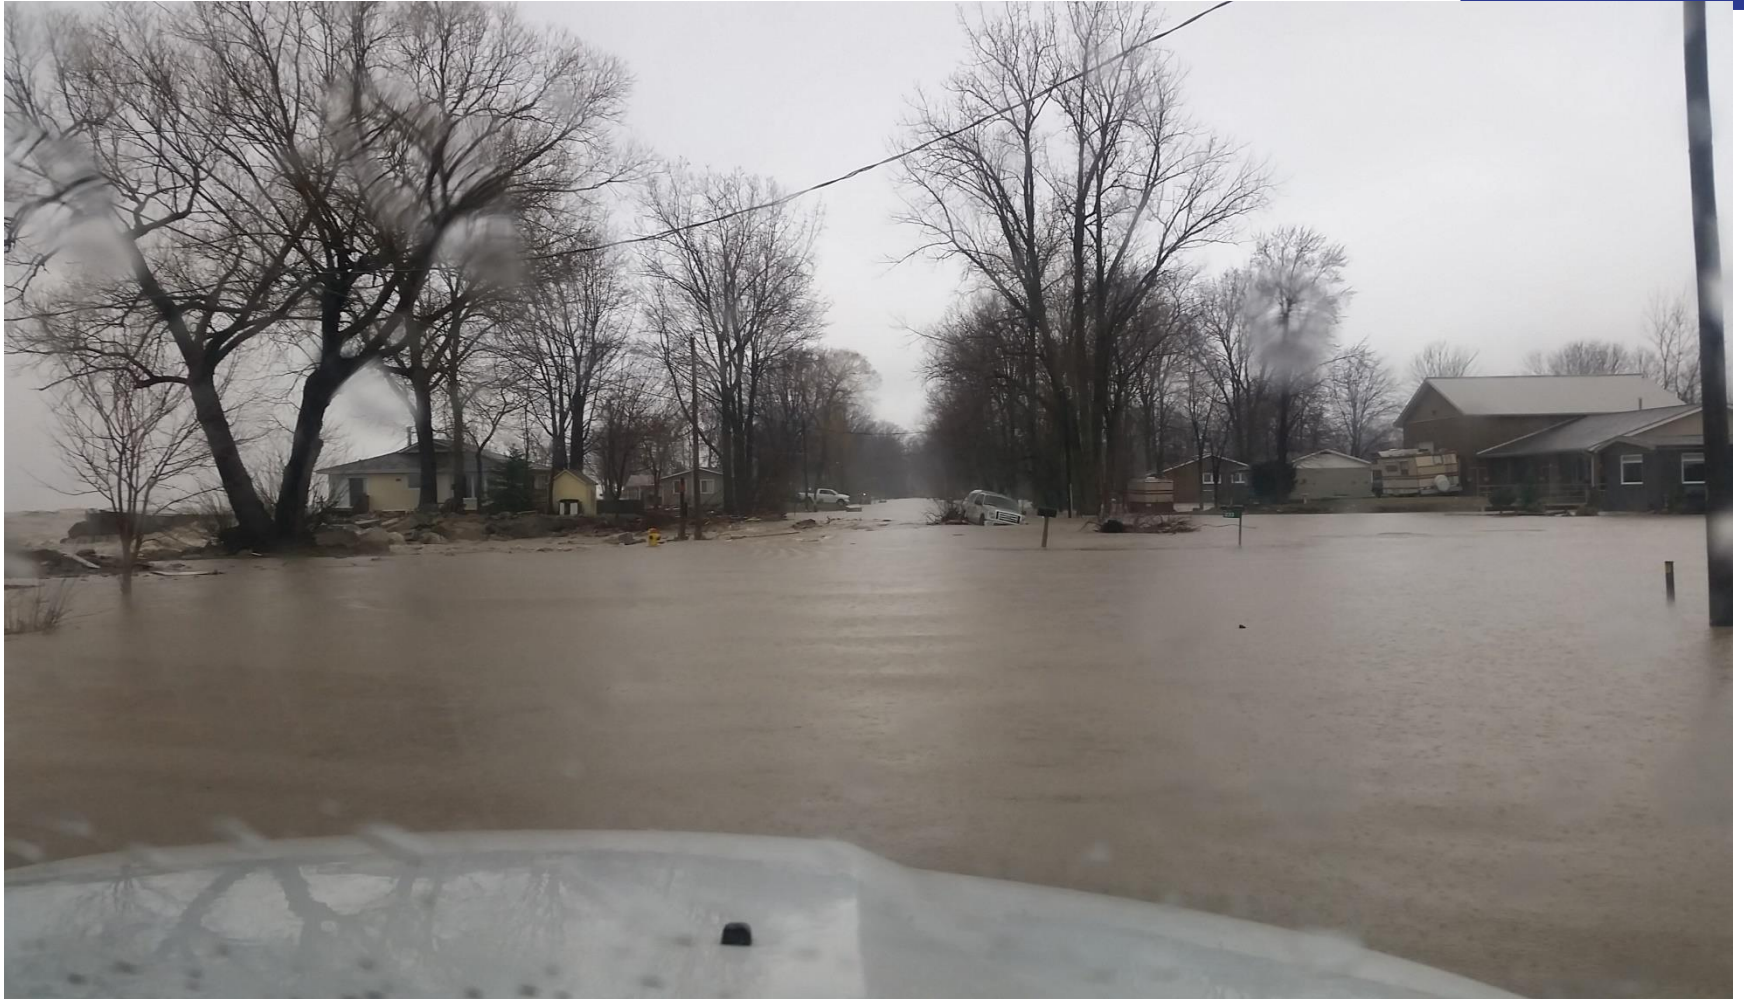
Lake Erie – Cotterie Park Road (2018)

Recent Storm Events

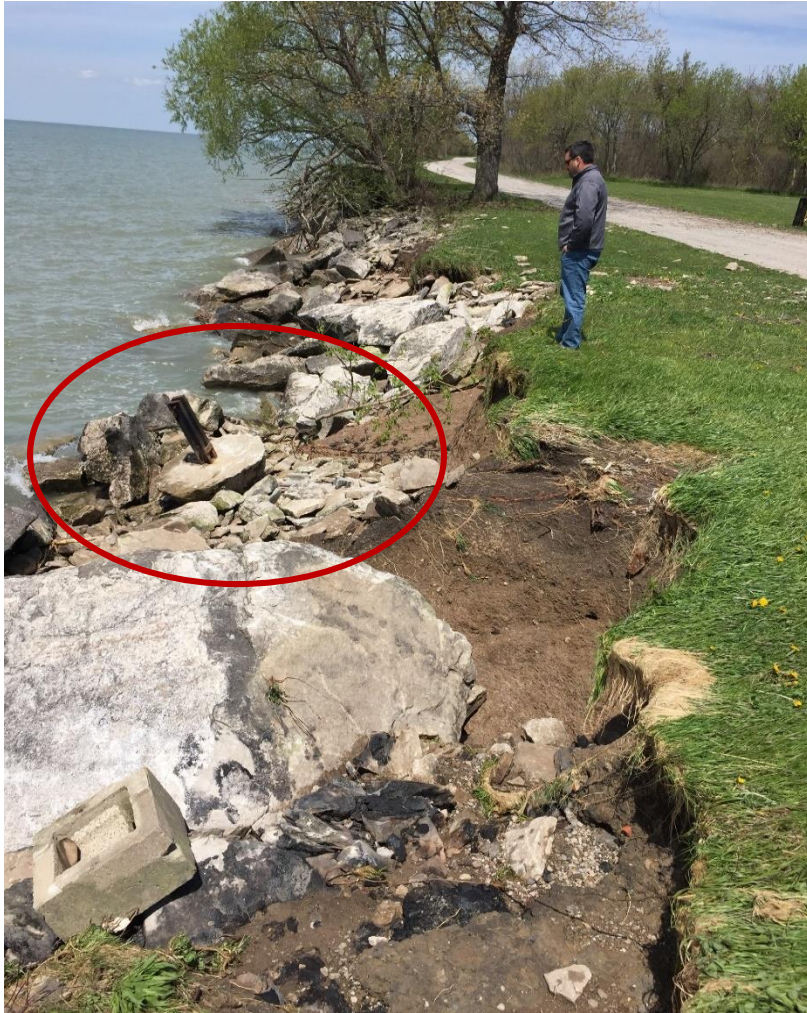
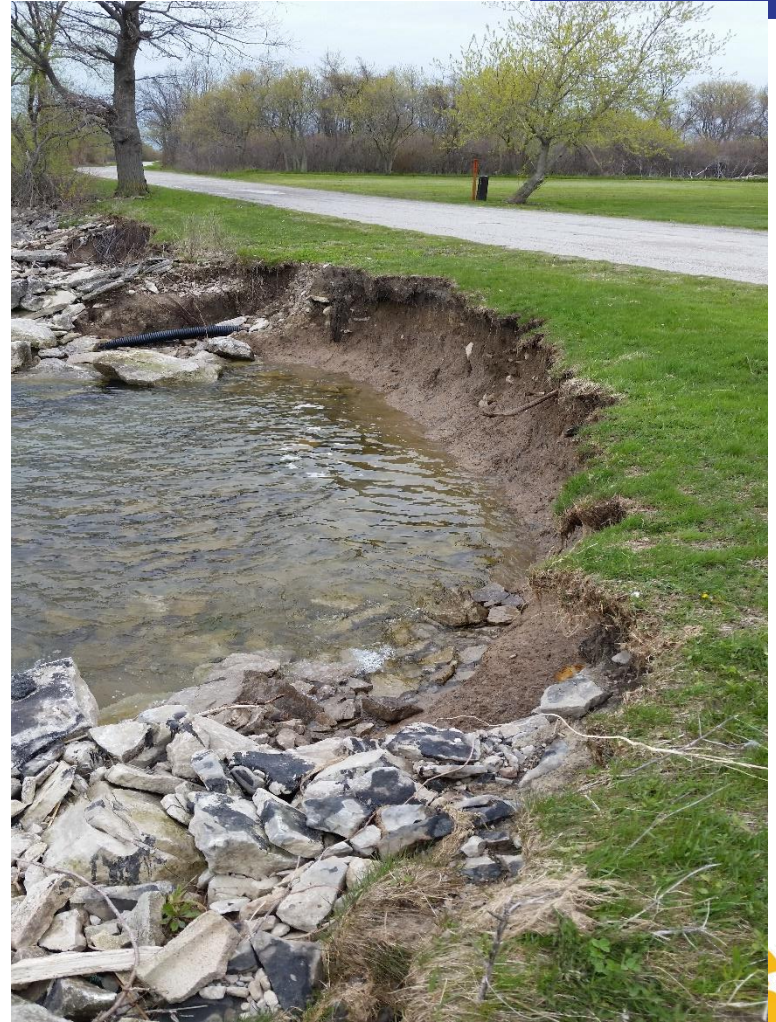
Lake Erie – Pelee Island

Recent Storm Events

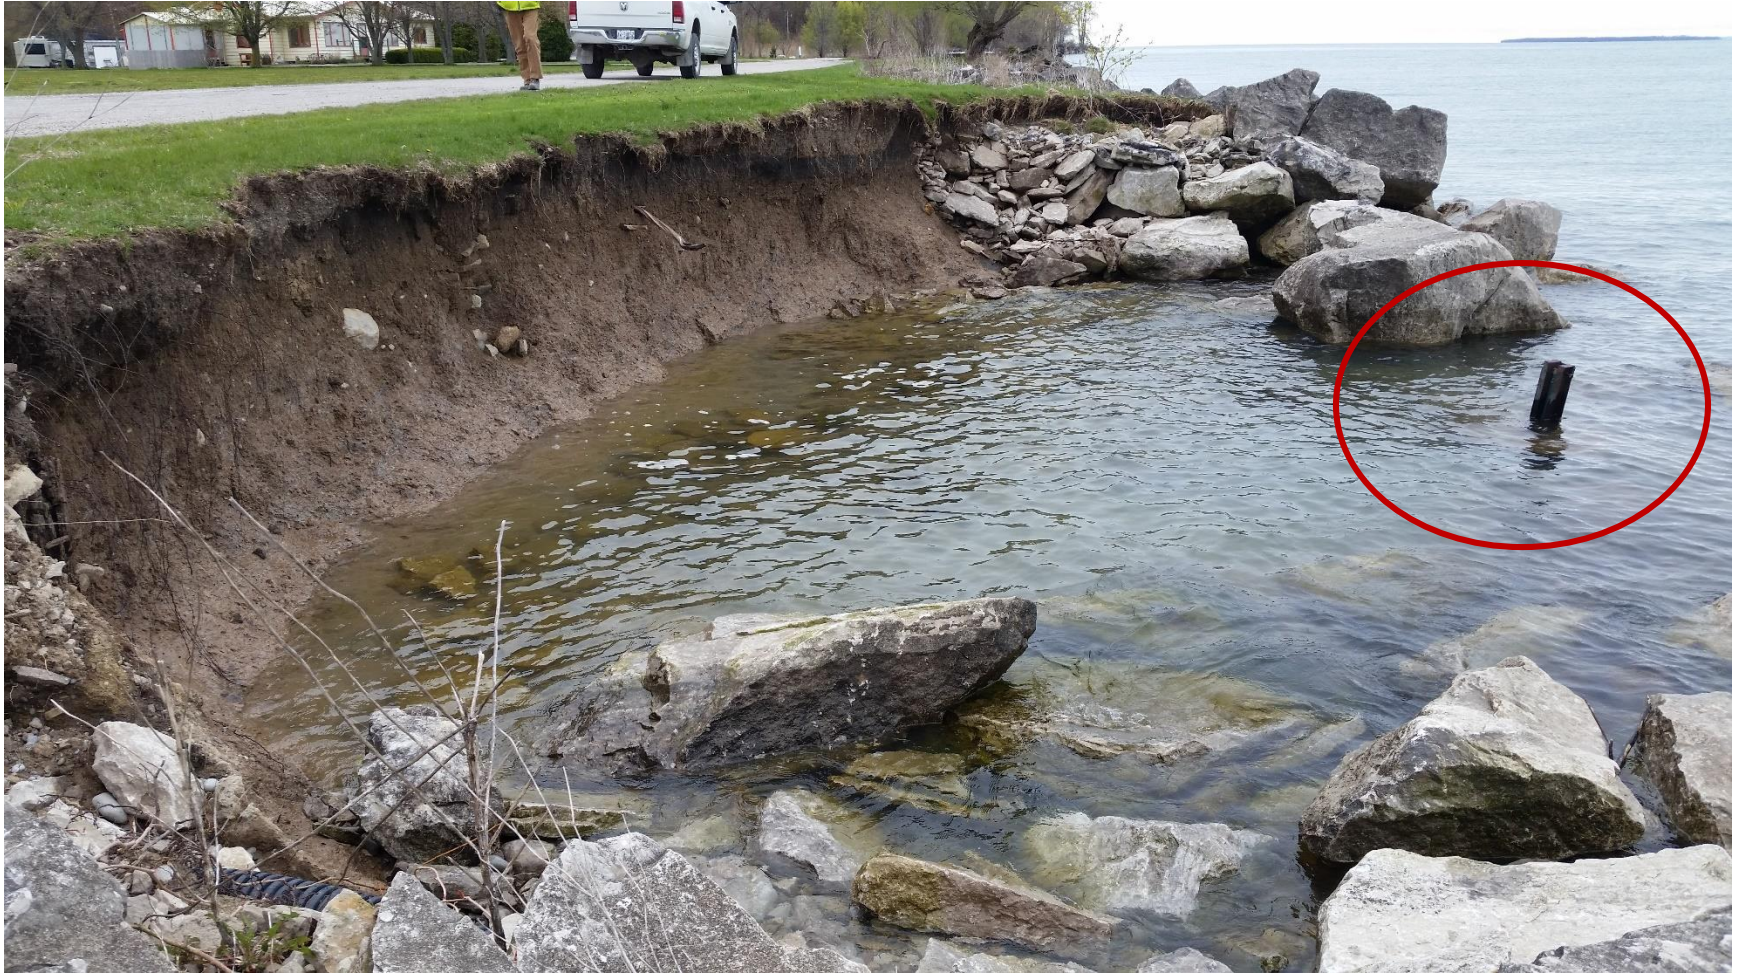
Lake Erie – Pelee Island

Recent Storm Events

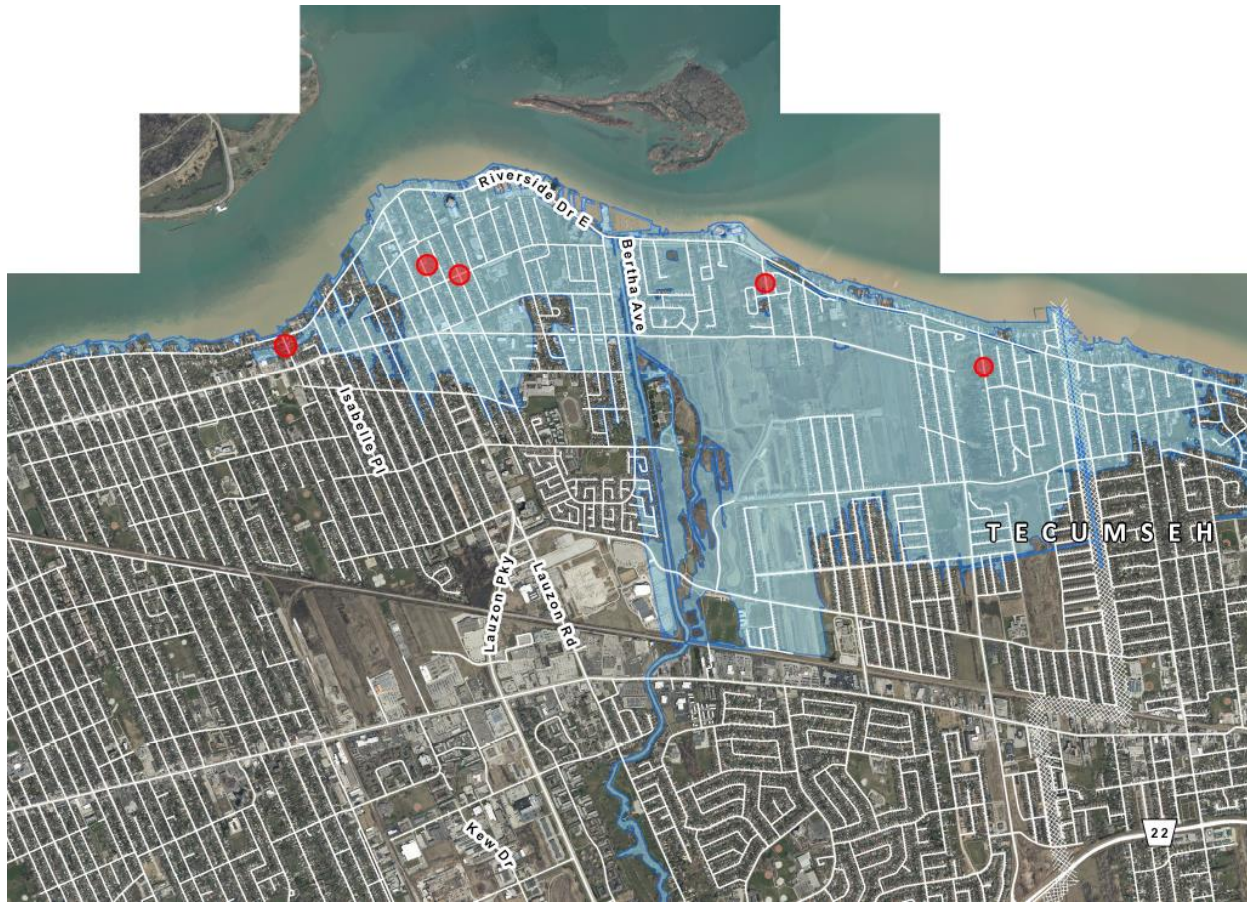
Florence Ave, Frank Ave, Jarvis Ave, St. Rose Ave.

Potential Lake Flooding (key map)

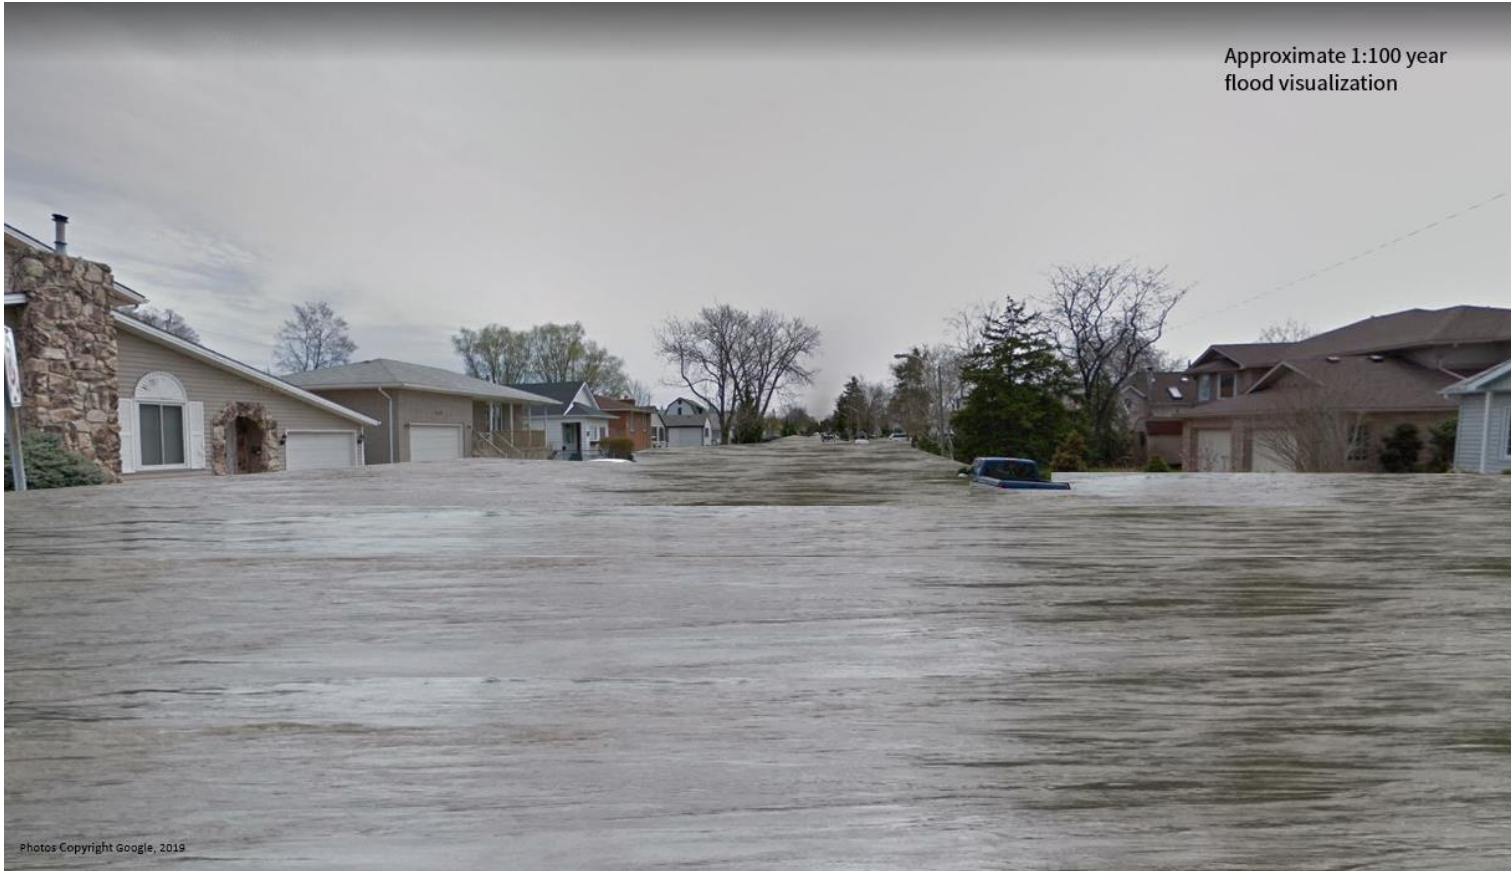
Frank Ave

Approximate 1:100 year
flood visualization

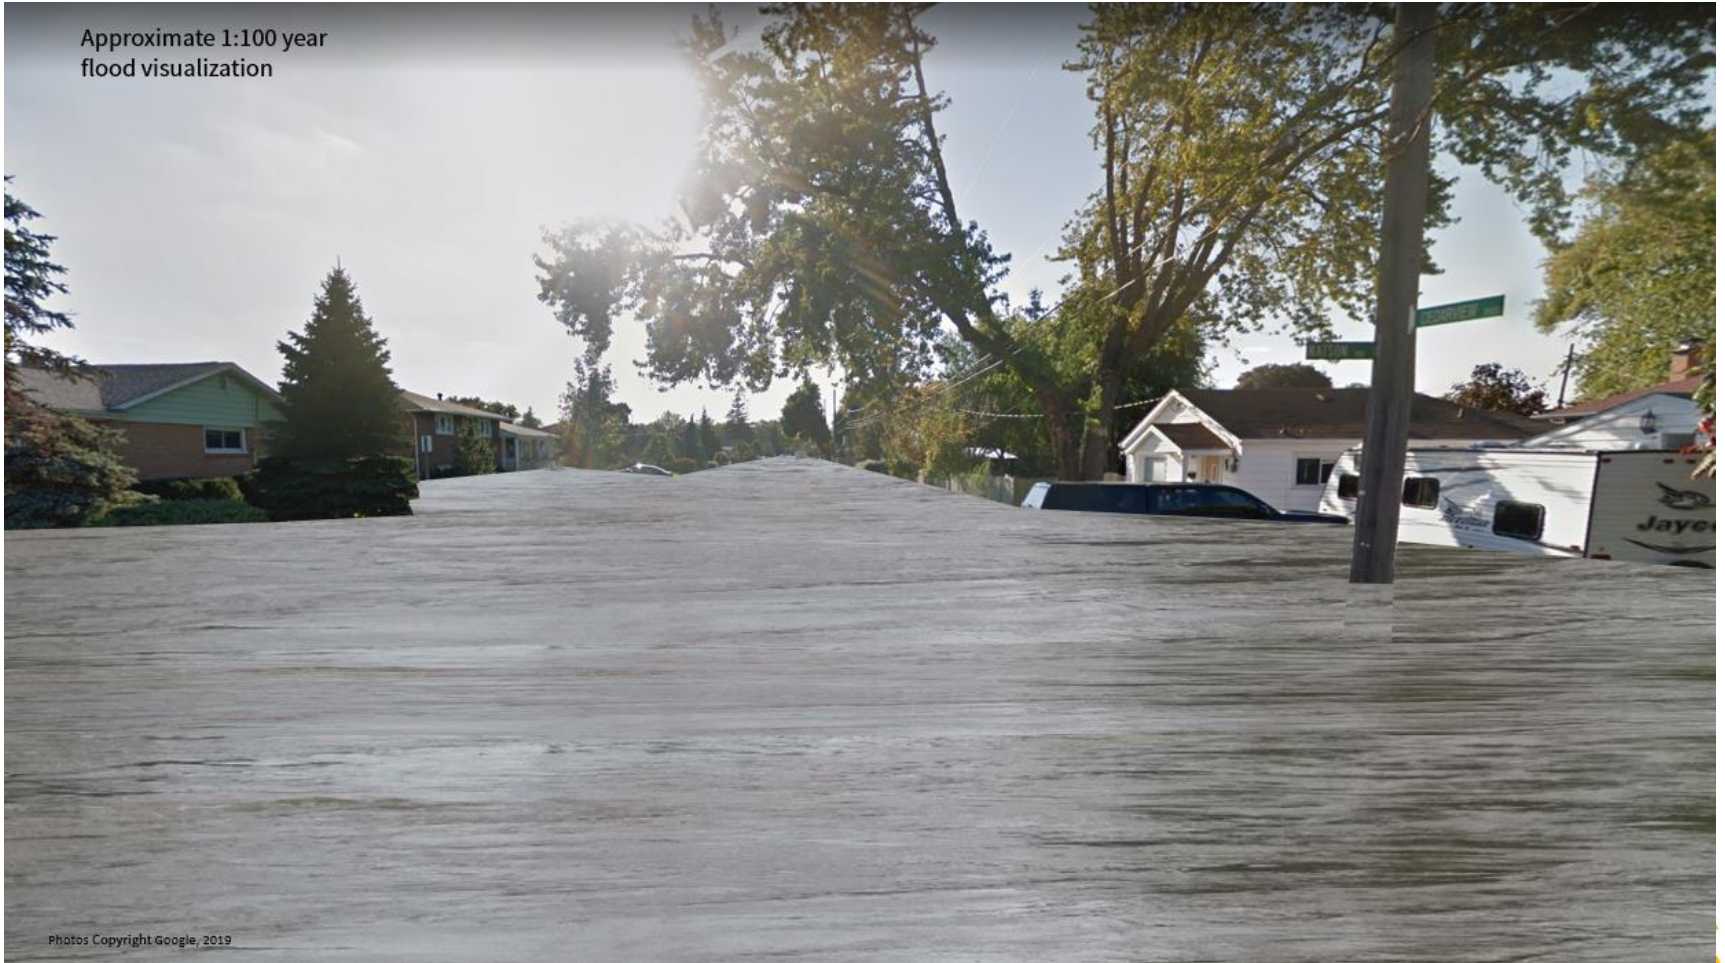
Watson & Cedarview

Approximate 1:100 year
flood visualization

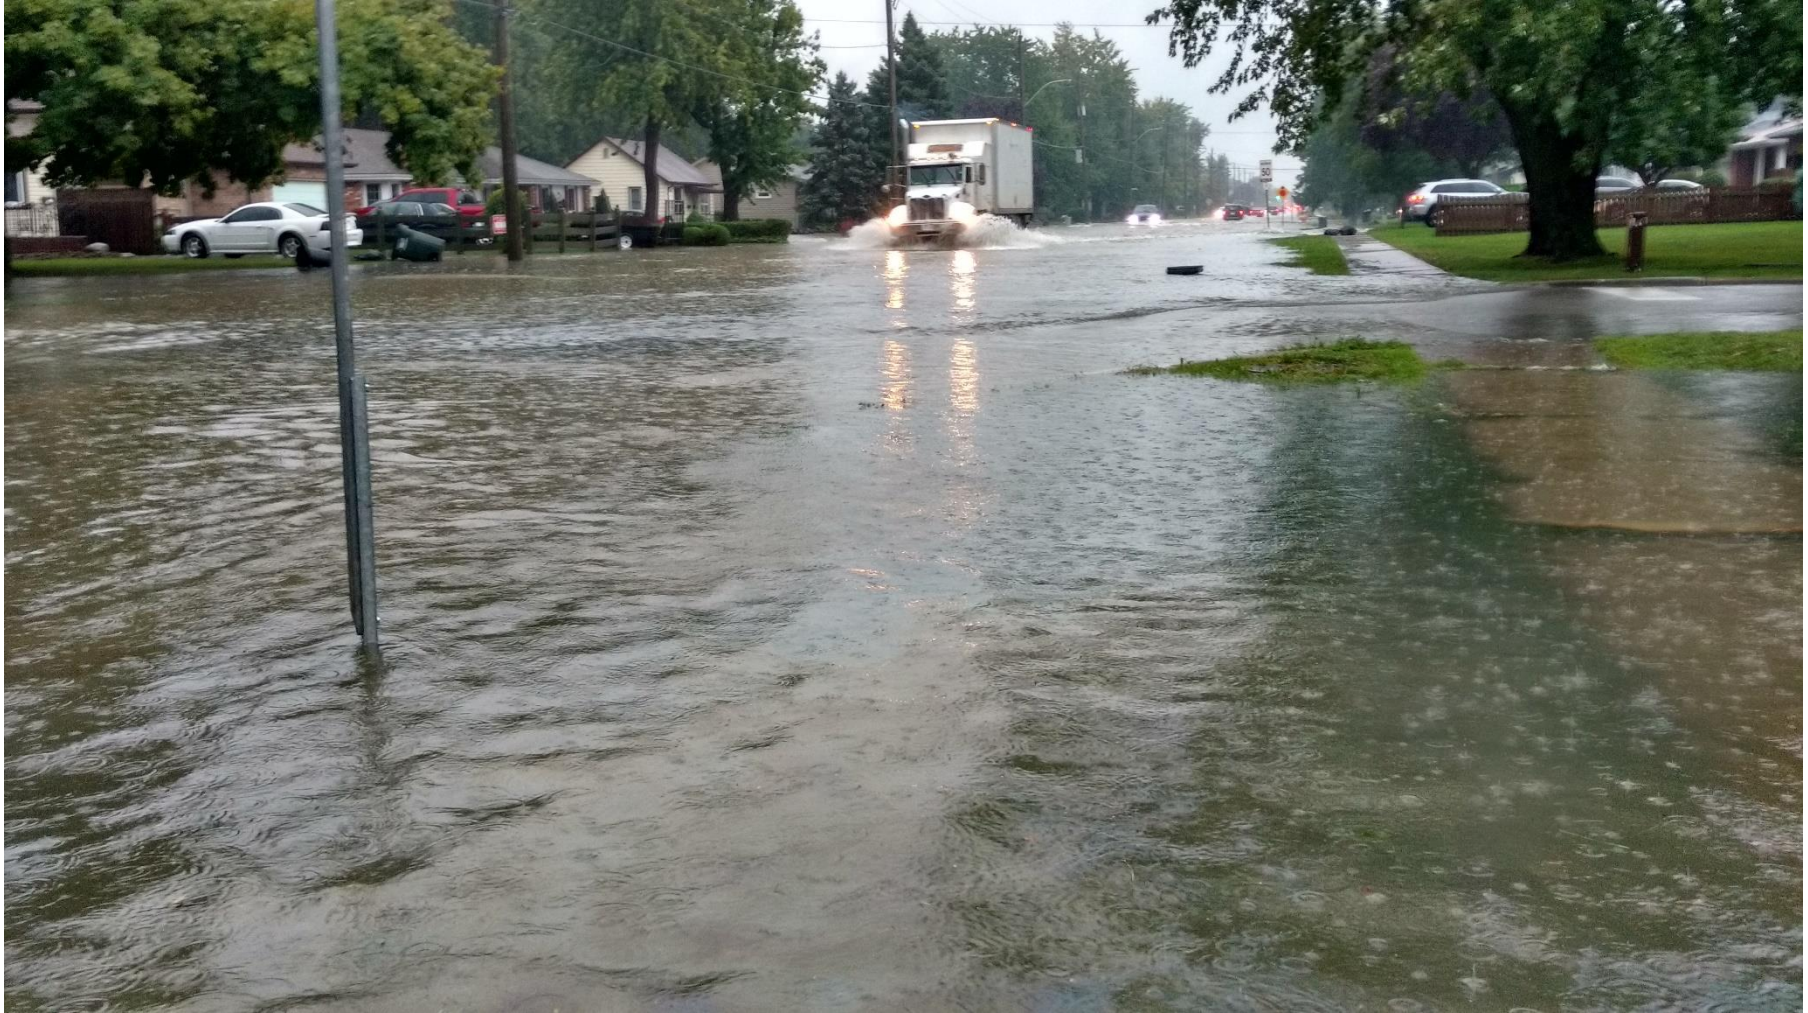
Lesperance Road

Recent Storm Events (Rainfall)

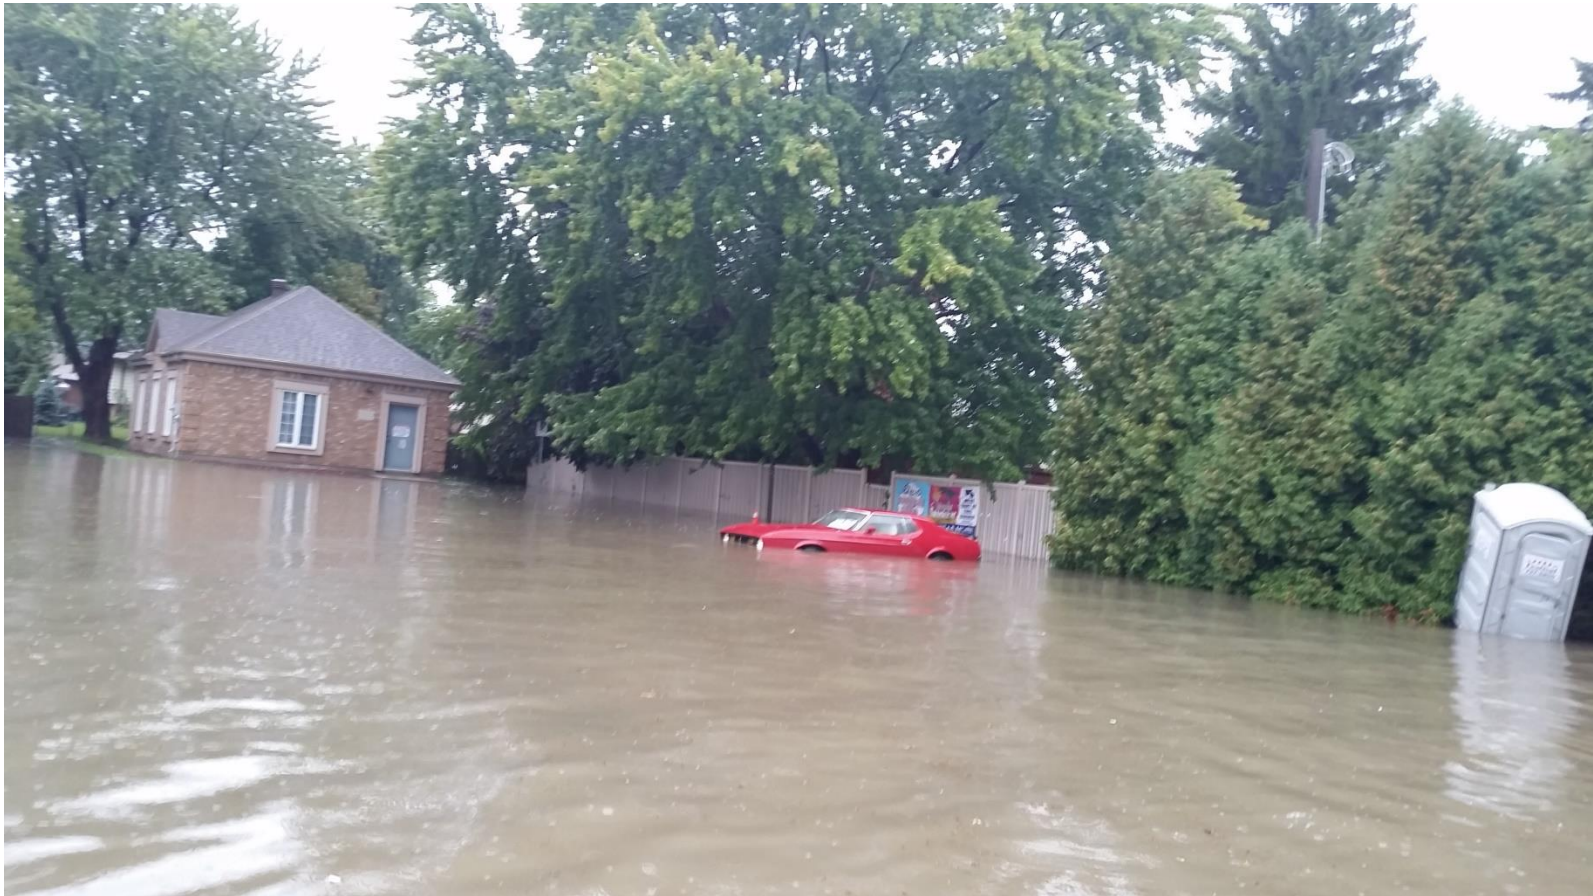
Lesperance Road – one block south of Riverside Drive

Recent Storm Events (Rainfall)
