Essex Region Conservation Authority

Meeting Agenda

RESTORATION PLAN

PREPARED BY
ESSEX REGION CONSERVATION AUTHORITY

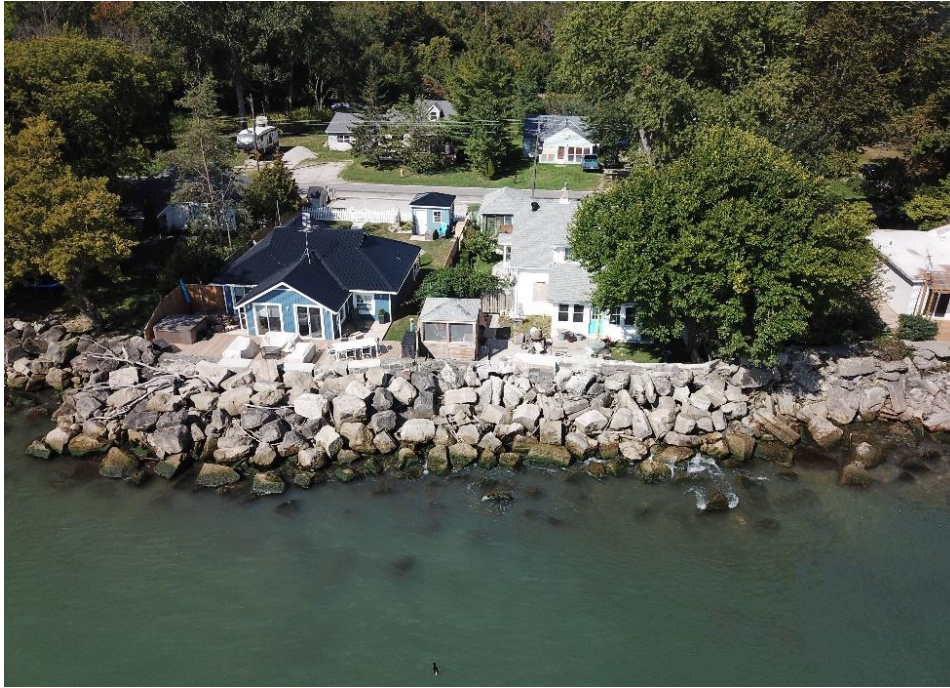
Figure 2: Shore parallel armour stone structures along Pulley Road.

supply of sediment that nourished and maintained the barrier beach, and this likely accelerated nearshore downcutting of the lakebed (Fig. 2; Zuzek Inc., 2021).

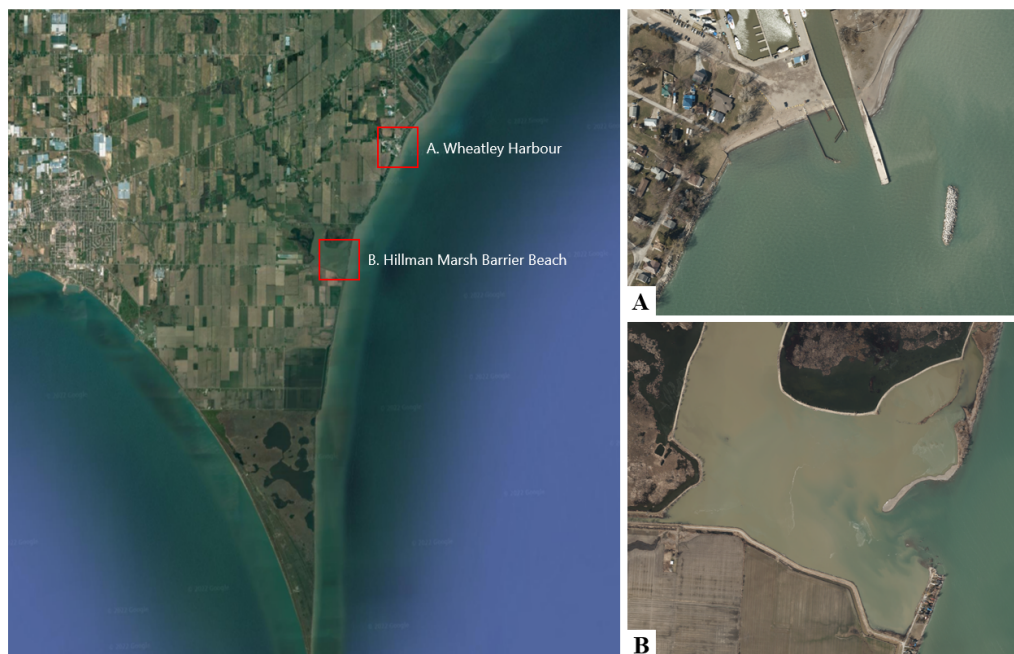
Figure 3: Hillman Marsh is located on the Point Pelee Peninsula, extending south of the shore of Essex-County. (A) The Wheatley Harbour and attached jetty have trapped or removed 525,000 m³ of sediment from the downdrift shoreline, directly affecting (B) the Hillman Marsh Barrier Beach, a 1.5 km long, eastern-facing shoreline.

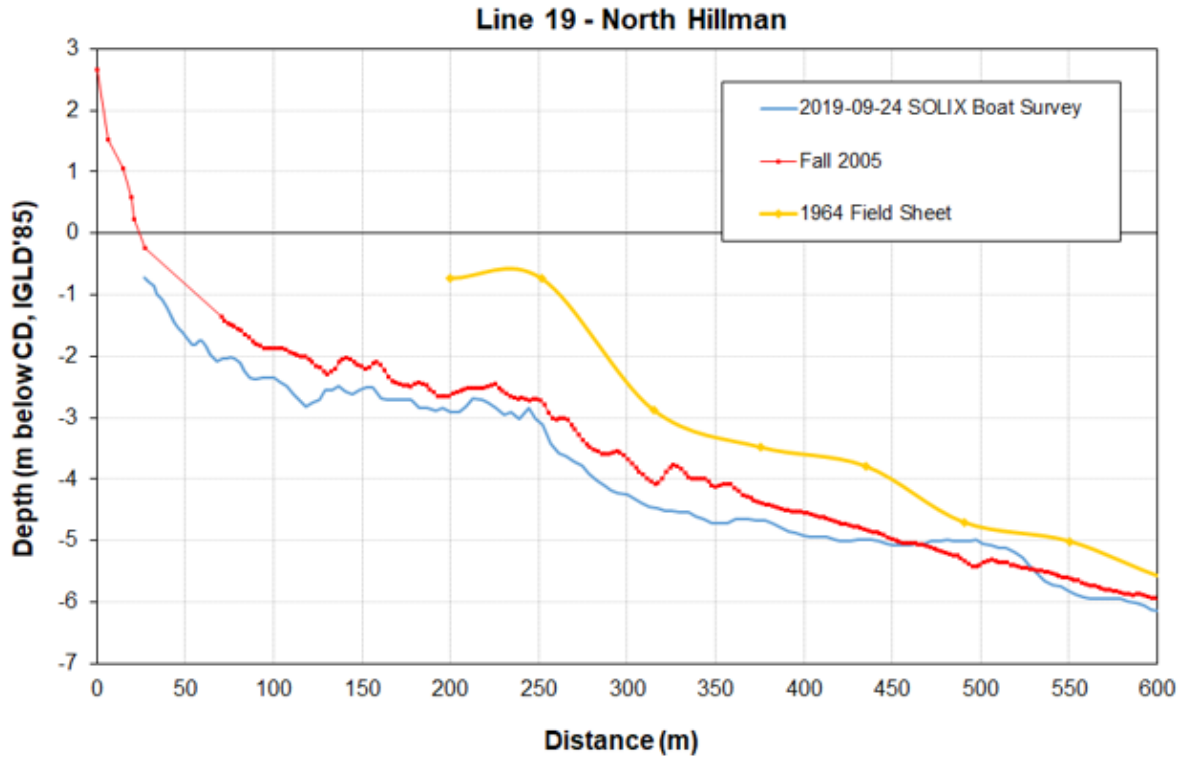
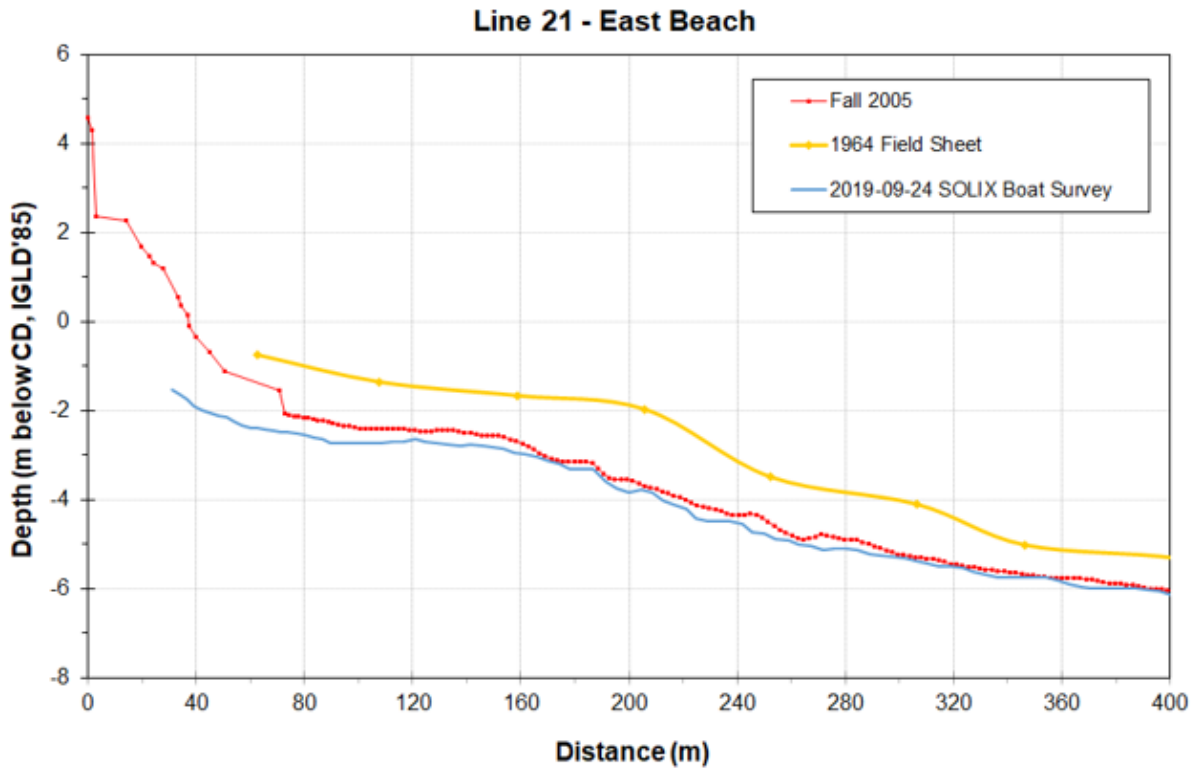
Figure 5: Bathymetric survey results show extreme lakebed downcutting at the Hillman Marsh barrier beach and East Beach (Zuzek Inc., 2021). "Depth below CD" refers to the depth below Chart Datum (173.5 m).

The natural delivery of longshore sediment transport to the Hillman Marsh barrier beach has been negatively impacted by the Wheatley Harbour jetty since its construction in 1951 (Baird, 2007). The Wheatley Harbour (built in early 1900's), attached jetty (1951), and offshore breakwater (1978) have collectively trapped or removed 525,000 m³ of sediment (Fig. 3A), but since ~2010, Small Craft Harbours and the Wheatley Harbour Authority have been mechanically bypassing dredged sediment from the navigation channel at Wheatley and placing it at the north end of the barrier beach (Zuzek Inc., 2018). Waterfront development between Wheatley Harbour and Hillman Marsh, as well as communities in East Beach and Marentette Beach, began in the 1920's when there was a lack of understanding of hazards, but has continued despite an eroding shoreline, flooding, and sediment supply concerns (Baird, 2007). While hardening at the southern spit slowed the erosion of East Beach Road, the lake bottom continues to experience significant downcutting along the stretch of shoreline from Wheatley to Point Pelee National Park. A 2019 survey found that the north end of the Hillman Marsh barrier beach nearshore area roughly 200 m offshore was 2 m deeper compared to the conditions from the 1964 survey (Fig. 5, Line 19). Similarly, approximately 2.5 km south of the site along East Beach, the entire nearshore area was more than 1 m deeper in 2019 compared to 1964 out to depths of 5 m below Chart Datum (Fig. 5, Line 21).

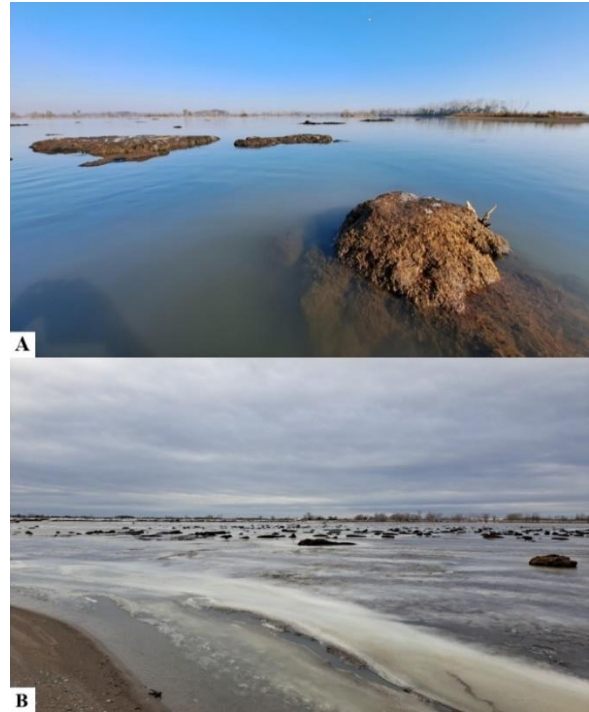
Figure 7: Decrease in width and elevation of the barrier beach has resulted in 3000-year-old chunks of peat to be exposed and dislodged. Photos taken (A) November 2nd, 2022 and (B) December 30th, 2022. Photos courtesy of Wayne King.

Due to the shallow bathymetry of Lake Erie's west basin (average depth of 8 m; Assel, 2004), ice develops quickly around Hillman Marsh, protecting the beach and marsh from winter storm-driven waves and sediment loss (BaMasoud and Byrne, 2012). However, rising temperatures and milder winters will reduce the amount of protective ice cover. Most notably, the winter of 2019/2020 had a near record low Annual Maximum Ice Cover (AMIC) of 15.9%, which had not been observed in almost a decade (Fig. 6; GLERL, 2022). Due to the collective factors of inadequate sediment supply, an eroding lake bottom, rising water levels, warming temperatures, and climate driven extreme storm events, Hillman Beach has decreased in both elevation and width, to such a degree that 3,000-year-old chunks of underlying peat are being exposed in the breach channel and dislodged (Zuzek Inc., 2021; Fig. 7).

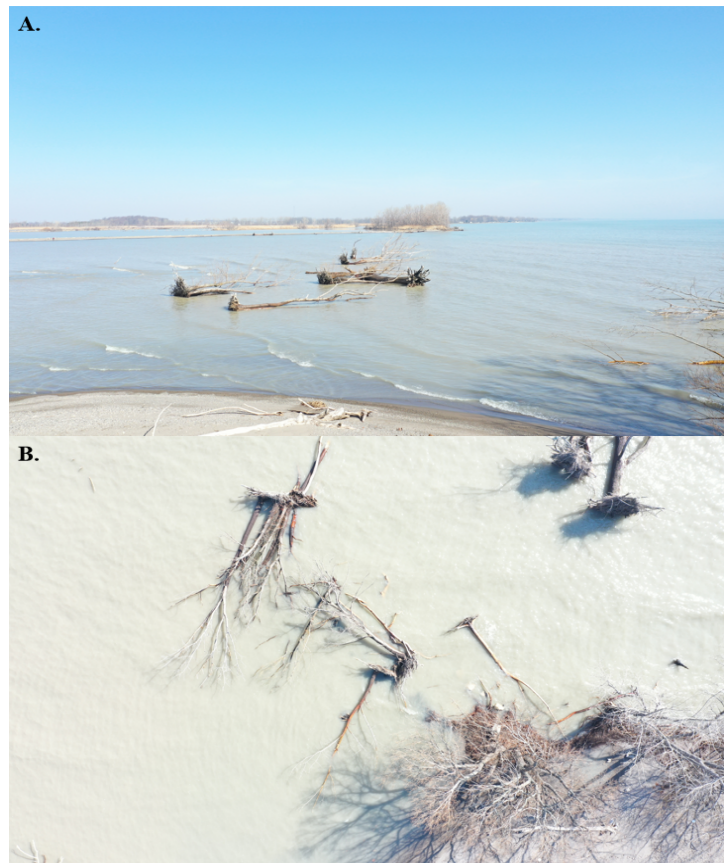
Figure 10: Dislodged and submerged vegetation along eroding shoreline in original barrier location. A) View from the southern spit looking north, B) aerial view between both spits. Photos taken March, 2021.

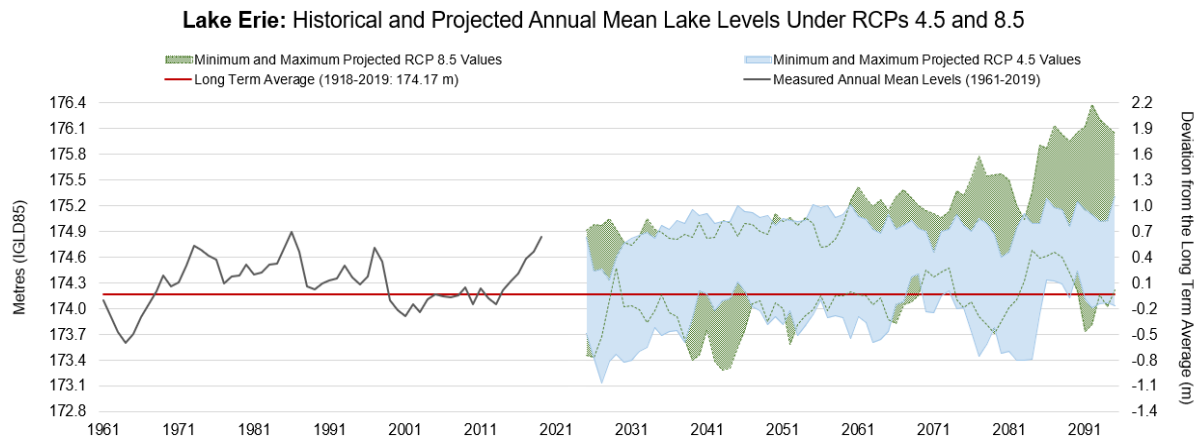
Figure 18: Historical and projected lake levels for Lake Erie under both RCP 4.5 and RCP 8.5. Projected for 2025-2095 (ERCA, 2022).

Static lake levels (non-storm conditions) have fluctuated by as much as two metres over the last 100-years on Lake Erie, and lake-levels are projected to increase in variability, resulting in more extreme highs and lows (Theuerkauf and Braun, 2021). Under RCP 4.5, average annual lake-levels for Lake Erie are expected to rise by 0.3 m by the end of the century. Under RCP 8.5, average annual lake-levels are expected to increase by 0.5 m by the end of the century (Fig. 18; ECCC, 2022). In addition to higher average lake level conditions, the extreme high levels associated with wet periods such as 2019 are expected to be on the order of 0.4 to 0.5 m higher with 2.0°C to 2.5°C of global warming (Seglenieks and Temgoua, 2022). Higher average lake levels and higher extreme water levels during wet periods will increase the exposure of infrastructure, transportation, natural environment, and recreation facilities to natural hazards such as erosion and flooding.

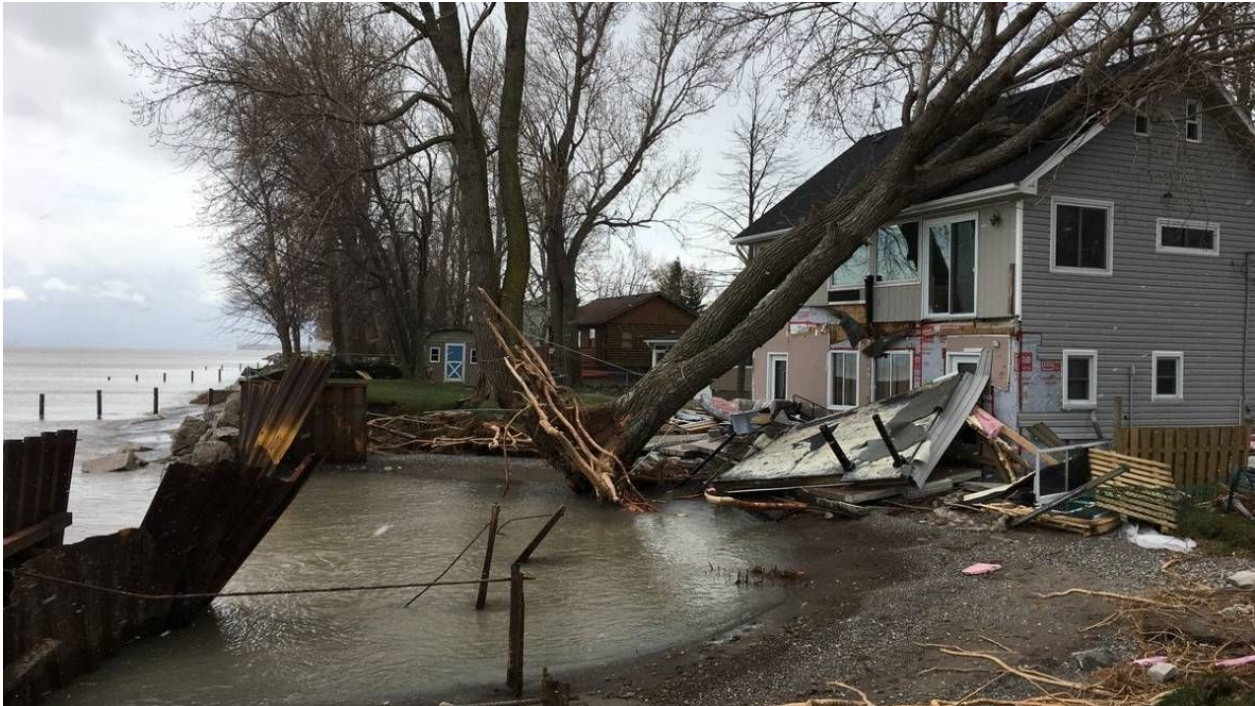
Figure 19: Failed seawall and home damage along Marentette Beach (south of HMCA) following the April 2018 ice storm.

can become breached and damaged, reducing their protective function for coastal infrastructure (Fig. 19). The increased exposure to coastal storms is a pressing issue at HMCA, as the Road 1 dyke is vulnerable to failure, which could lead to extensive inland flooding due to the low-lying nature of the agricultural lands in the drainage schemes (Zuzek Inc., 2021).

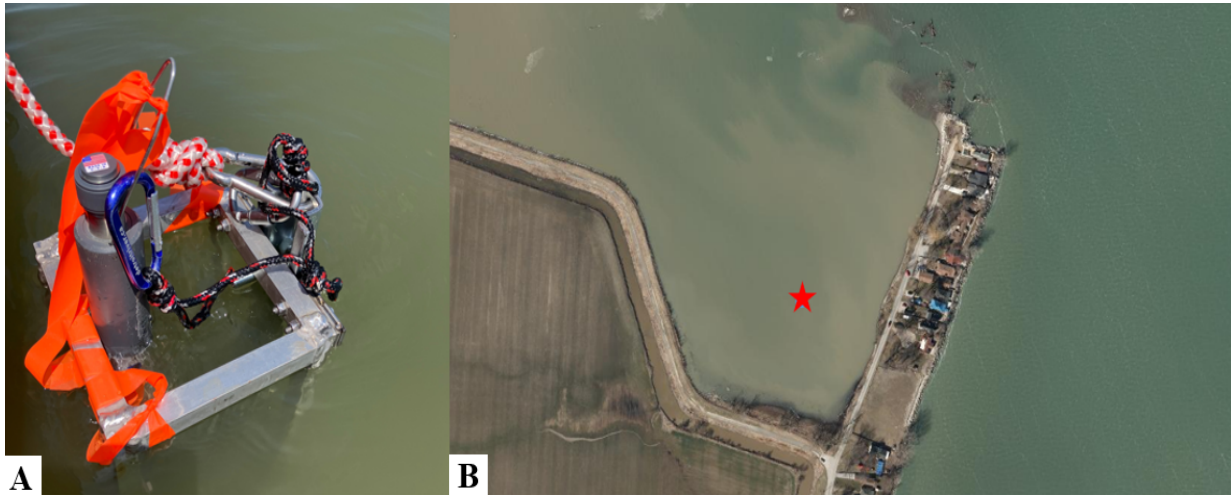
Figure 21: (A) Set up of deployed turbidity sensor. (B) Location of turbidity sensor in the Marsh.

A water quality monitoring instrument (YSI 600OMS V2 Optical Monitoring Sonde; Fig. 21A) was deployed at Hillman Marsh in July 2023 to collect continuous measurements of temperature and turbidity at an interval of 15 minutes. The sensor was placed in a sheltered area of the marsh, roughly 80 m offshore (Fig. 21B), to get an accurate understanding of turbidity levels in the area that would be the main focus in revegetation efforts further along in the project. Discrete measurements were taken of pH, dissolved oxygen, specific conductivity, and ambient conductivity roughly every 3 weeks using a YSI ProDSS Multiparameter Digital Meter (Table 1). Water samples were collected and sent to a laboratory for measurements of total suspended solids (TSS). The sensor was retrieved in late October 2023, with a total of 111 full days and 2 partial days of data.

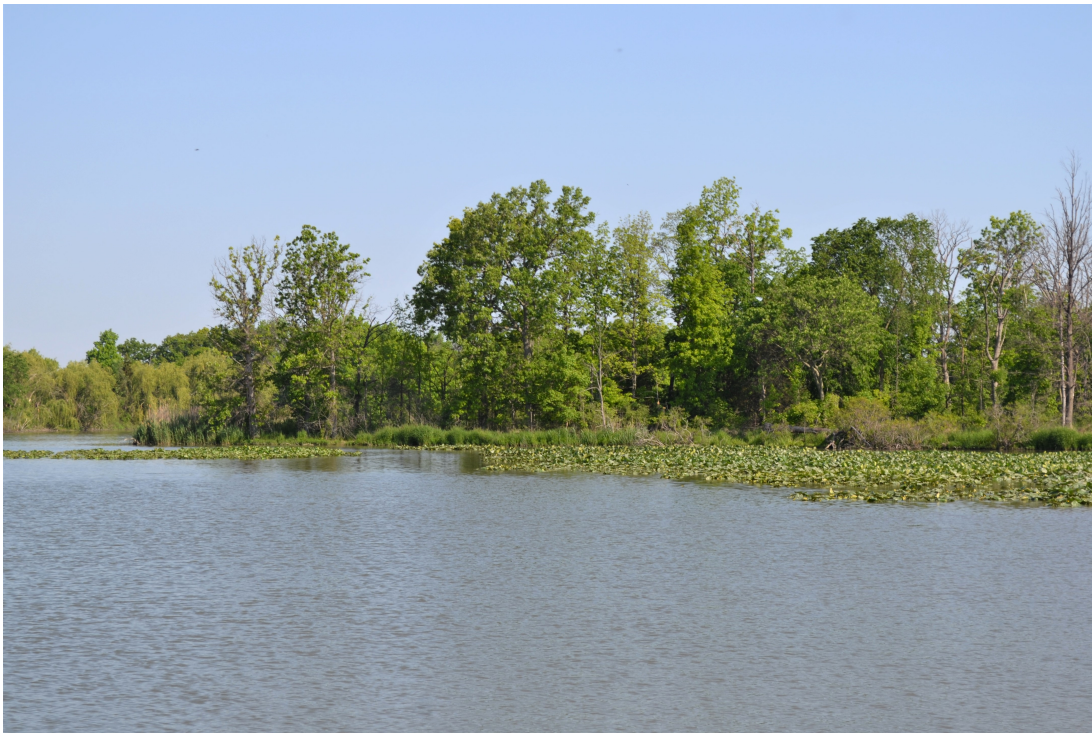
Figure 23: Floating aquatic vegetation in Hillman Marsh re-establishing this summer (June 2023).

Since breaching of the protective barrier beach, wave agitation may have resulted in sediment stirrup in Hillman Marsh, and the subsequent increased turbidity levels resulted in the loss of submerged aquatic vegetation. Although emergent and floating vegetation can grow in turbid waters (floating vegetation has resurfaced this summer; Fig. 23), clear water is needed early in the growing season for new seedlings to establish (Austin et al., 2017). Once the barrier beach is restored, there will be a buffer between the marsh and the harsh conditions of Lake Erie, which should result in less sediment stirrup - allowing for the successful reestablishment of aquatic vegetation. Additionally, an increase in aquatic vegetation will help reduce future turbidity levels caused by bottom-feeding fish by trapping sediment (McNair and Chow-Fraser, 2003). Re-establishing aquatic vegetation will also help attenuate waves, regulate nutrients, and absorb CO₂ (Austin et al., 2017).

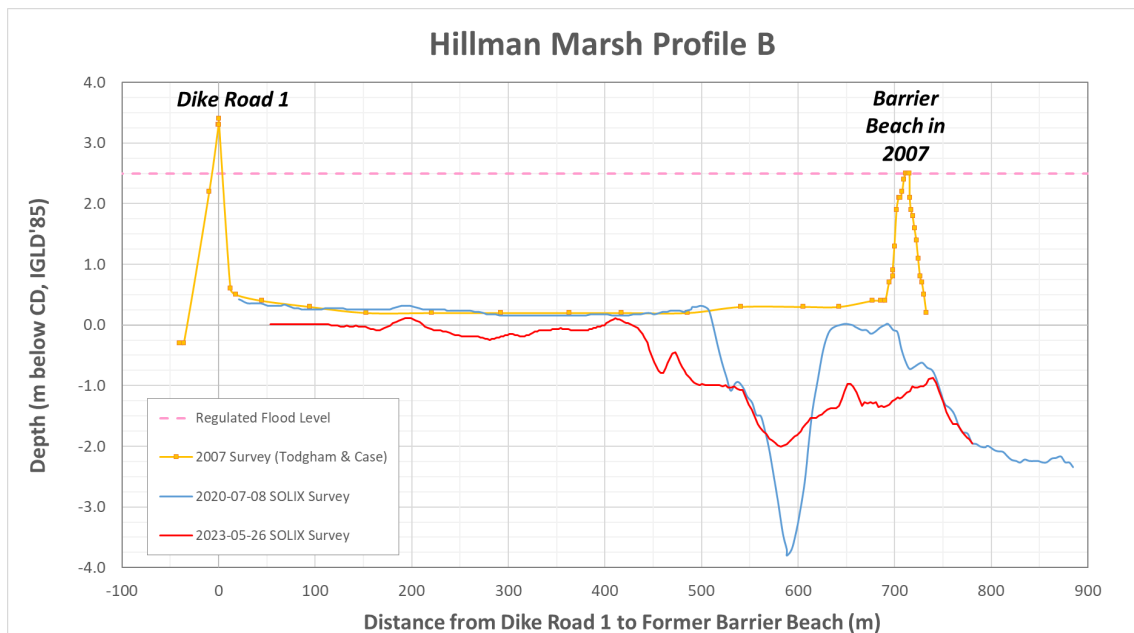
Figure 25: 2007 to 2023 Comparison of Marsh and Barrier Depths at Profile B in Figure 24.
