# GREAT LAKES WATER LEVELS

## Current Conditions and Outlook

July 15, 2019

Essex Region  
Conservation Authority  
*sustaining the place for life*

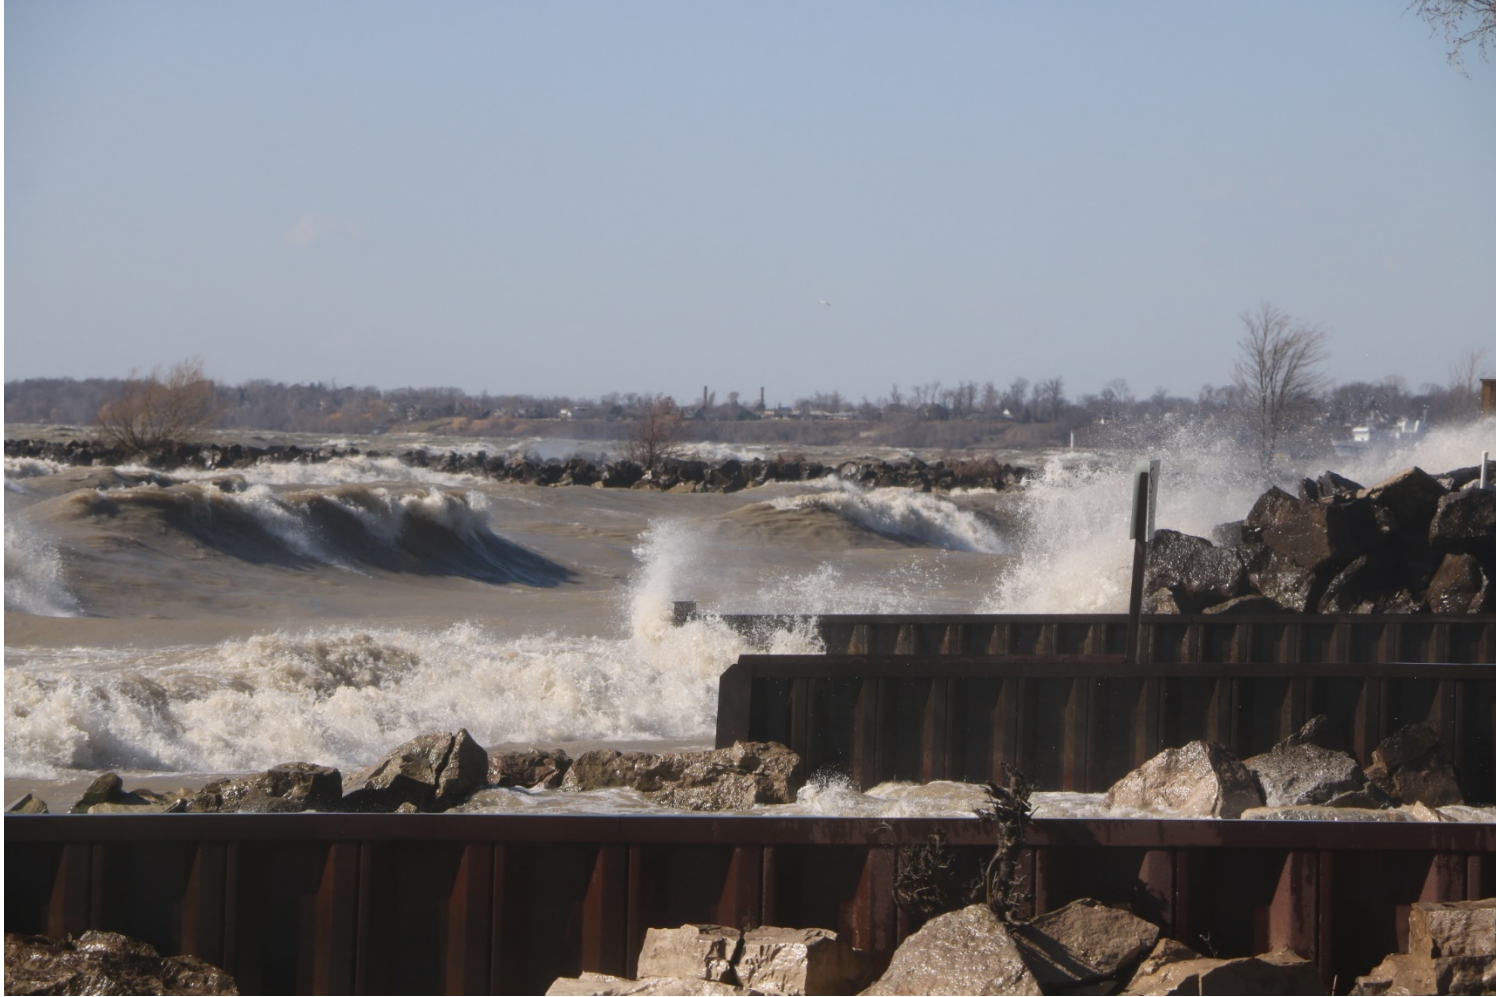
Lake Erie - Sturgeon Creek Outlet

# Recent Storm Events

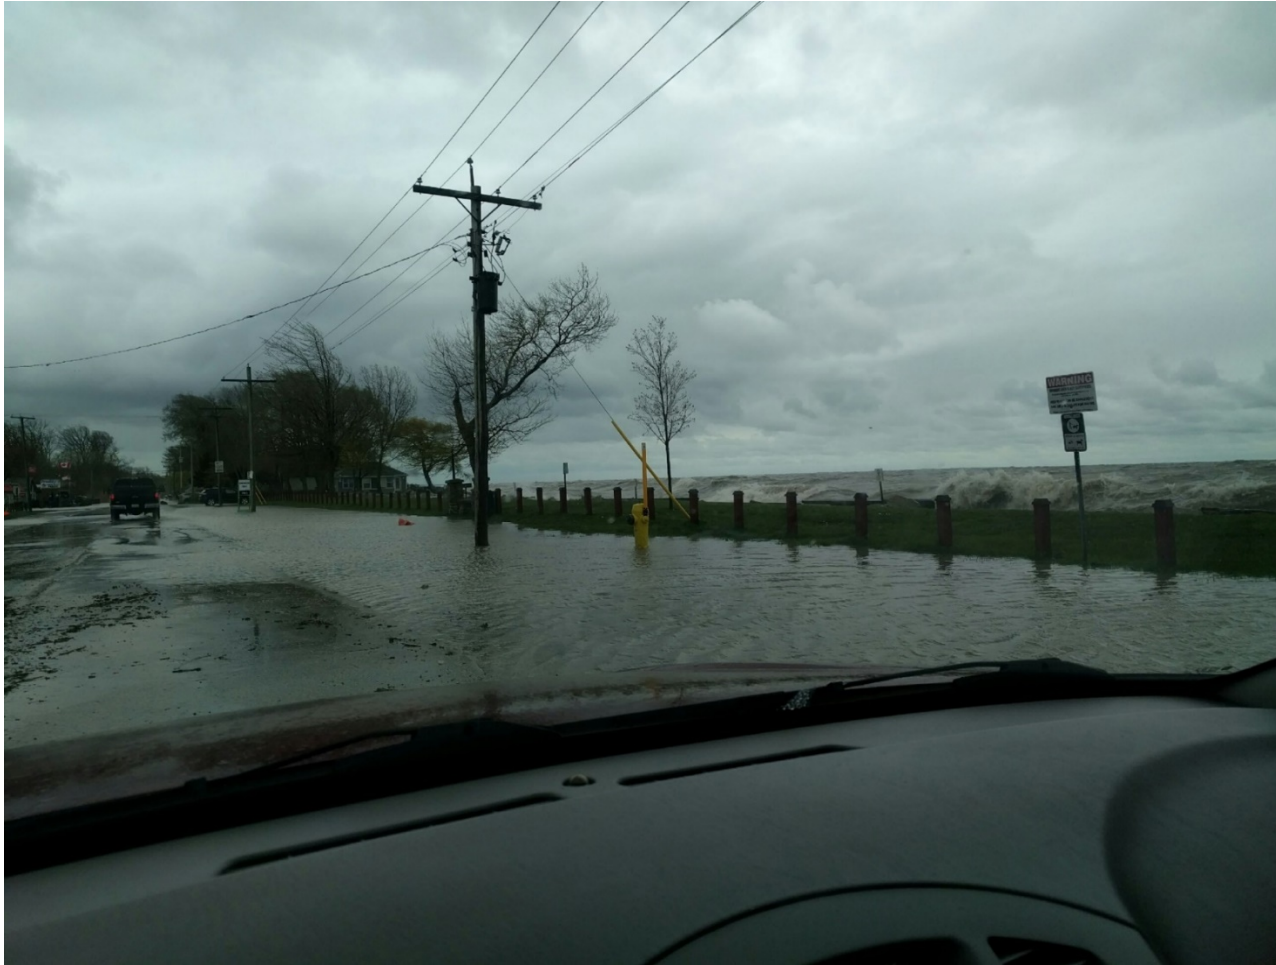
Lake Erie – Point Pelee Drive

# Recent Storm Events

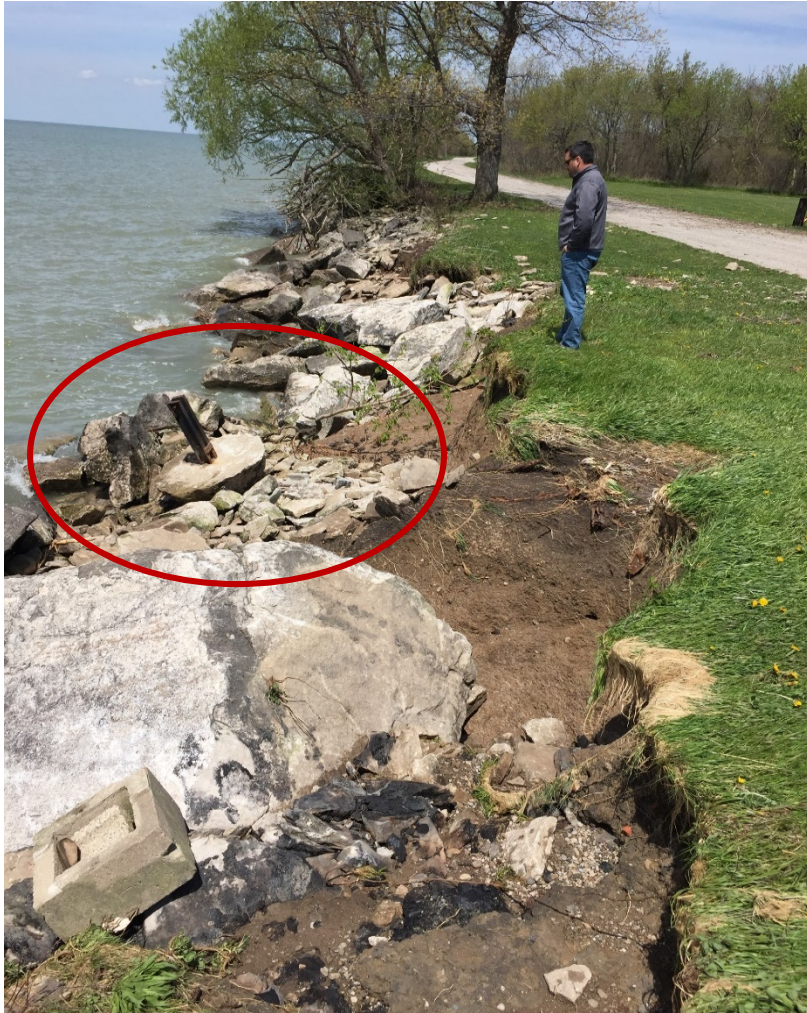
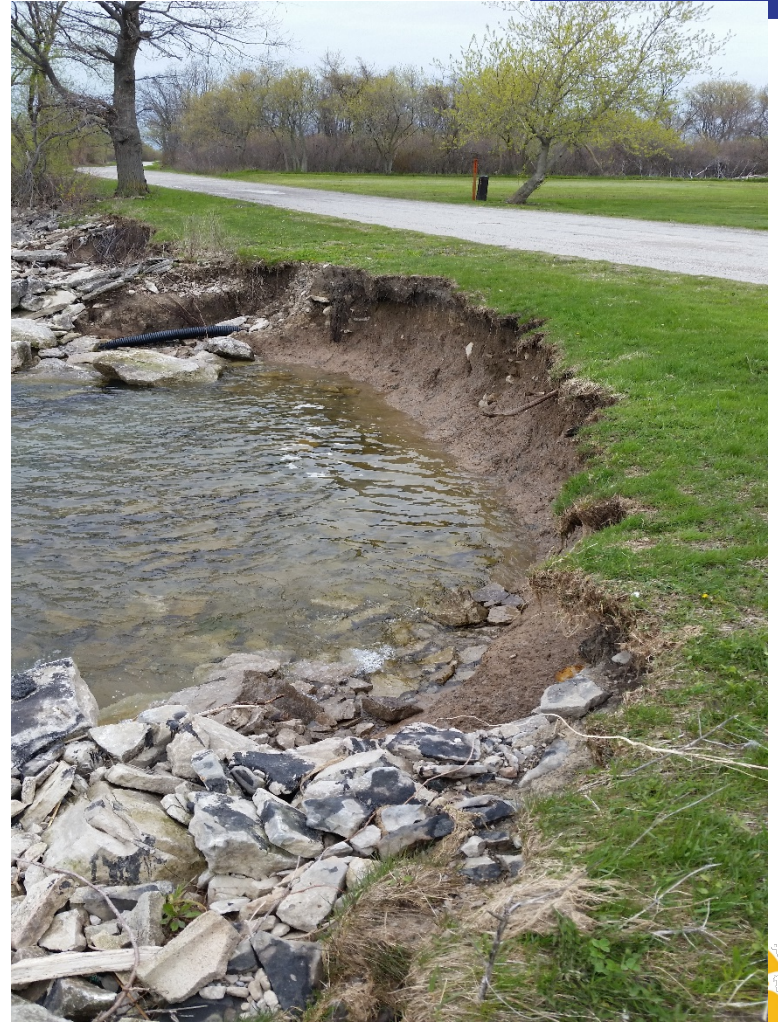
Lake Erie – Pelee Island

# Recent Storm Events

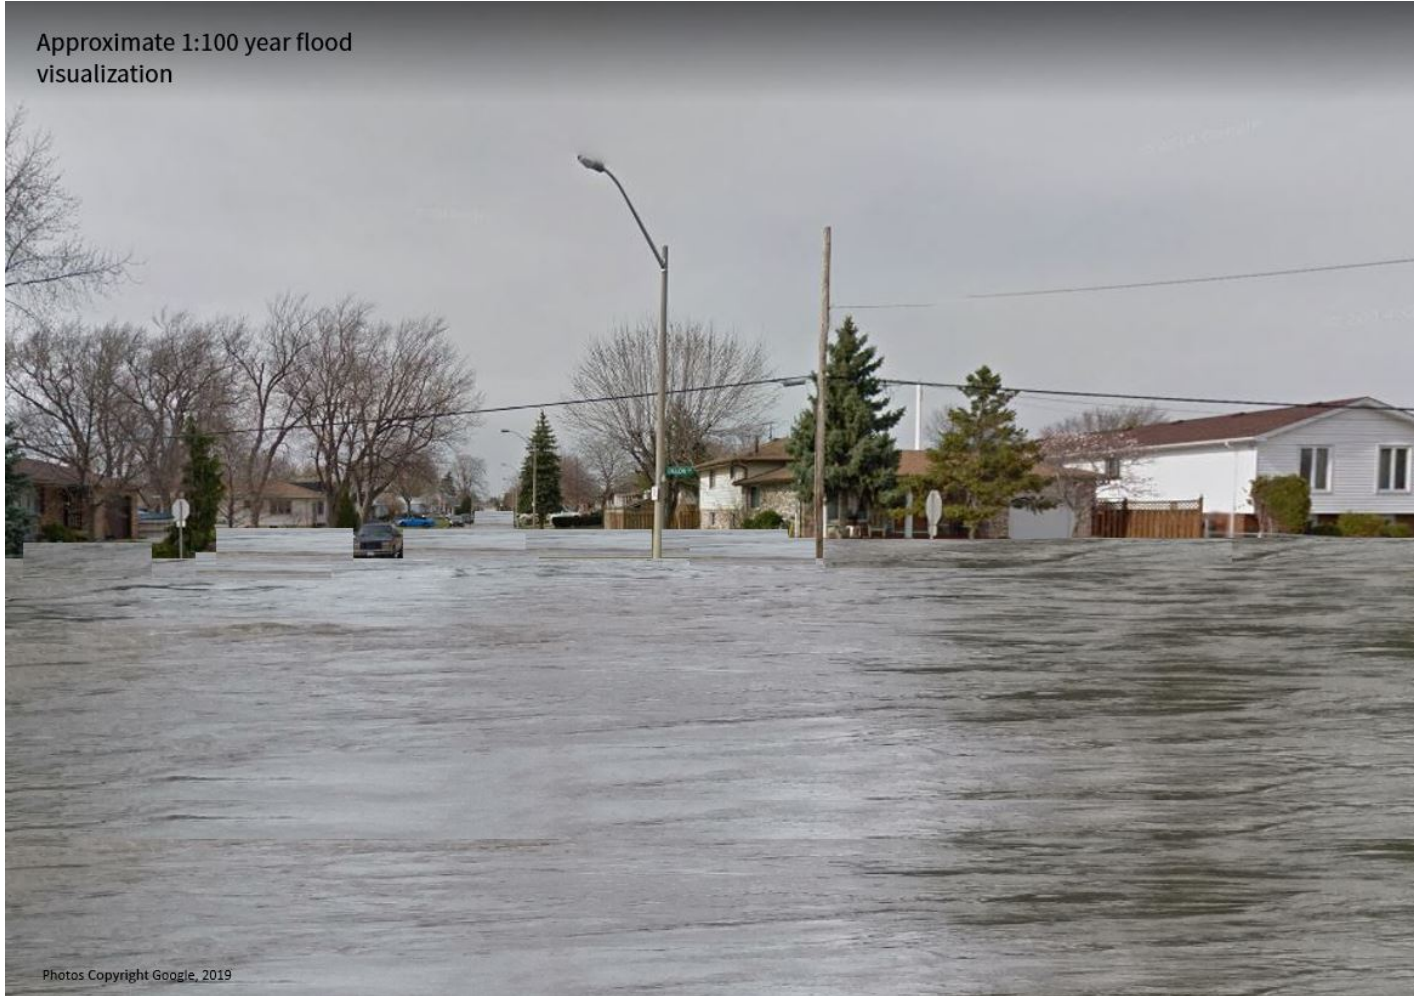
Approximate 1:100 year flood  
visualization

Intersection of Chene and Dillon (visualization)

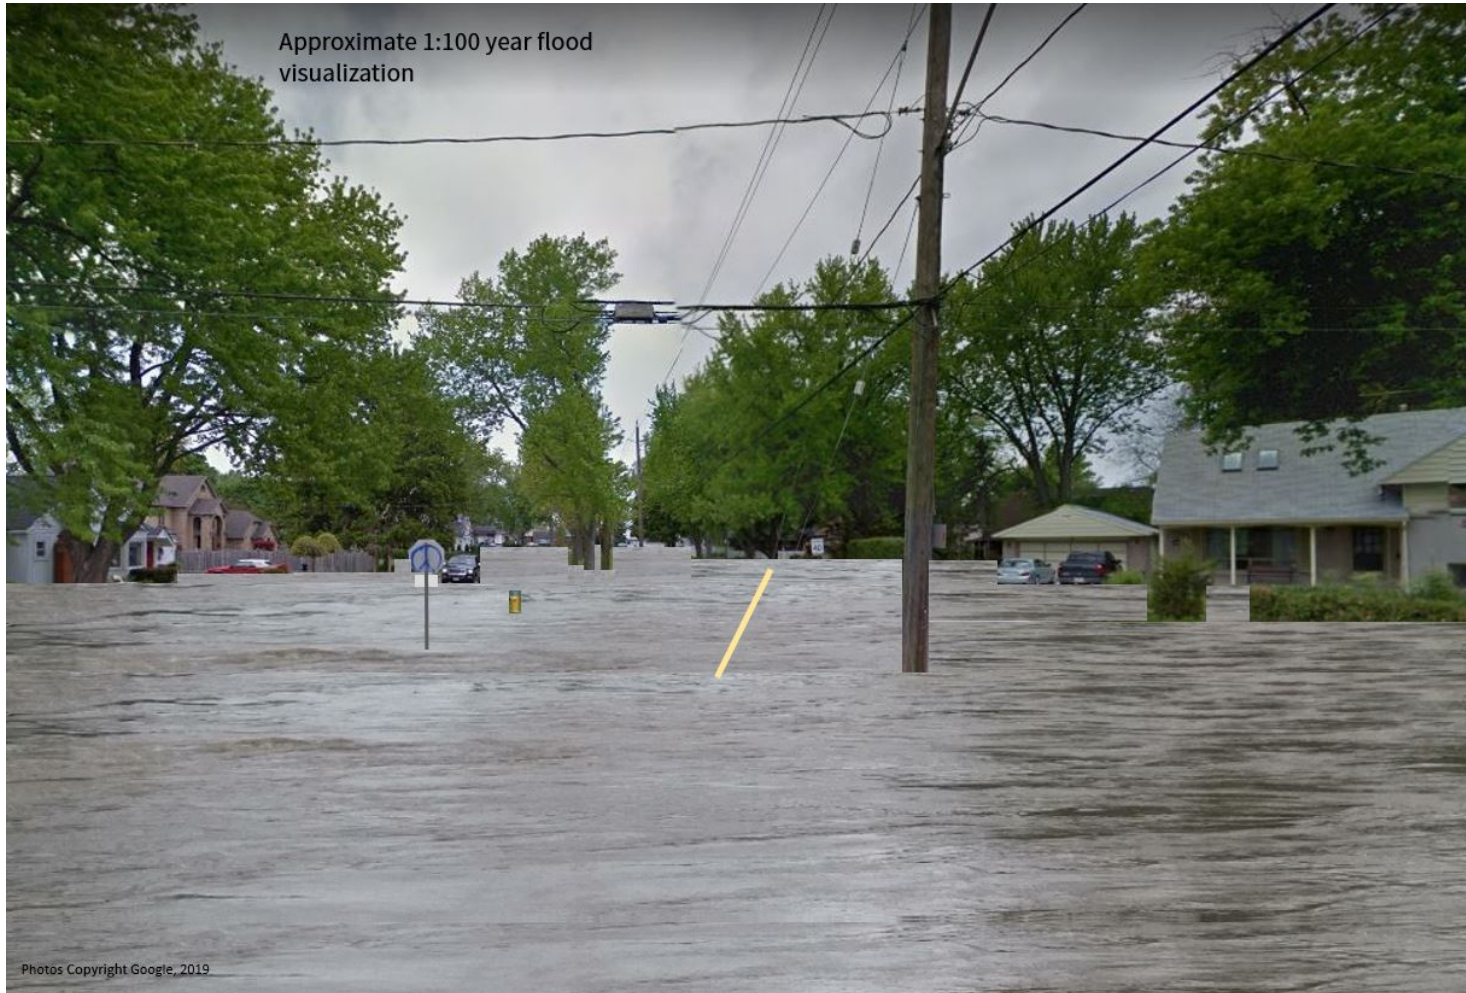
Intersection of Lacasse and Dillon (visualization)

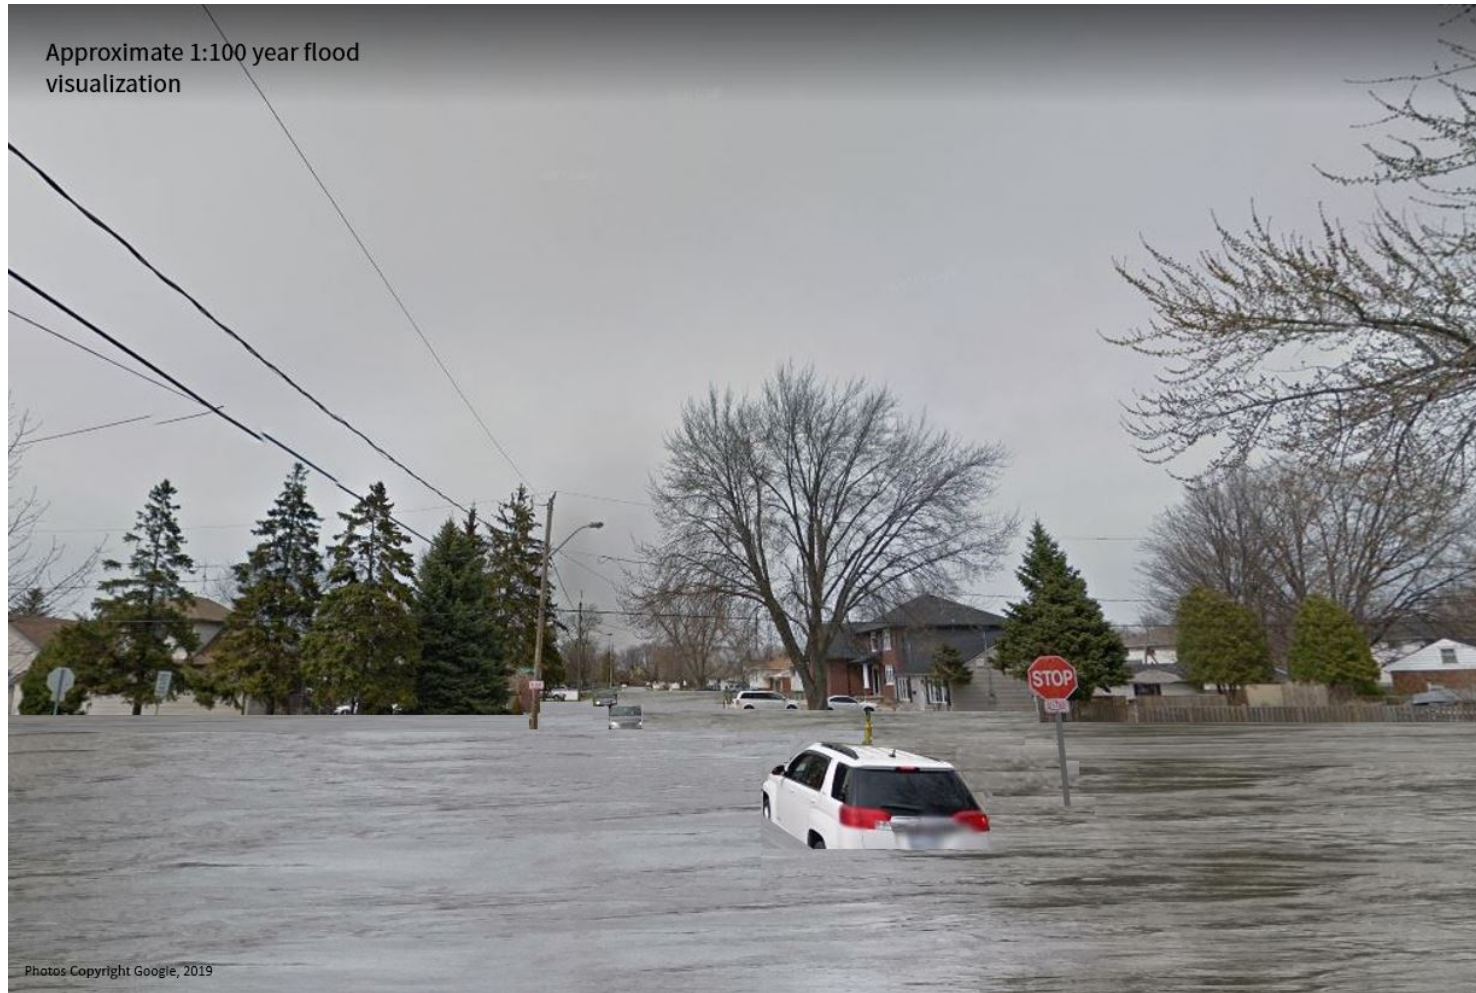
Intersection of St. Pierre and Dillon (visualization)
