GREAT LAKES WATER LEVELS

Current Conditions and Outlook

July 15, 2019

Essex Region
Conservation Authority
sustaining the place for life

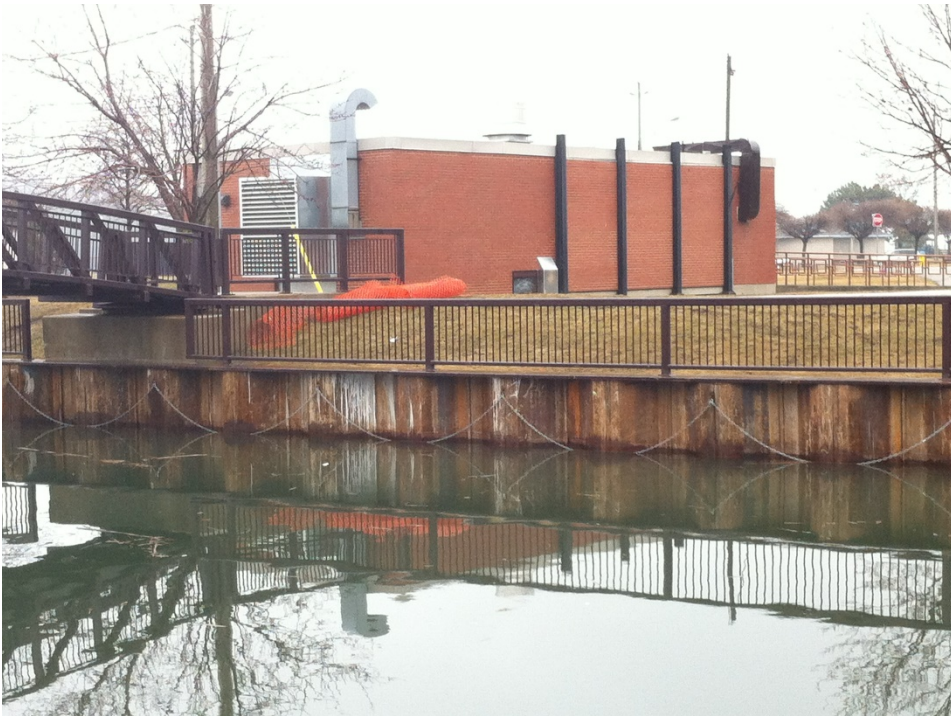
March 2015

Little River – Little River Pump Station at Riverside Drive

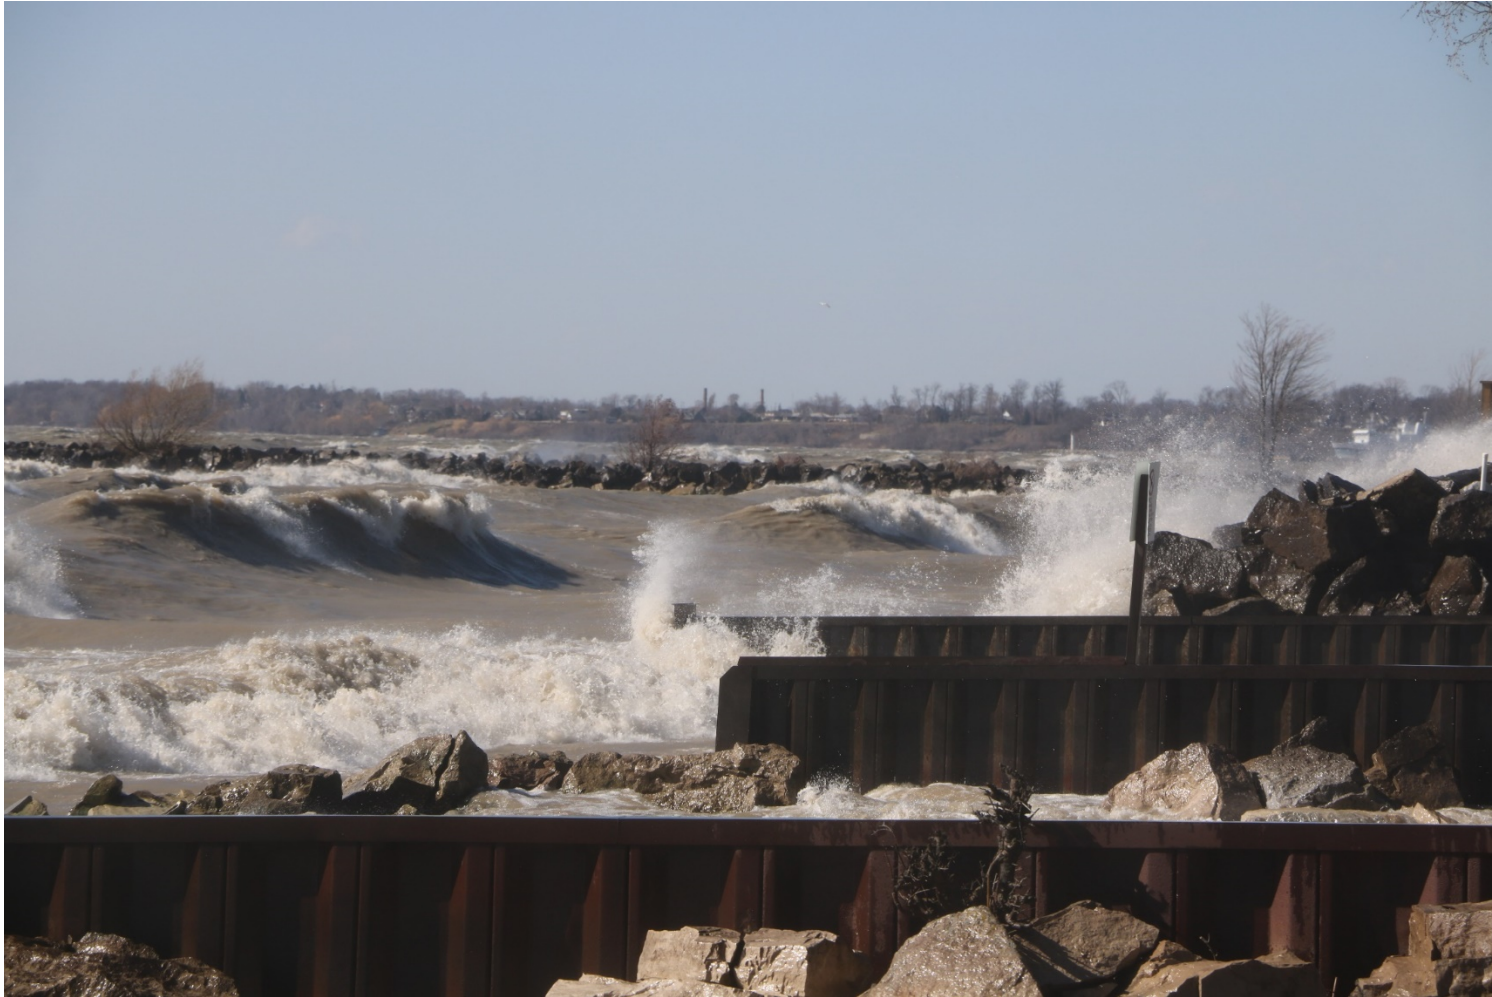
Lake Erie - Sturgeon Creek Outlet

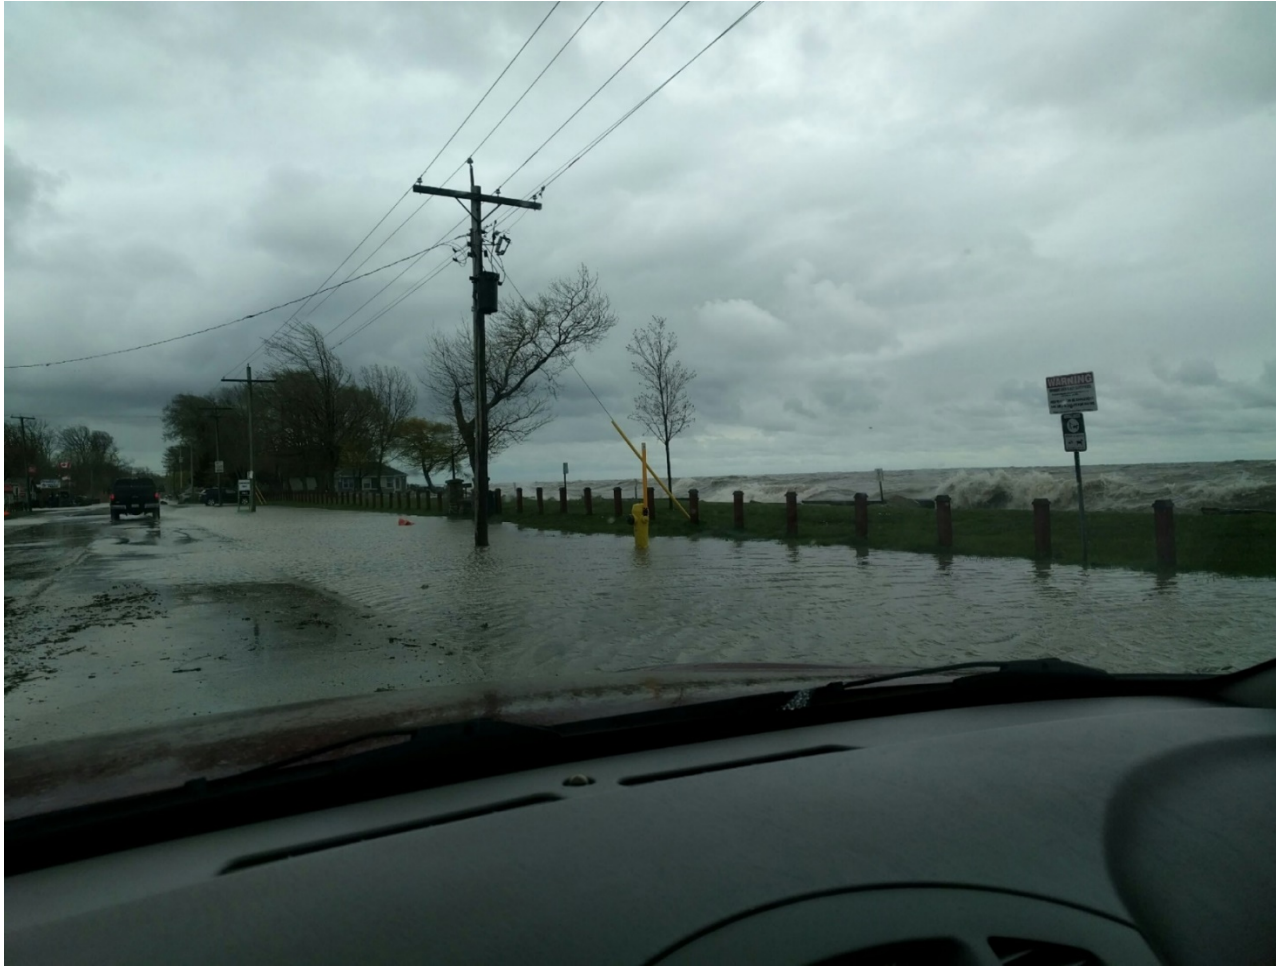
Lake Erie – Point Pelee Drive

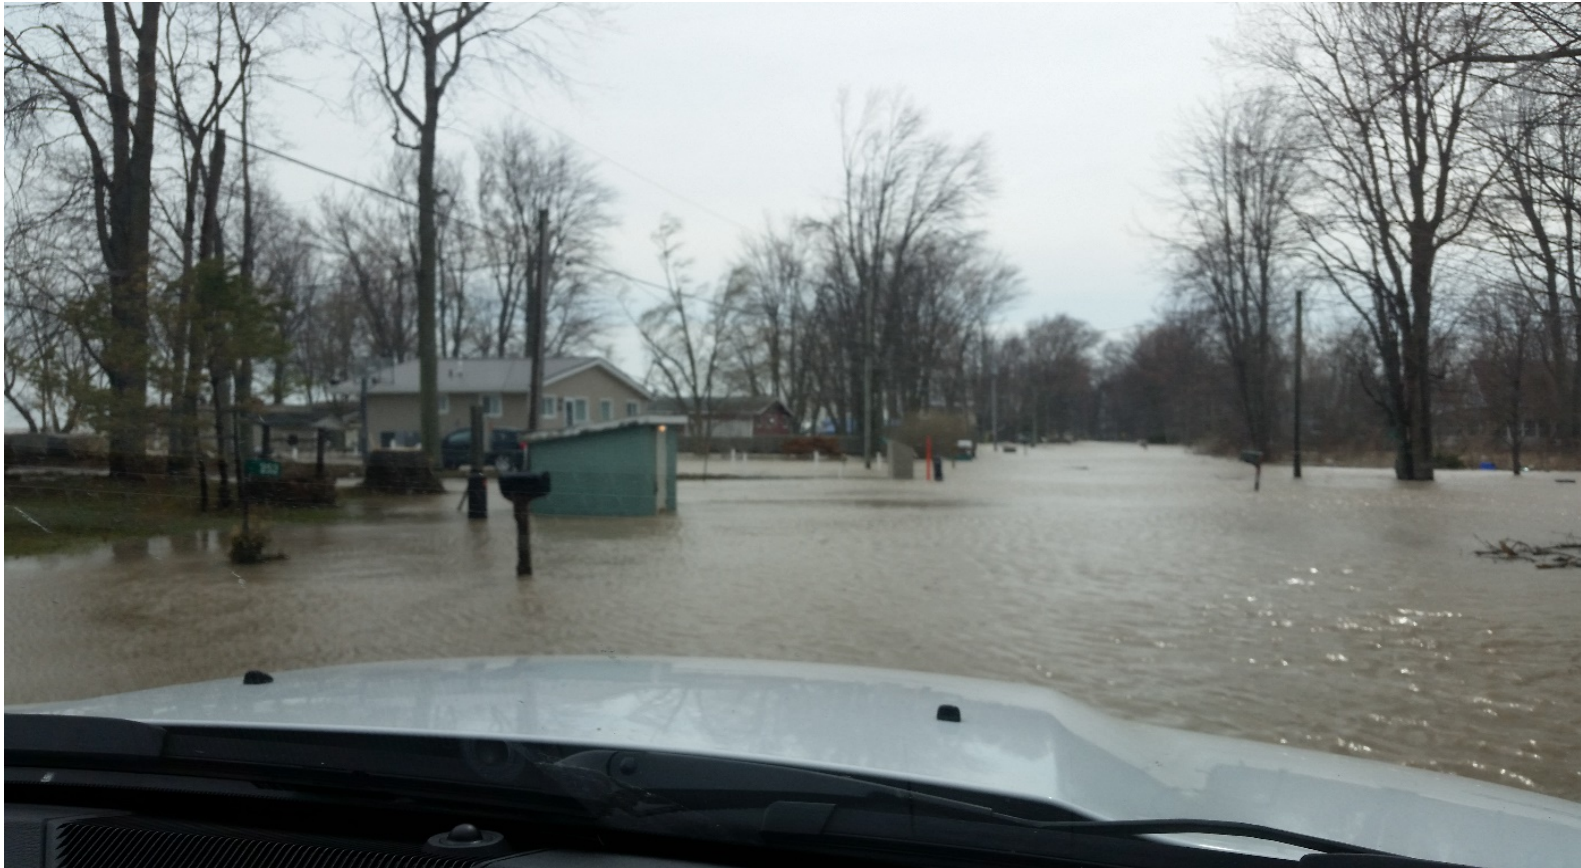
Lake Erie – Cotterie Park Road 2019 (April 11, 14 and May 1, 8, 12)

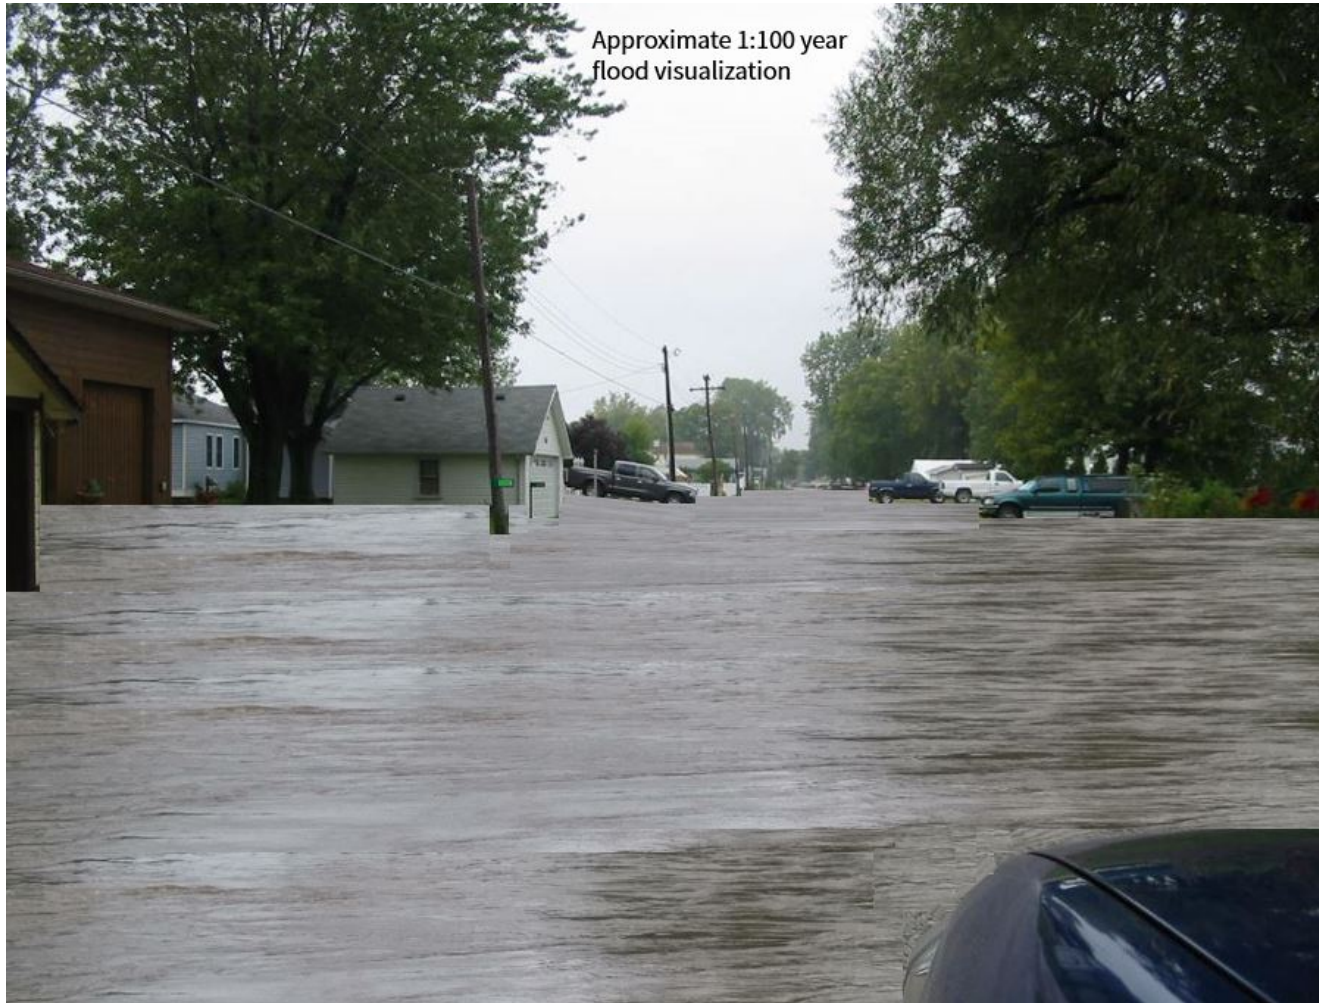
Lakeside Drive

Approximate 1:100 year
flood visualization

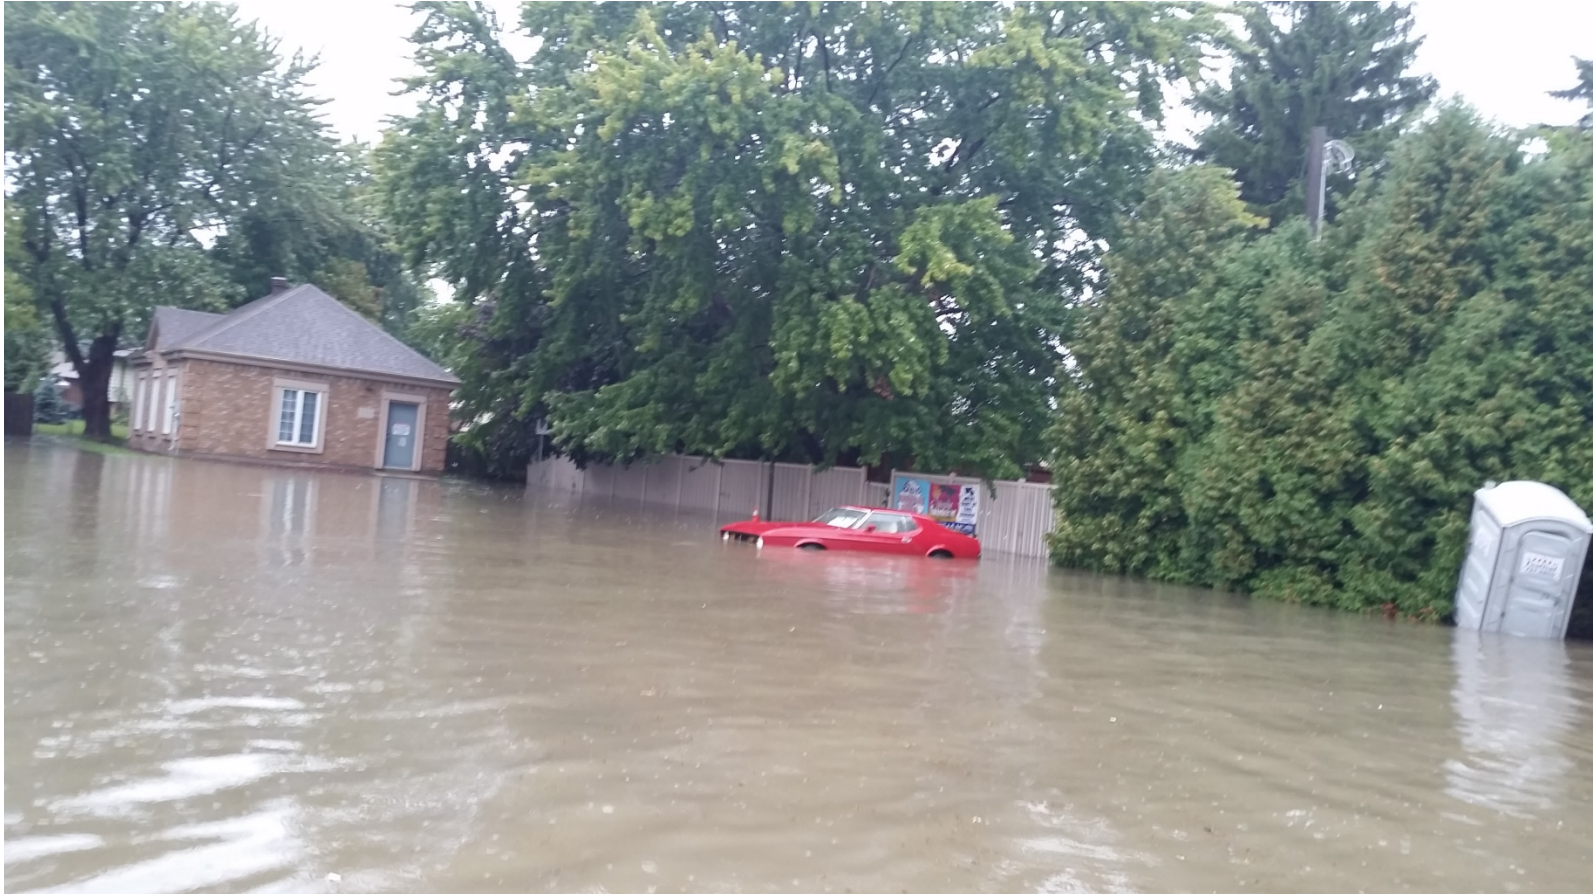
Lesperance Road – one block south of Riverside Drive
